Westlake Interceptor Repair Savings Prove Long-Term Success

CITY OF WESTLAKE

REHABILITATION PROJECT

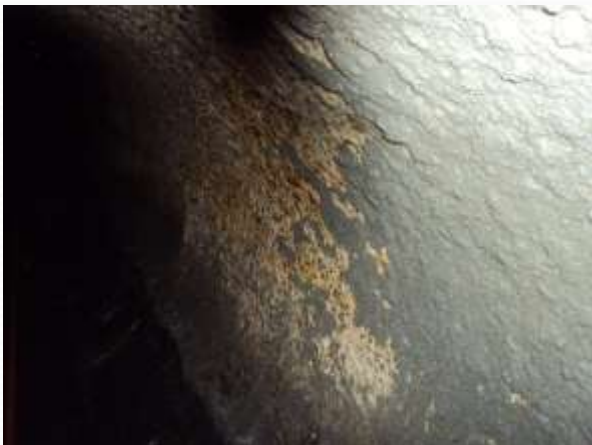
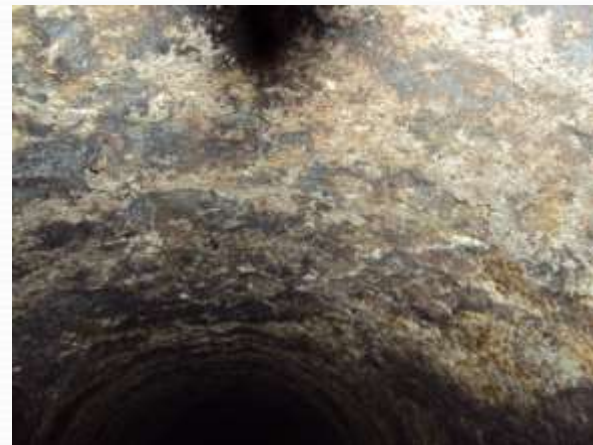
HYDROGEN SULFIDE CORROSION

- BACTERIAL GROWTH OCCURS ON RCP WITH A $\text{pH} < 7$
 - CARBON DIOXIDE
 - HYDROGEN SULFIDE
- 17 pH SWAPS TAKEN – MH INSPECTION
 - 15 SITES – pH OF 5
 - 2 SITES – pH OF 2

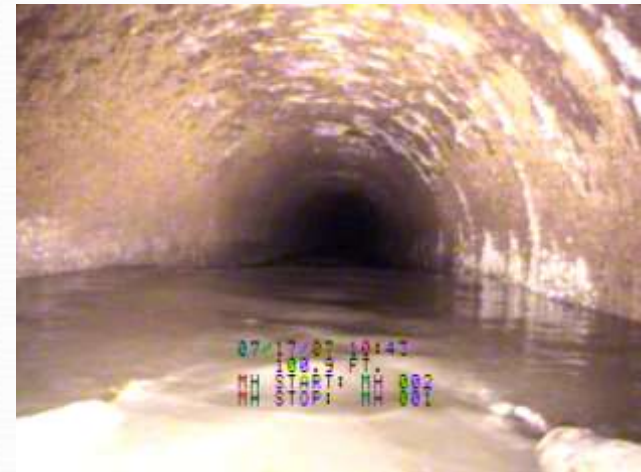
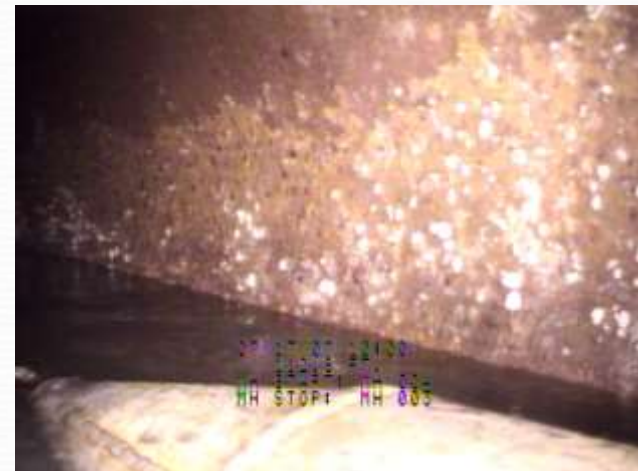
MAINLINE FINDINGS

- HYDROGEN SULFIDE CORROSION WAS SEEN IN THE FIRST 7 MANHOLE RUNS FROM THE TREATMENT PLANT.
 - GRADE CHANGES
 - 90 DEGREE BEND
 - PROXIMITY TO PLANT

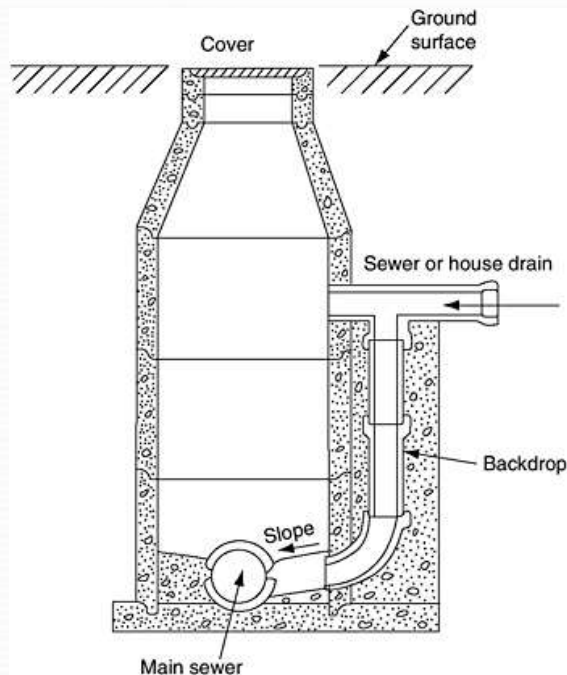
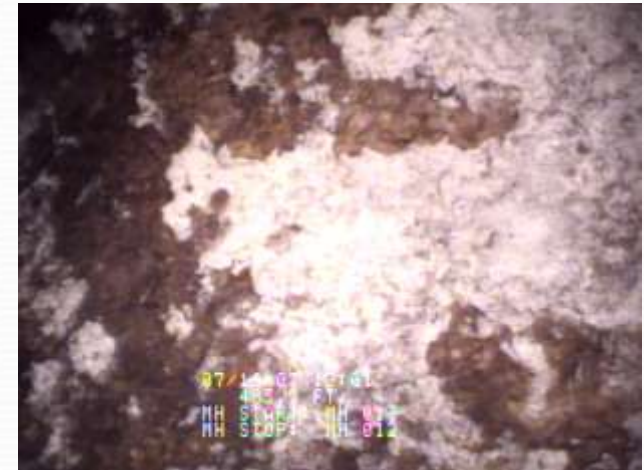
MAINLINE FINDINGS

- HYDROGEN SULFIDE CORROSION WAS SEEN AT ALL MAJOR TRUNK LINES (6) DUE TO DROP MANHOLES
 - 50' +/- MANHOLE
 - REMAINDER GOOD CONDITION

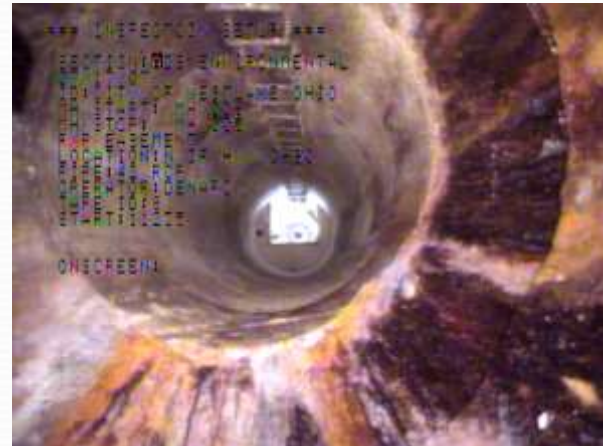
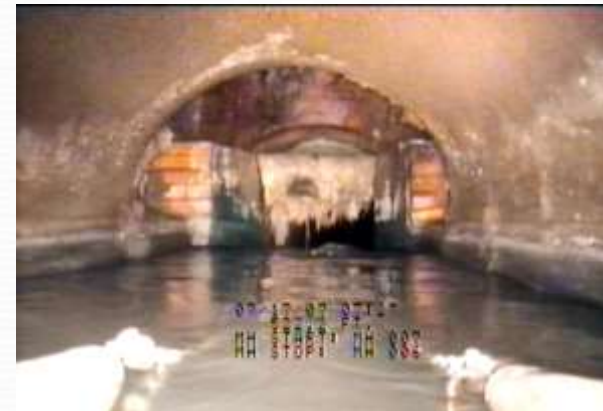
MANHOLE FINDINGS

- THE MAJORITY OF THE MANHOLES HAD INFILTRATION.
- LARGE MINERAL DEPOSITS EXISTED AT SOME MANHOLES FROM INFILTRATION.
- HYDROGEN SULFIDE CORROSION OCCURED AT DROP MANHOLES.

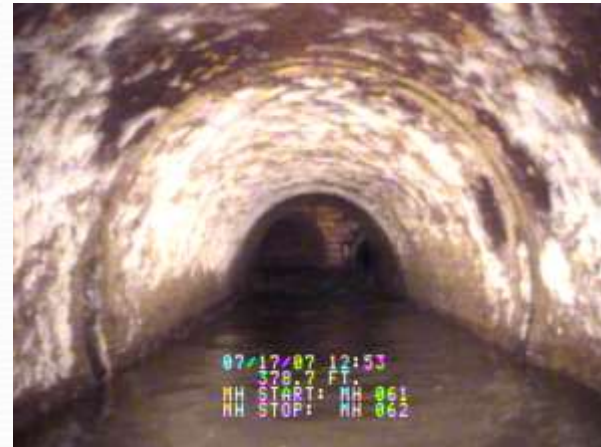
POST INSPECTION

- VARIOUS PORTIONS OF THE INTERCEPTOR WERE FILMED THIS YEAR
