**Concrete Restoration at the Columbus
Southerly WWTP**

June 16, 2010

**Bill Johngrass, P.E. – Project Manager
URS Corporation**

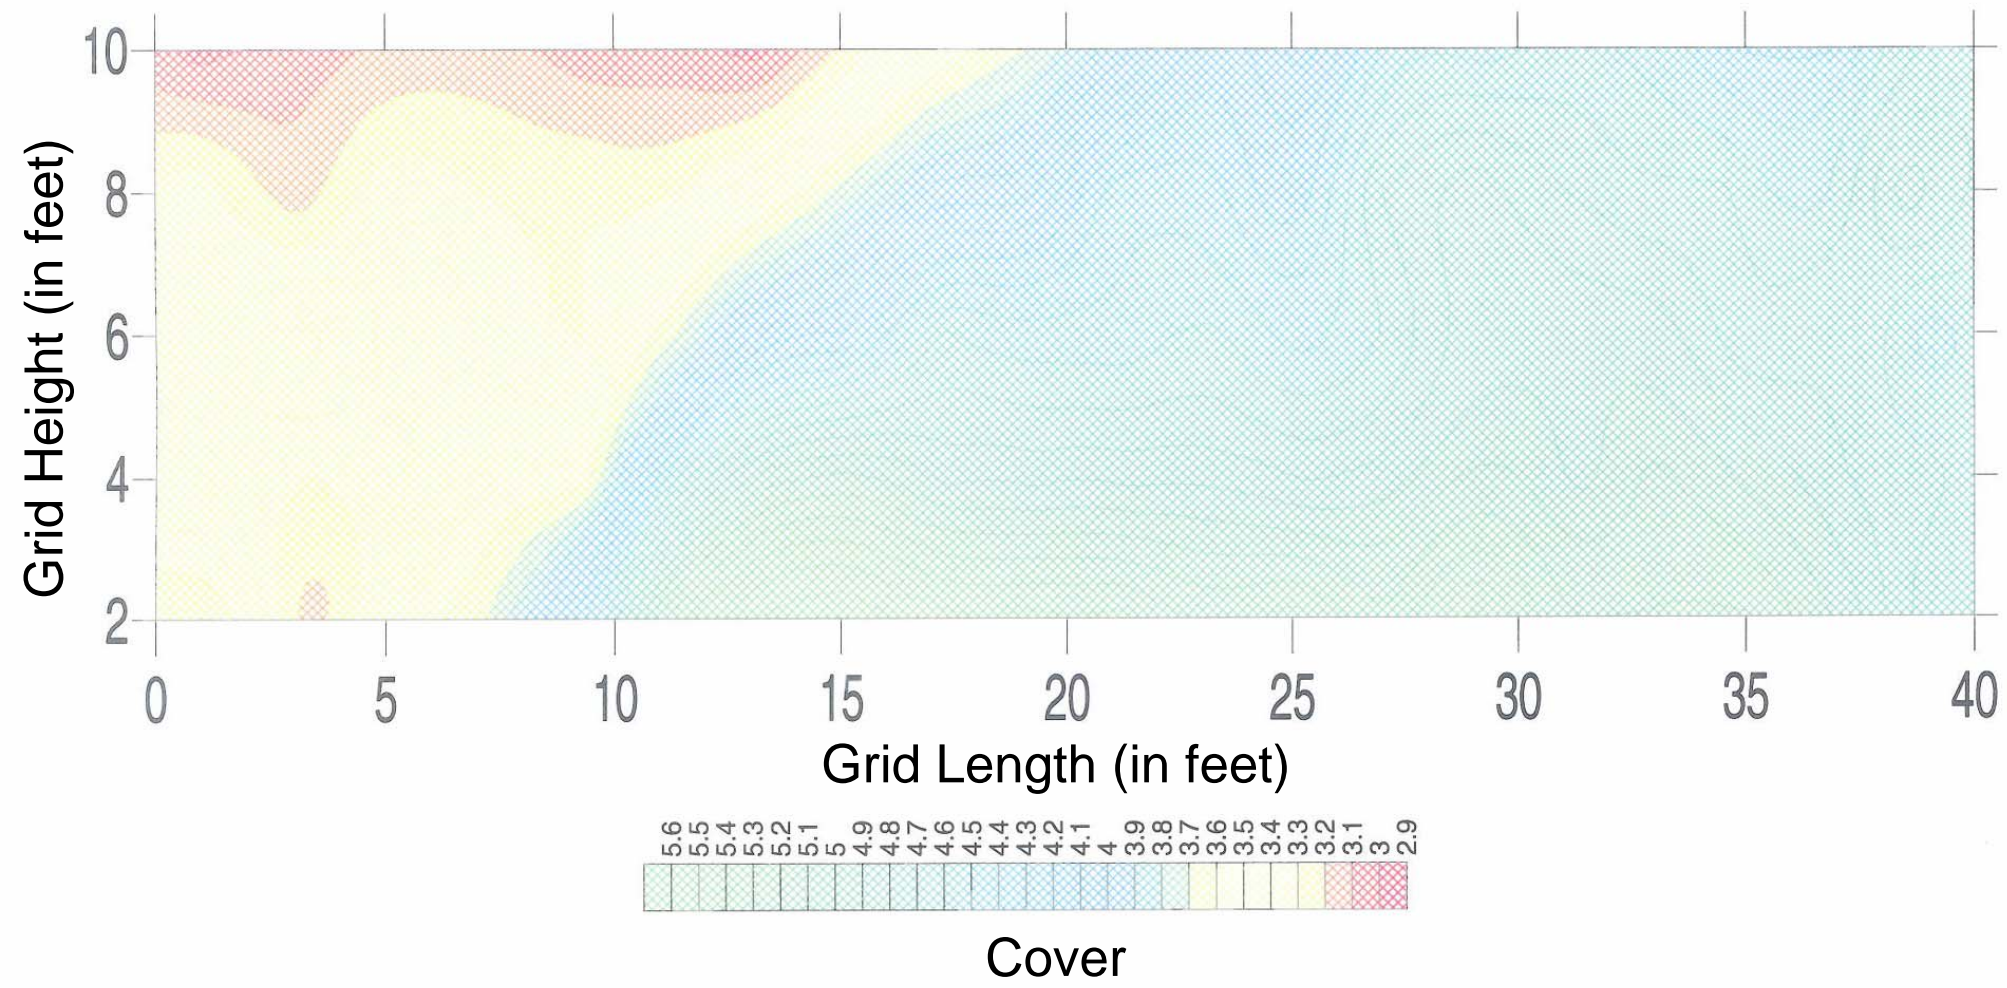
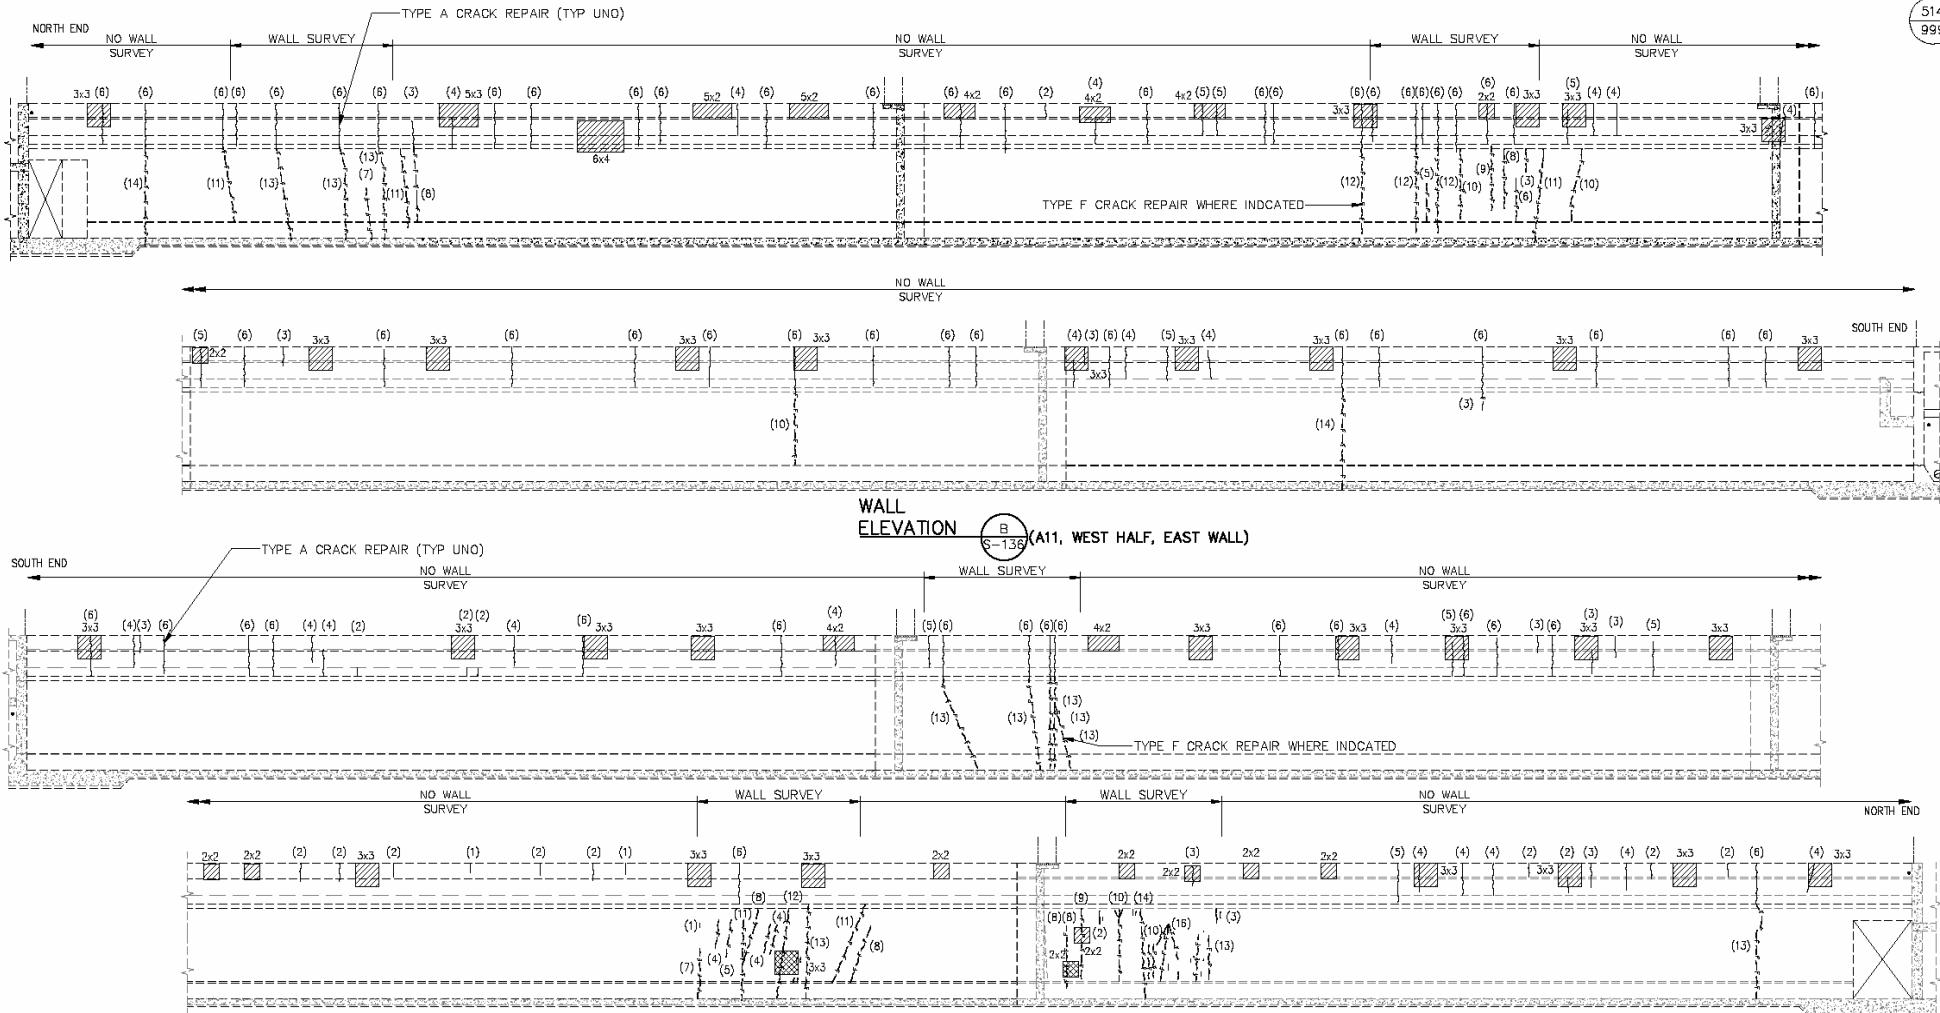
STRUCTURAL
A11 REHABILITATION
WALL ELEVATIONS

WALL ELEVATION (A11, WEST HALF, EAST WALL)

WALL ELEVATION (A11, EAST HALF, WEST WALL)

- (a) { - NARROW CRACK REPAIR: APPROXIMATE LENGTH - a FT
SEE REPAIR TYPE A/S-288. (WHERE INDICATED, THIS SHEET.)
- (a) L - WIDE CEMENTITIOUS CRACK REPAIR: APPROXIMATE LENGTH - a FT
SEE REPAIR TYPE F/S-288. (WHERE INDICATED, THIS SHEET.)
- (a x b) [hatched] - SHALLOW SURFACE REPAIR: APPROXIMATE AREA - a X b FT
SEE REPAIR TYPE C/S-288.
- (a x b) [cross-hatched] - DEEP SURFACE REPAIR: APPROXIMATE AREA - a X b FT
SEE REPAIR TYPE D/S-288.

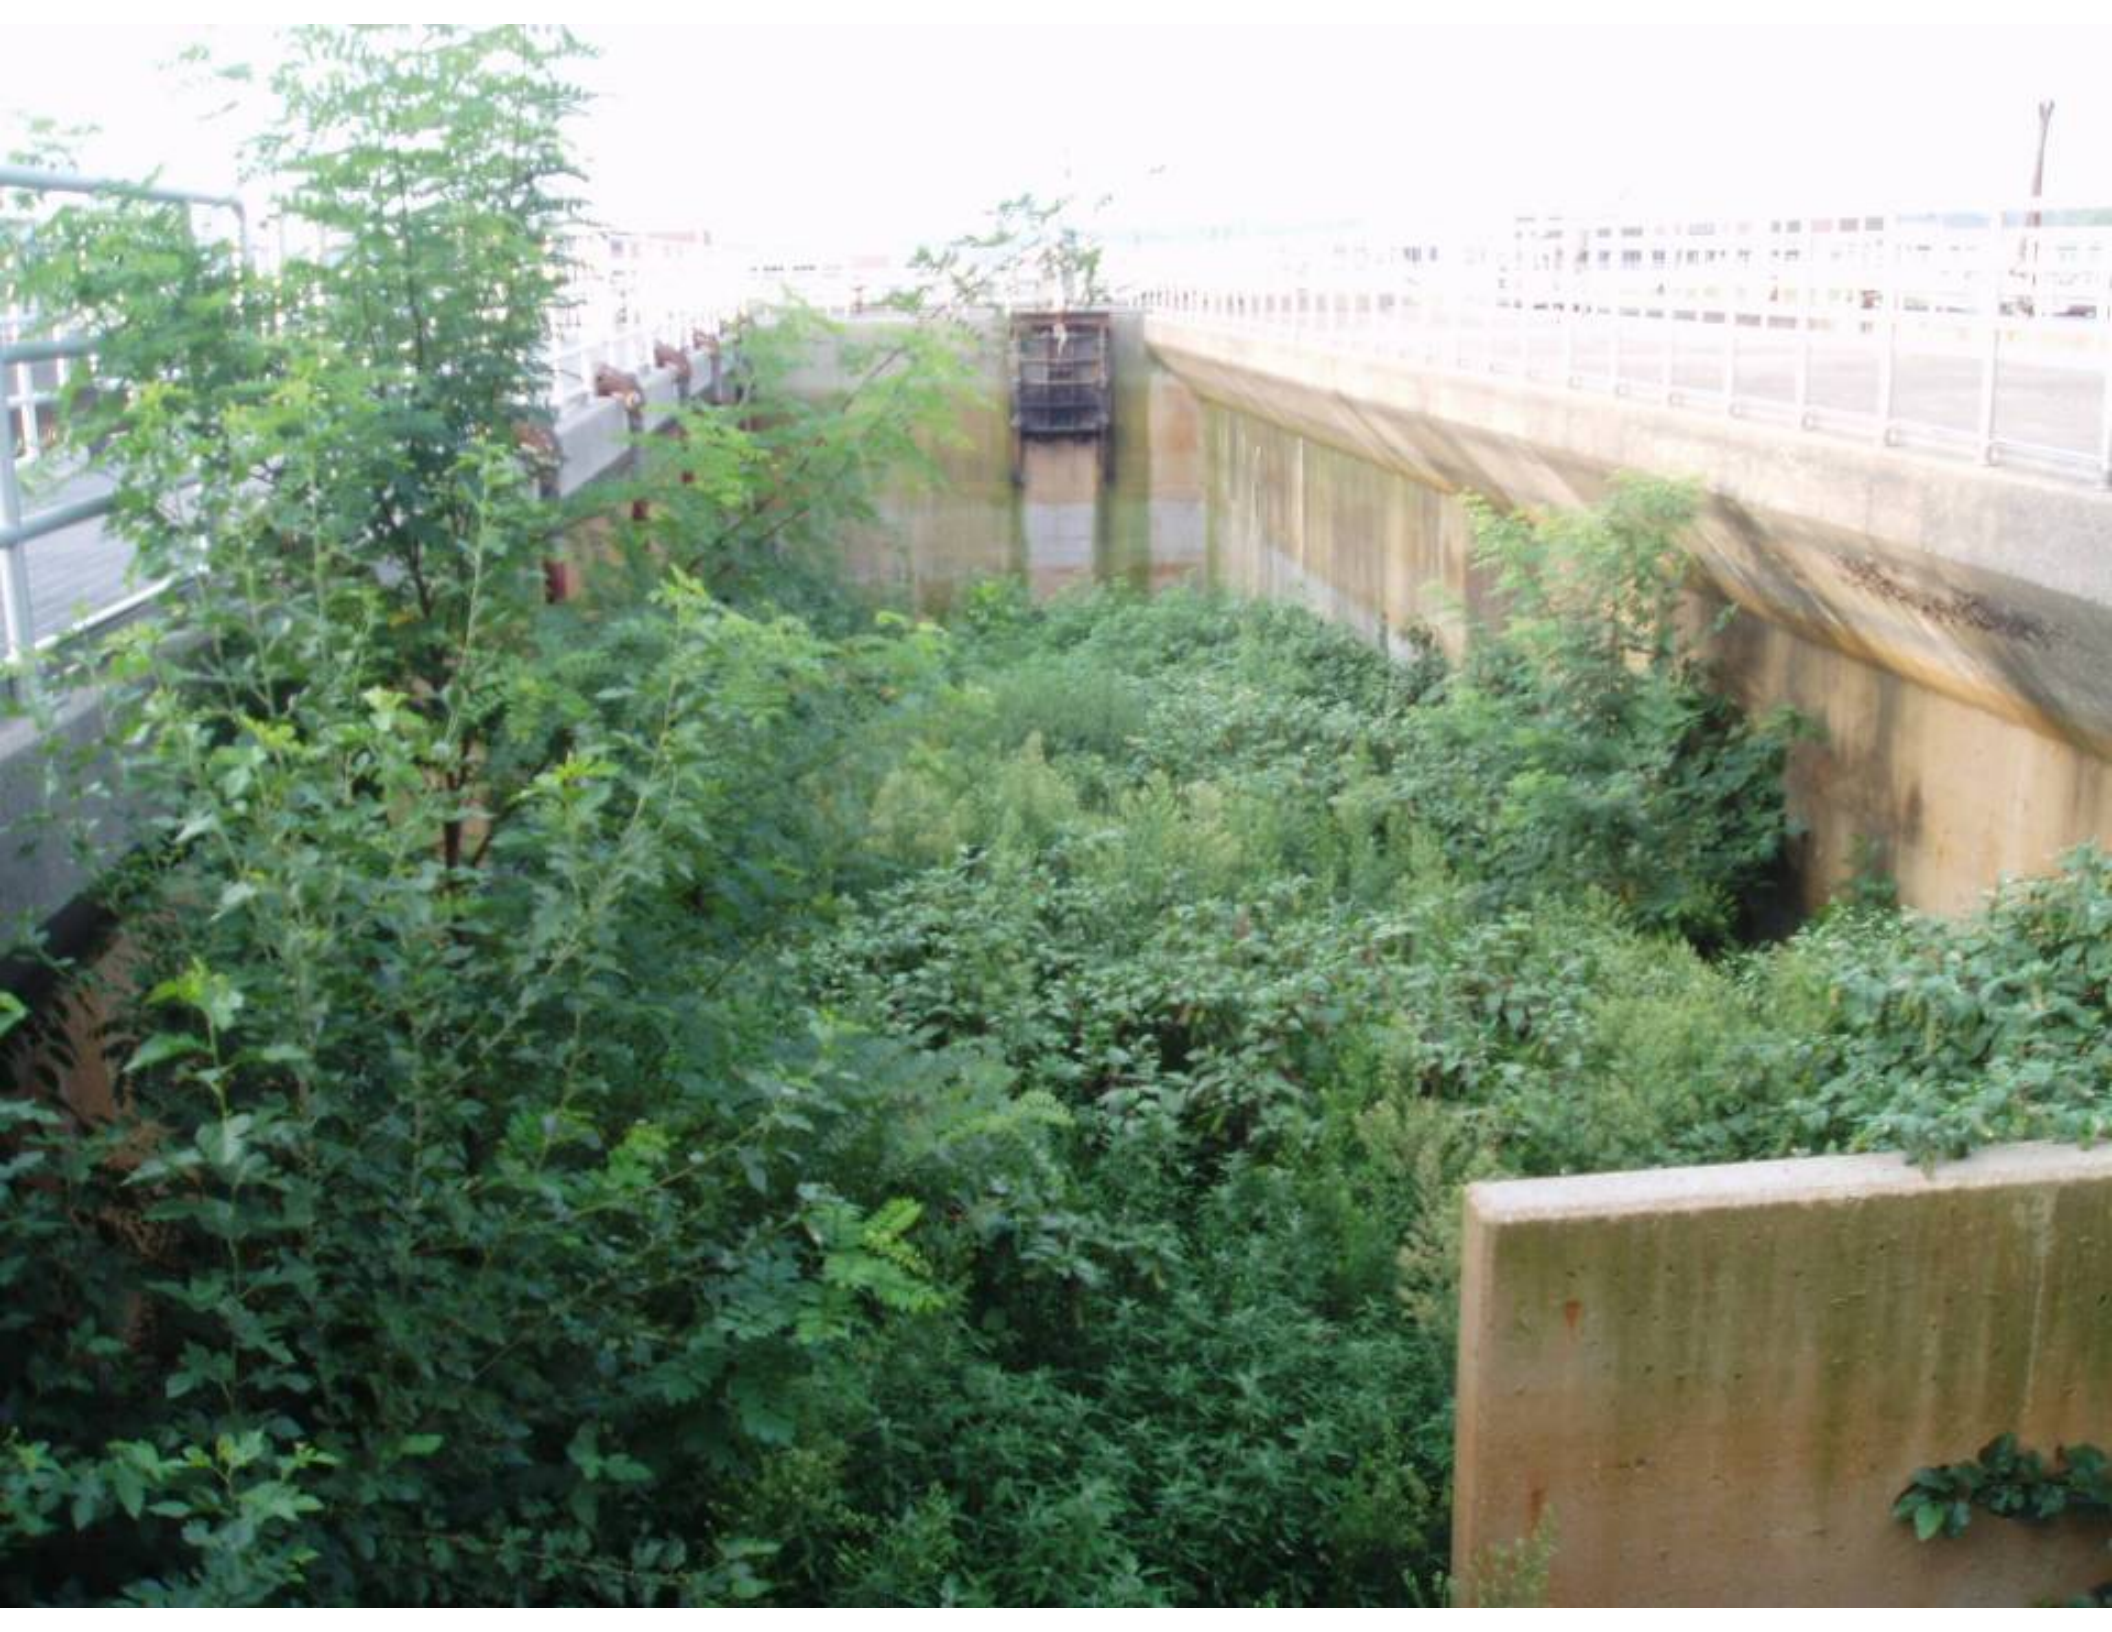
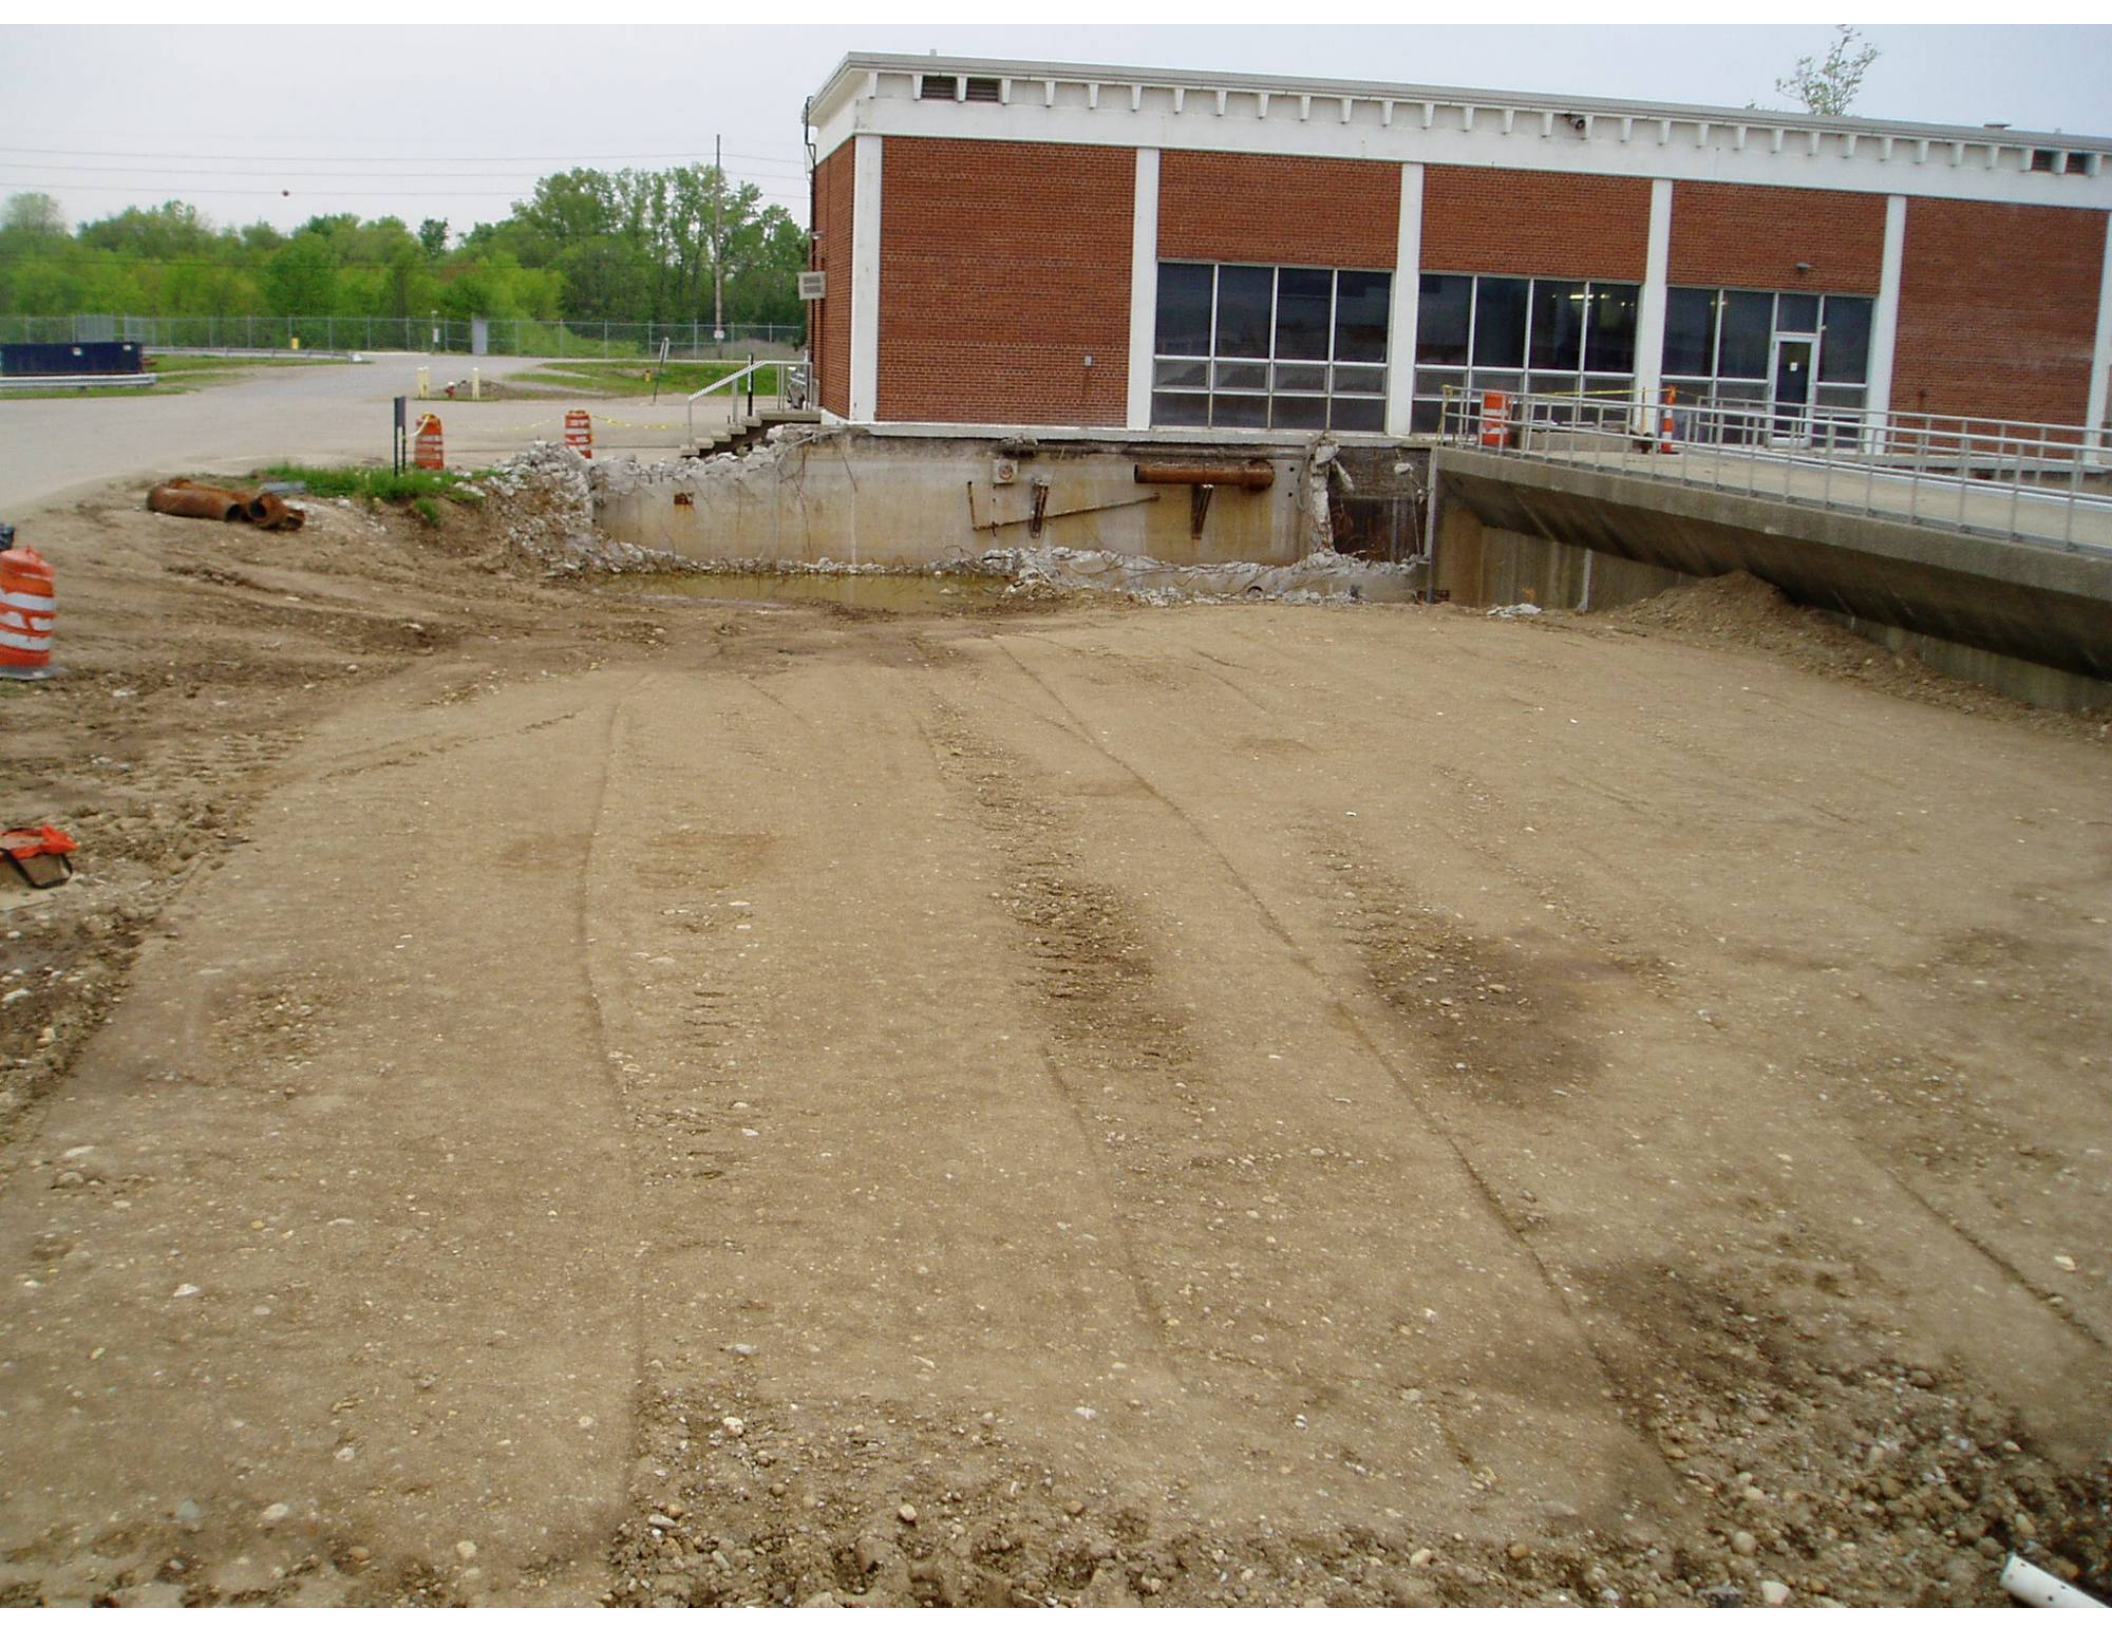
Pre-Aeration Tanks

- Tanks no Longer in Use
- Safety Concerns Due to Handrail and Concrete Deterioration
- Cost to Rehab (\$250,000+) Versus Cost to Remove (\$450,000)
- Decision Made to Demolish the Tanks

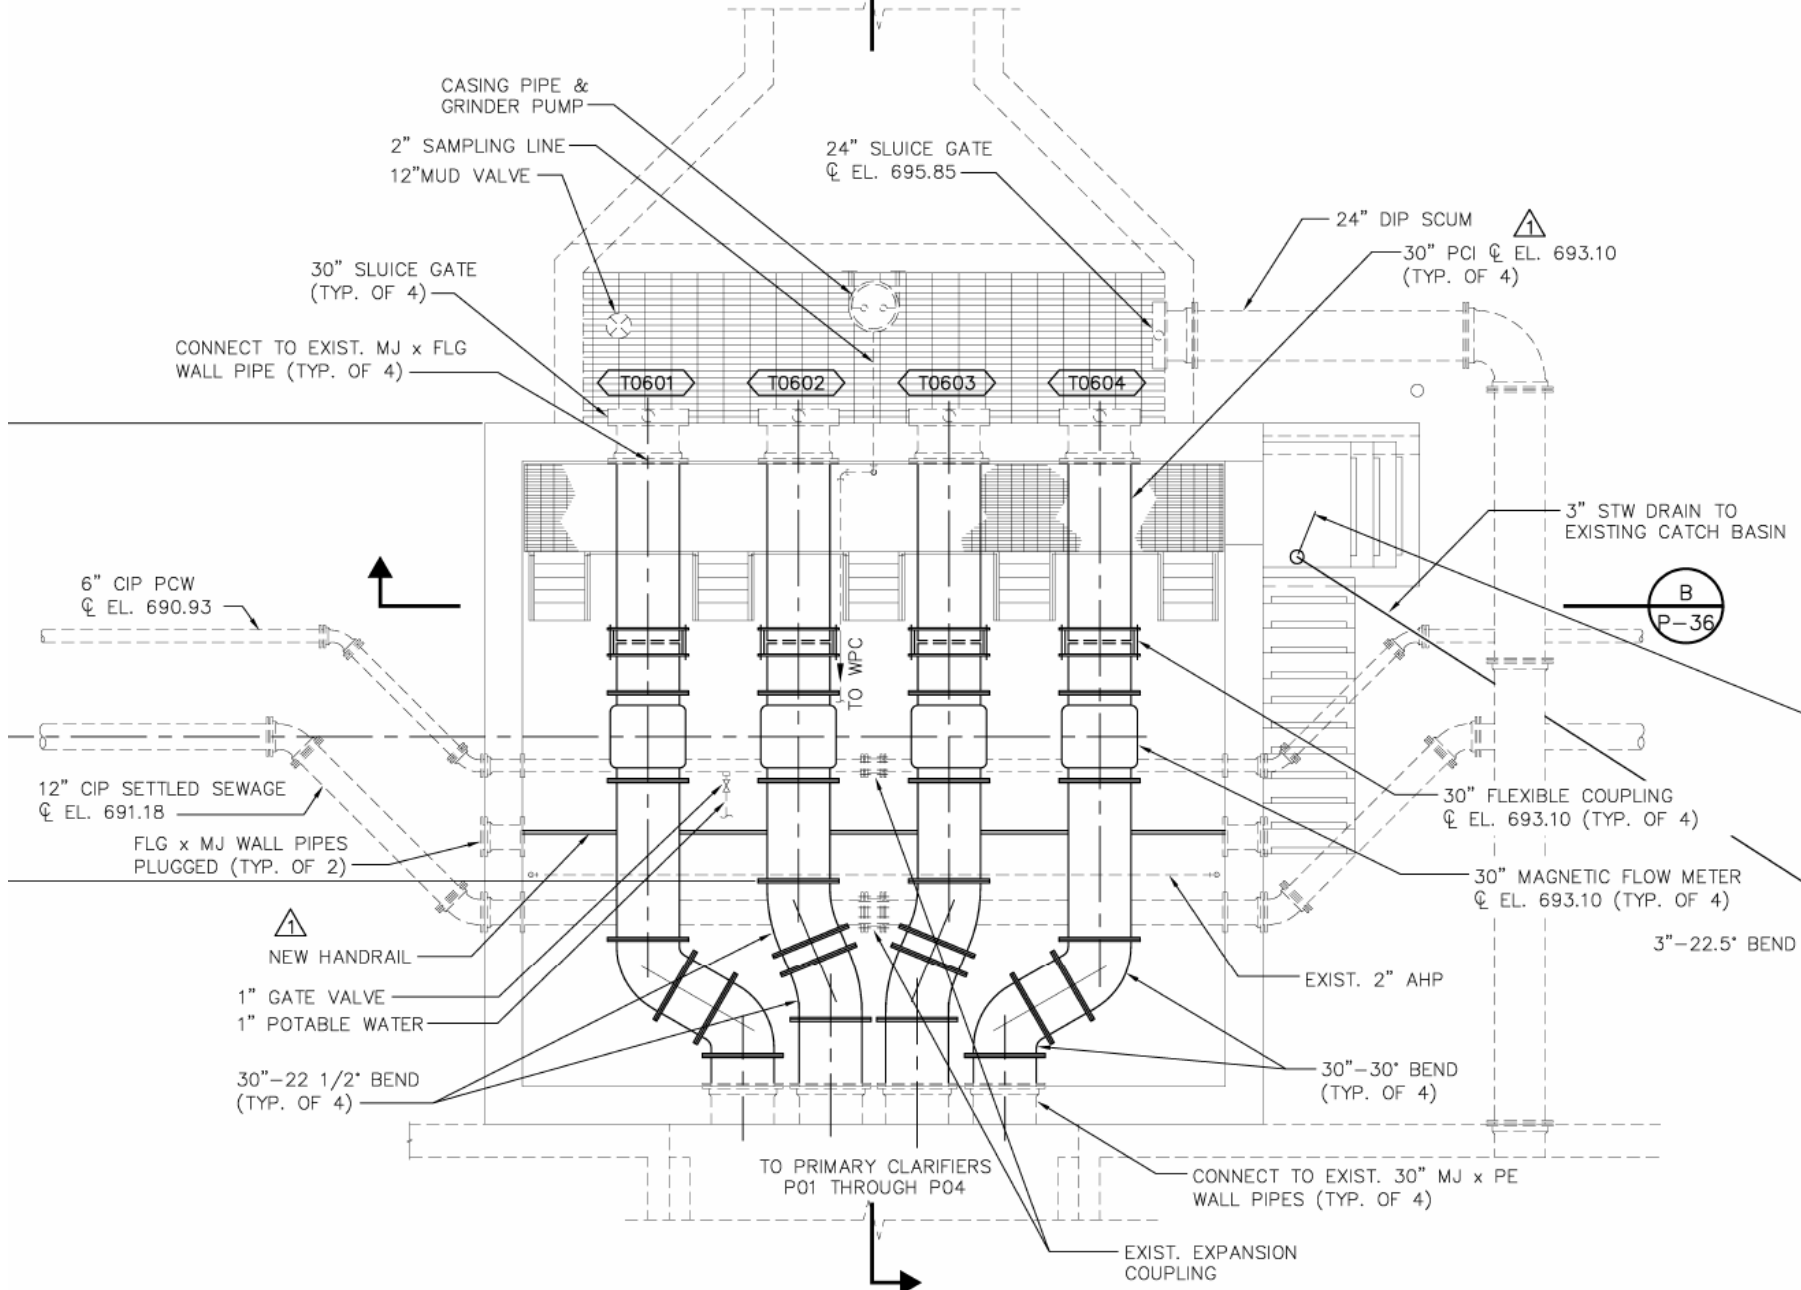
West Primary Metering Chamber

- Concrete Walls and Roof in Poor Condition
- Below Grade Walls (Part of Tunnel System) in Good Condition
- Recommendation to Rebuild Structure
- Due to Construction Sequencing, the Piping (Supported from the Ceiling) Had to Remain in Service During the Structure Replacement

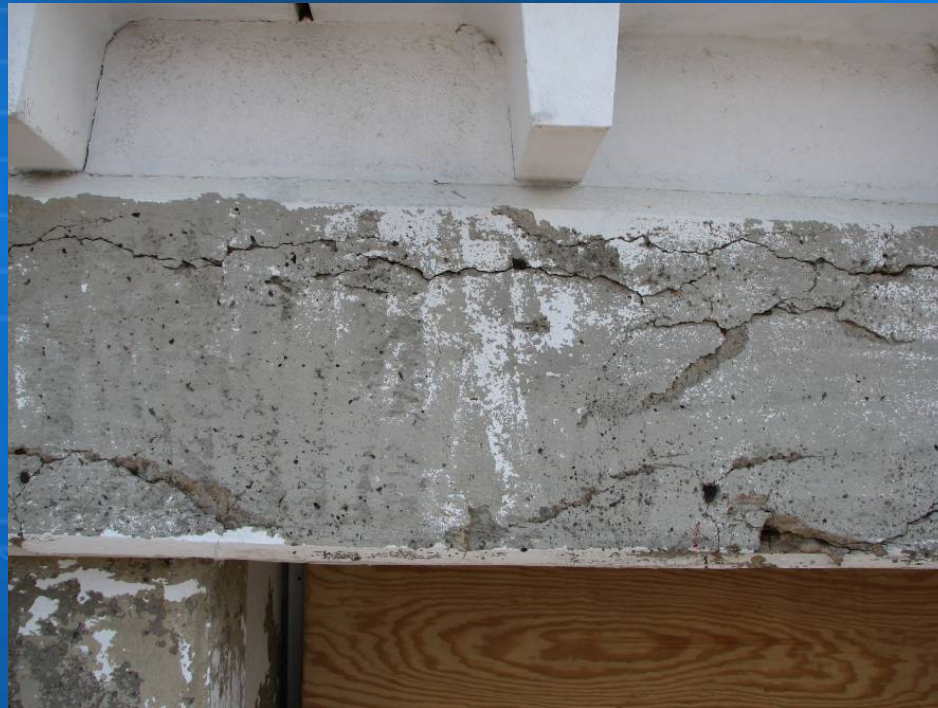
West Primary Control Building

- Significant Concrete Deterioration on the Exterior Beams and Columns

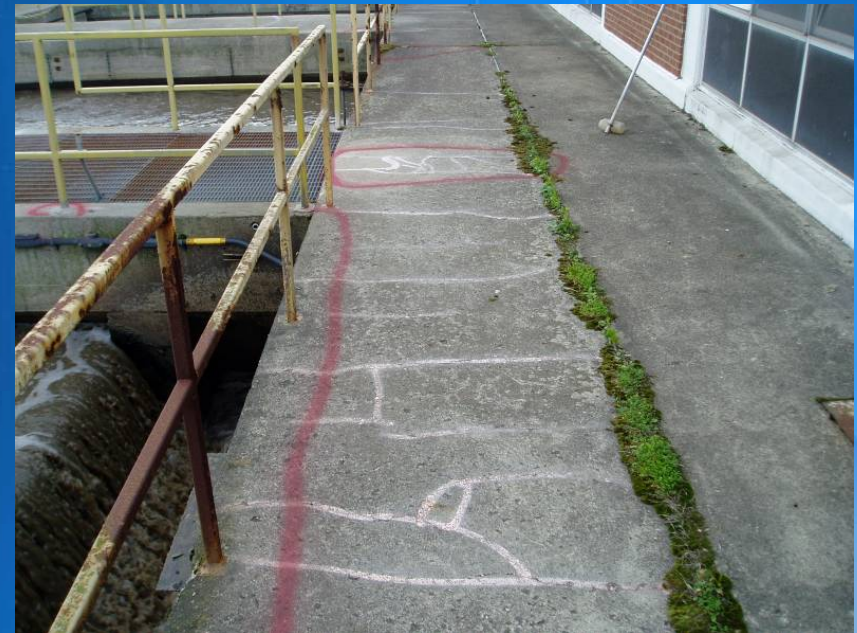
- Aeration Tank Rehabilitation
 - Center Train (Circa 1968) Had Significant Freeze-Thaw Damage Above the Water Line
 - Repairs Included the Following:
 - Replacement of Steel Handrail with Aluminum
 - Replacement of Galvanized Grating
 - Repair Expansion Joints
 - Crack/Spall Repairs and Slab Replacement
