## Managing the Useful Life of Your Segmented Block Combined Sewer

Dianne M. Sumego, PE  
June 28, 2017

**Sewer Condition Assessment for Lima, OH**  
**S Metcalf St & Lake St**  
 Inspection Area 9  
 105015

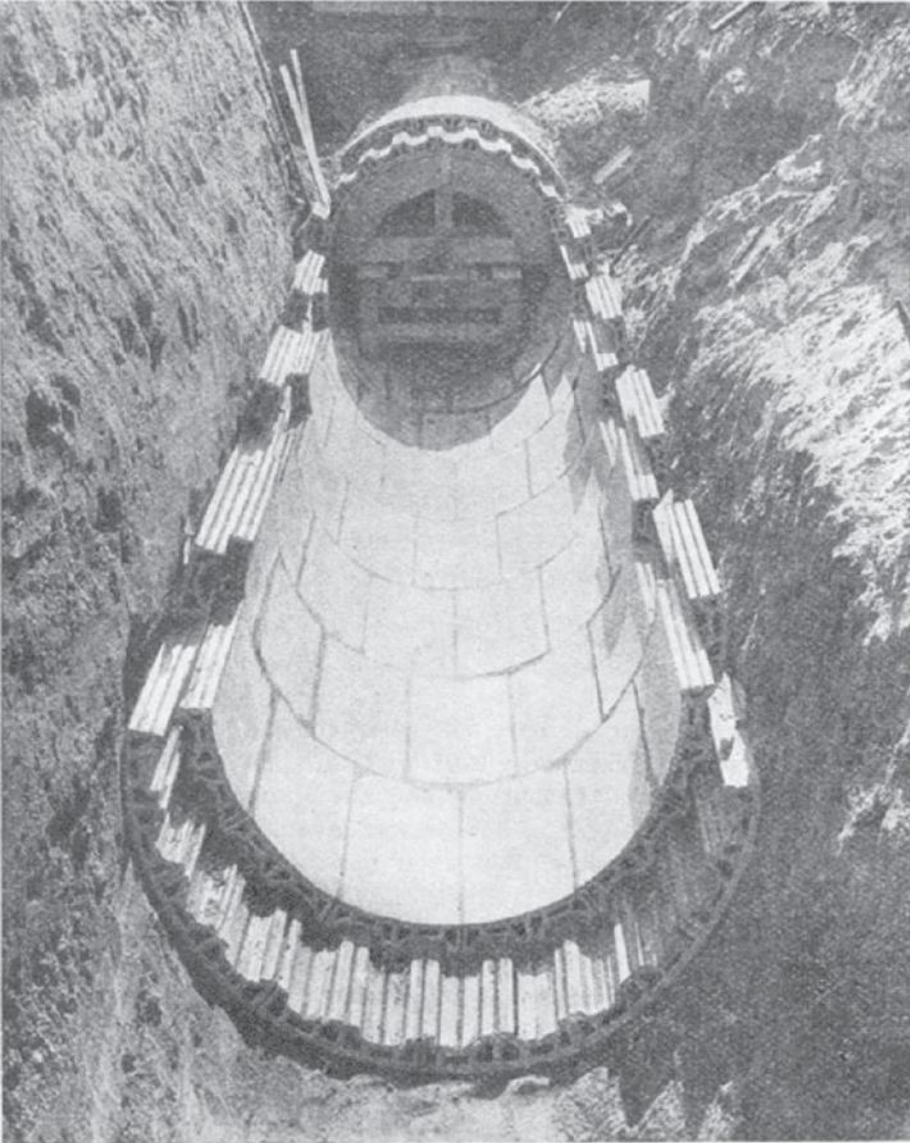
IV. A 48-INCH SEGMENTAL BLOCK SEWER UNDER CONSTRUCTION IN WAUSAU, WIS.

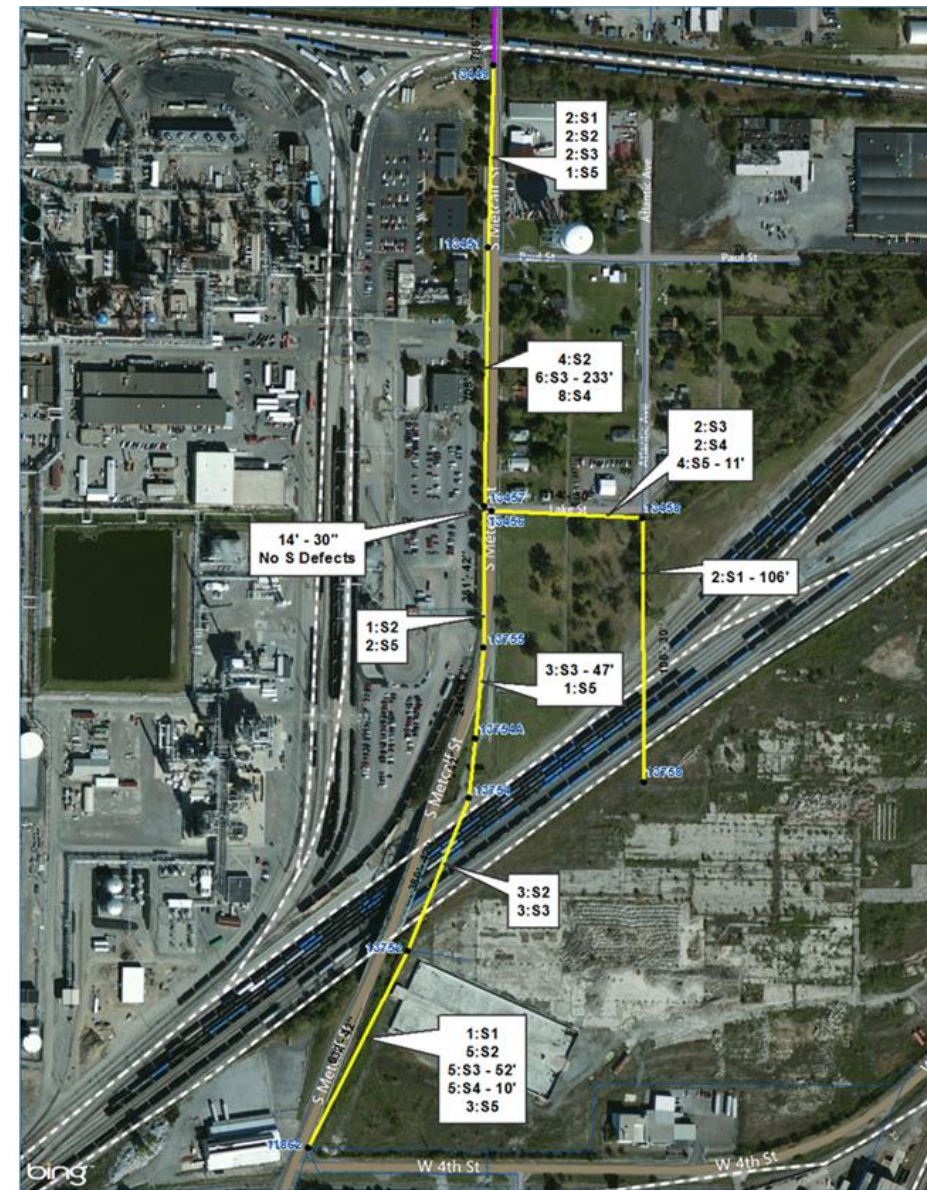
**SUMMARY OF INSPECTION RESULTS BY SEGMENT**

Segments			Number of Defects by Grade					
From MH	To MH	Size	Grade 5	Grade 4	Grade 3	Grade 2	Taps	
13458	13456	30	4	2	2	0	10	
11862	13752	42	3	2	7	5	0	
13457	13755	42	2	0	0	1	11	
13755	13754A	42	1	0	3	0	4	
13449	13451	72	1	0	2	2	0	
13752	13754	42	0	0	3	3	0	
13457	13451	57	0	8	6	4	20	
13458	13758	30	0	0	0	0	1	
13456	13457	30	0	0	0	0	0
