IF YOU LIKE IT, YOU SHOULD PUT A “LASER” RING ON

Condition Assessment and Rehabilitation – Lancaster, Ohio

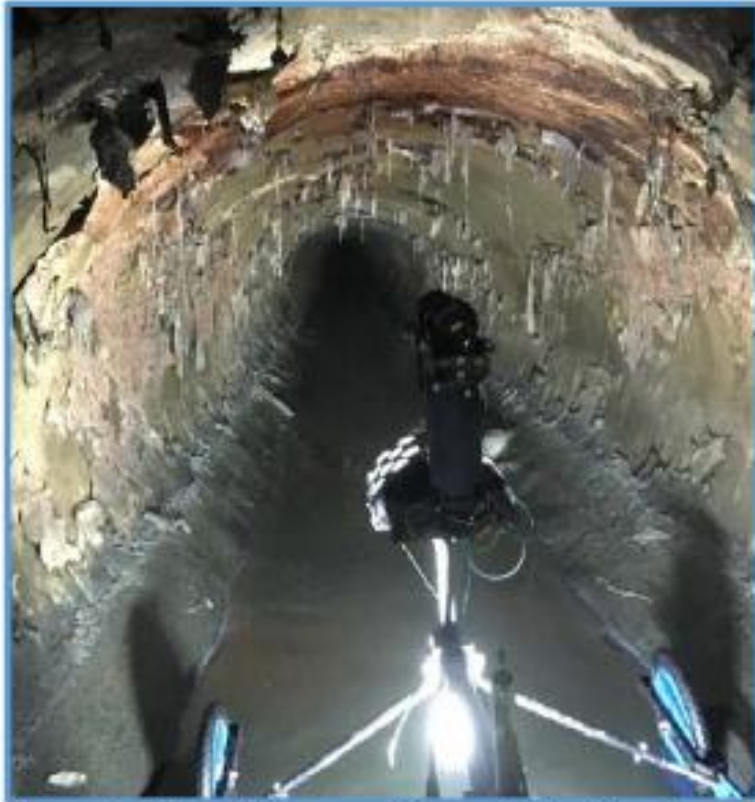
Photo 2.13 – “Swamp Buggy” inside the pipe

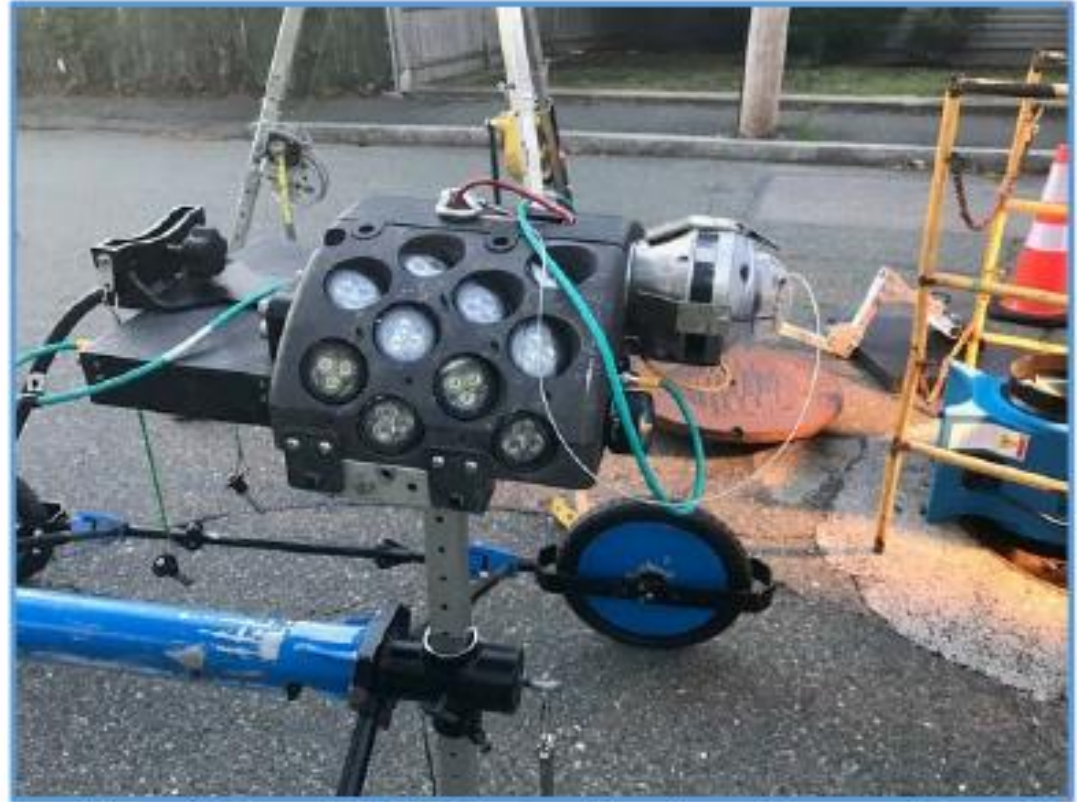
Photo 2.14 – LIDAR Sensor Head on “Swamp Buggy”

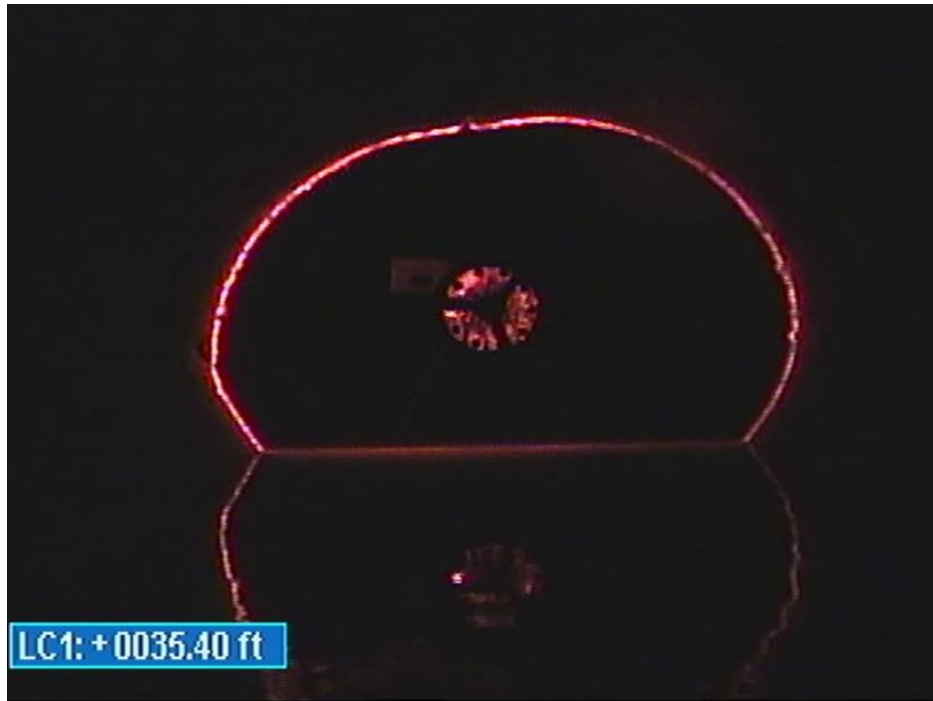
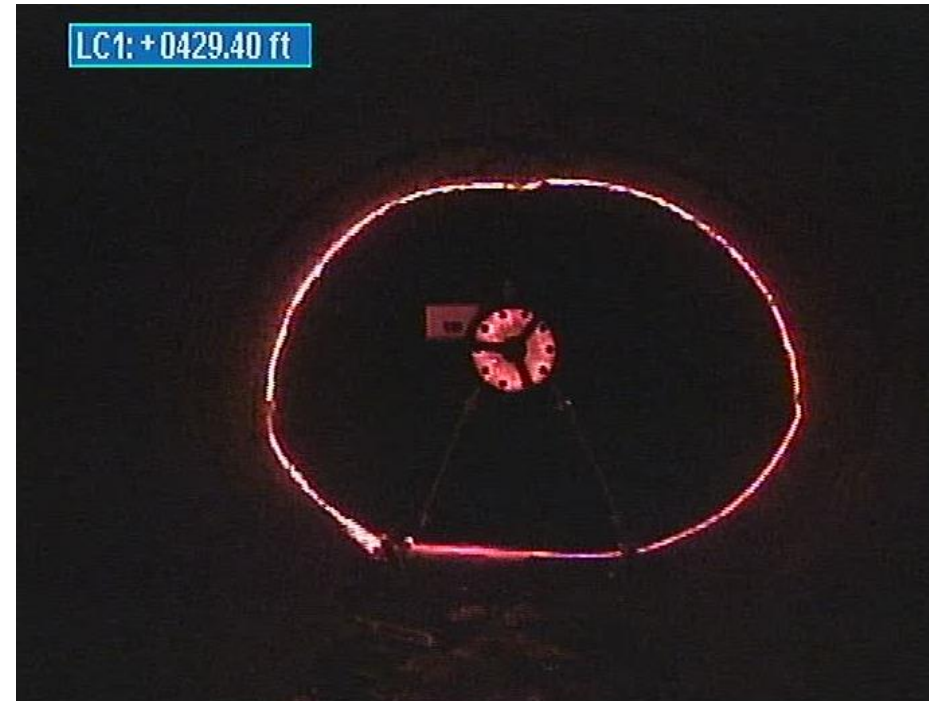
- Ovality of 18% (shown left)
- Ovality of 16% (shown right)

D/S MH	U/S MH	Material	Size (in)	Length (ft.)	Max Ovality	Recommendations
26A005	26A006	RCP	30	19	2%	CIPP
26A006	26A007	RCP	30	130	≤ 6%	CIPP + potential MH addition (at bend ~75' from U/S MH)
26A007	26A008	RCP	30	646	10%	CIPP + MH addition (~340' from U/S MH)
26A008	26A009	RCP	30	343	16%	CIPP
26A009	26A010	RCP	30	469	18%	CIPP
26A010	26A011	RCP	30	23	8%	CIPP
26A011	26A012	RCP/VCP	20/30	180	≤ 6%	CIPP + Note calling out size change in pipe
26A012	26A013	RCP	20	67	≤ 6%	CIPP
26A013	26A014	RCP	20	231	≤ 6%	CIPP + MH addition (at bend ~395' from U/S MH)
26A013	26A014	VCP	20	395	N/A	Re-CCTV in 5 years
26A014	26A015	VCP	20	239	N/A	Re-CCTV in 5 years
26A015	26A016	VCP	20	297	N/A	Re-CCTV in 5 years
