AMERICAN
STRUCTUREPOINT
INC.

OWEA ANNUAL CONFERENCE, JUNE 28TH, 2017, CINCINNATI, OHIO

**LARGE DIAMETER SEWER ASSESSMENT – WHEN TO
TAKE IT TO THE NEXT LEVEL?**

Central Large
Diameter Sewer Assessment

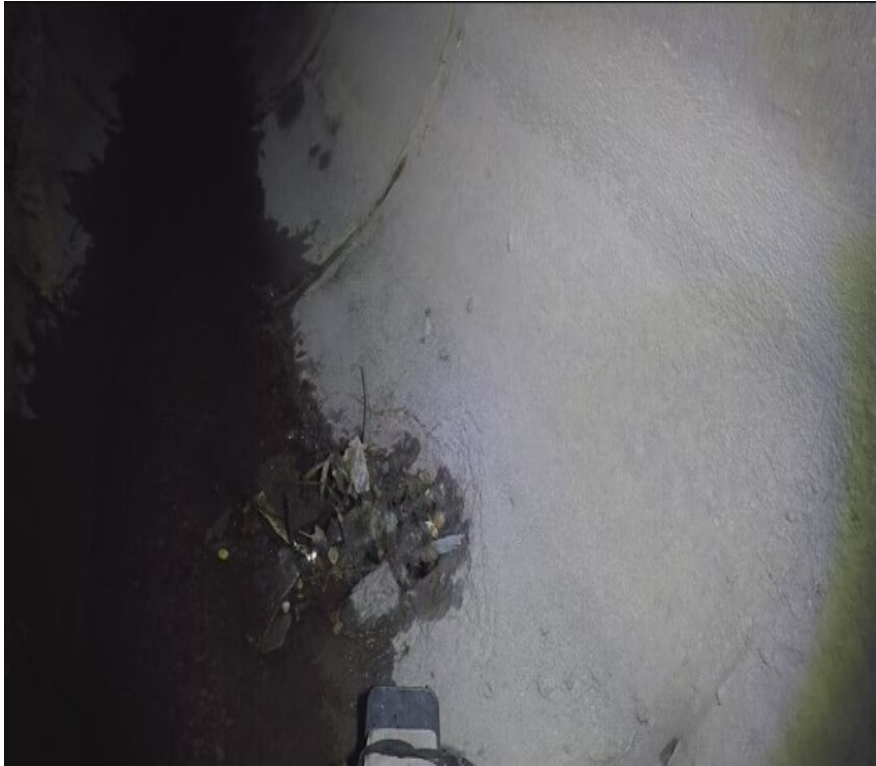
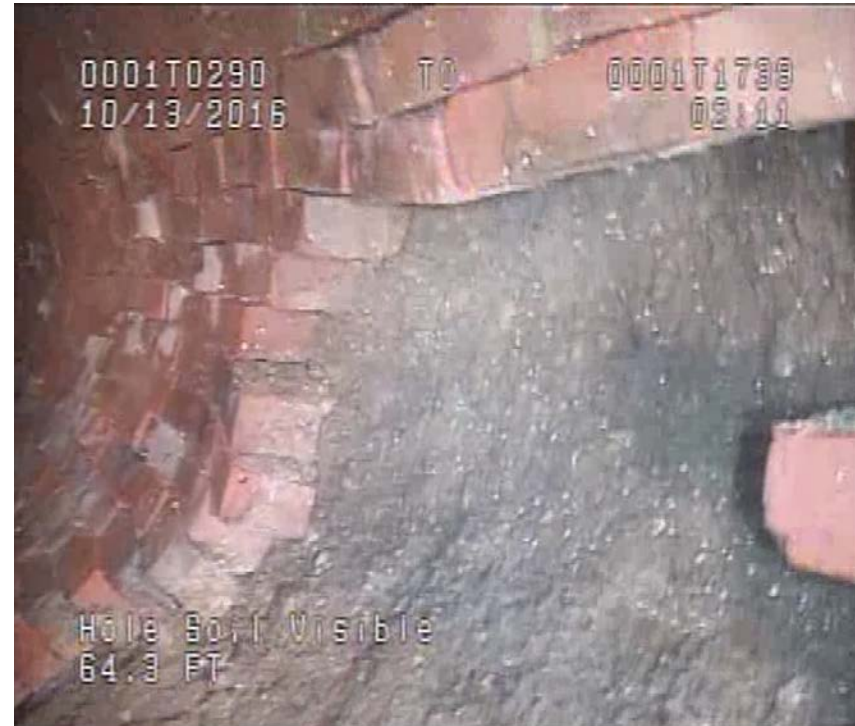
Hole Void Visible (HVV)

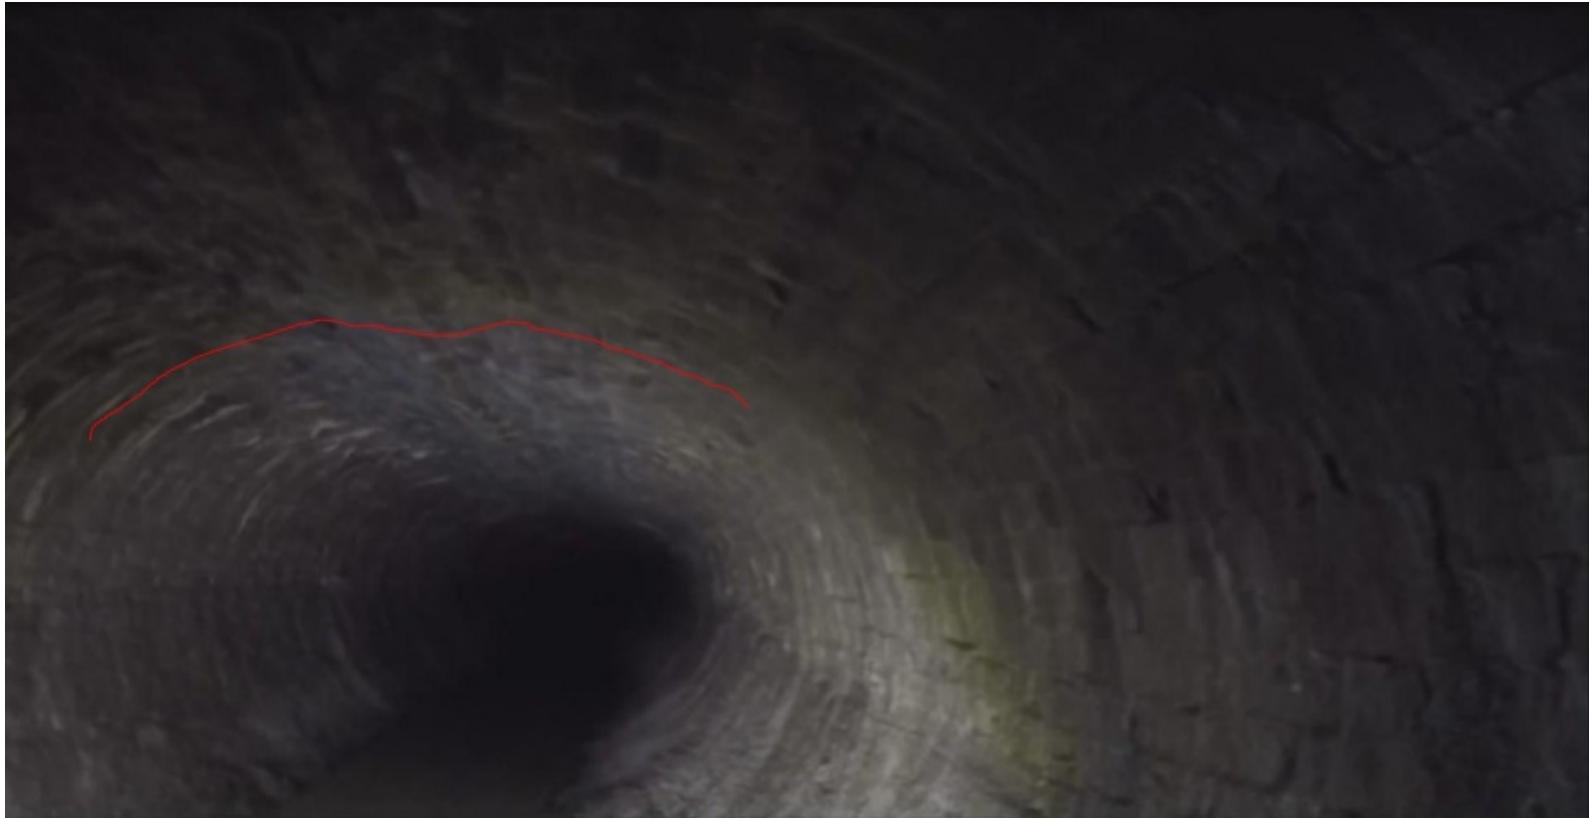
Ovalization/Deformation

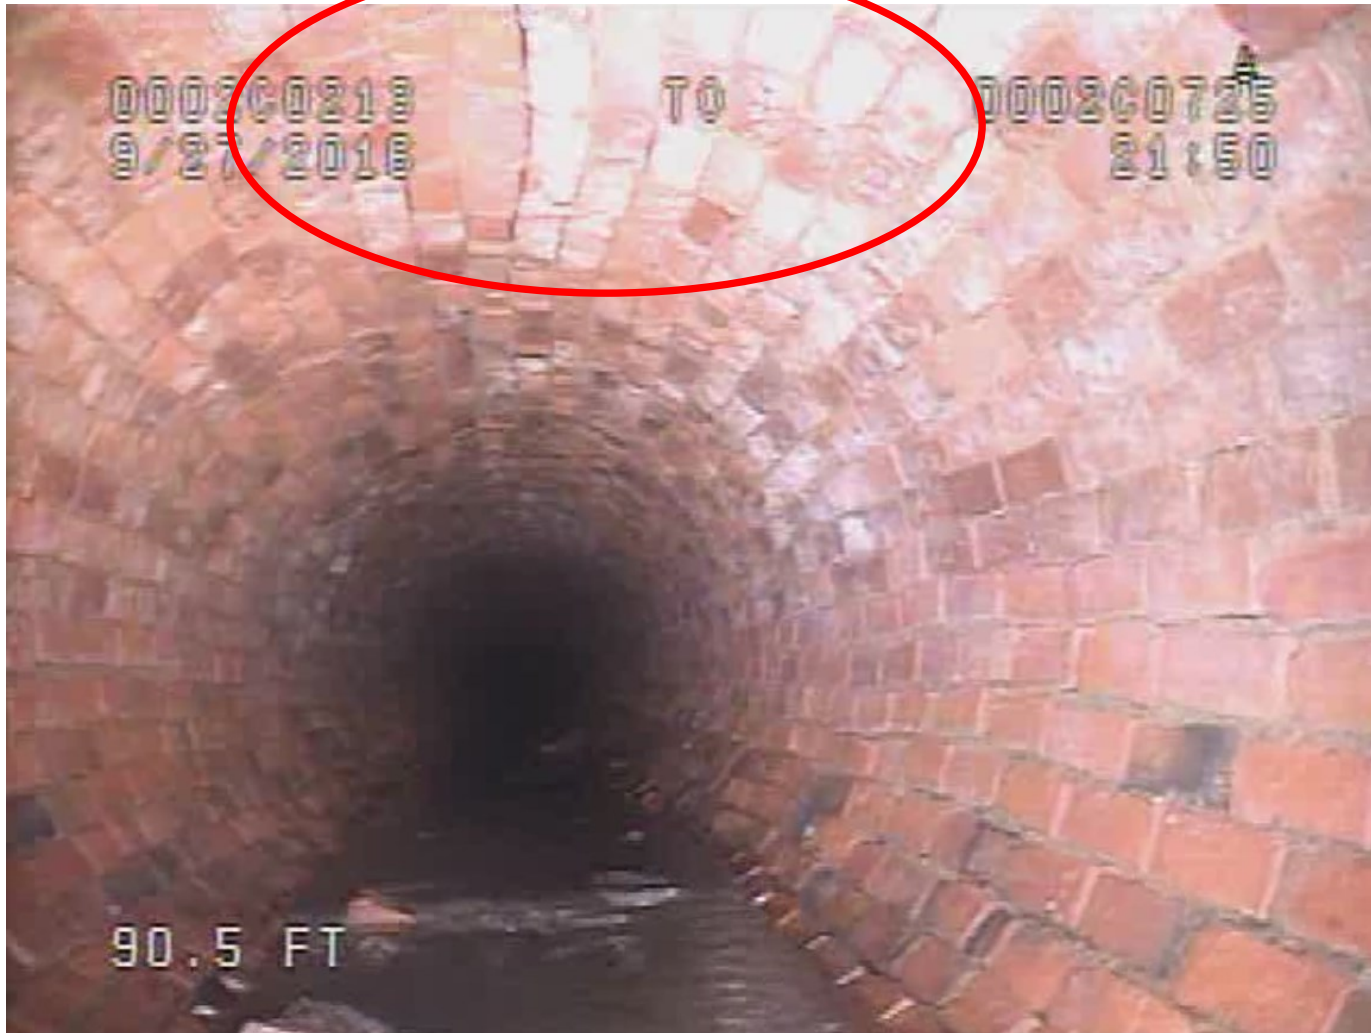
Bulging Crown w/ Fracture

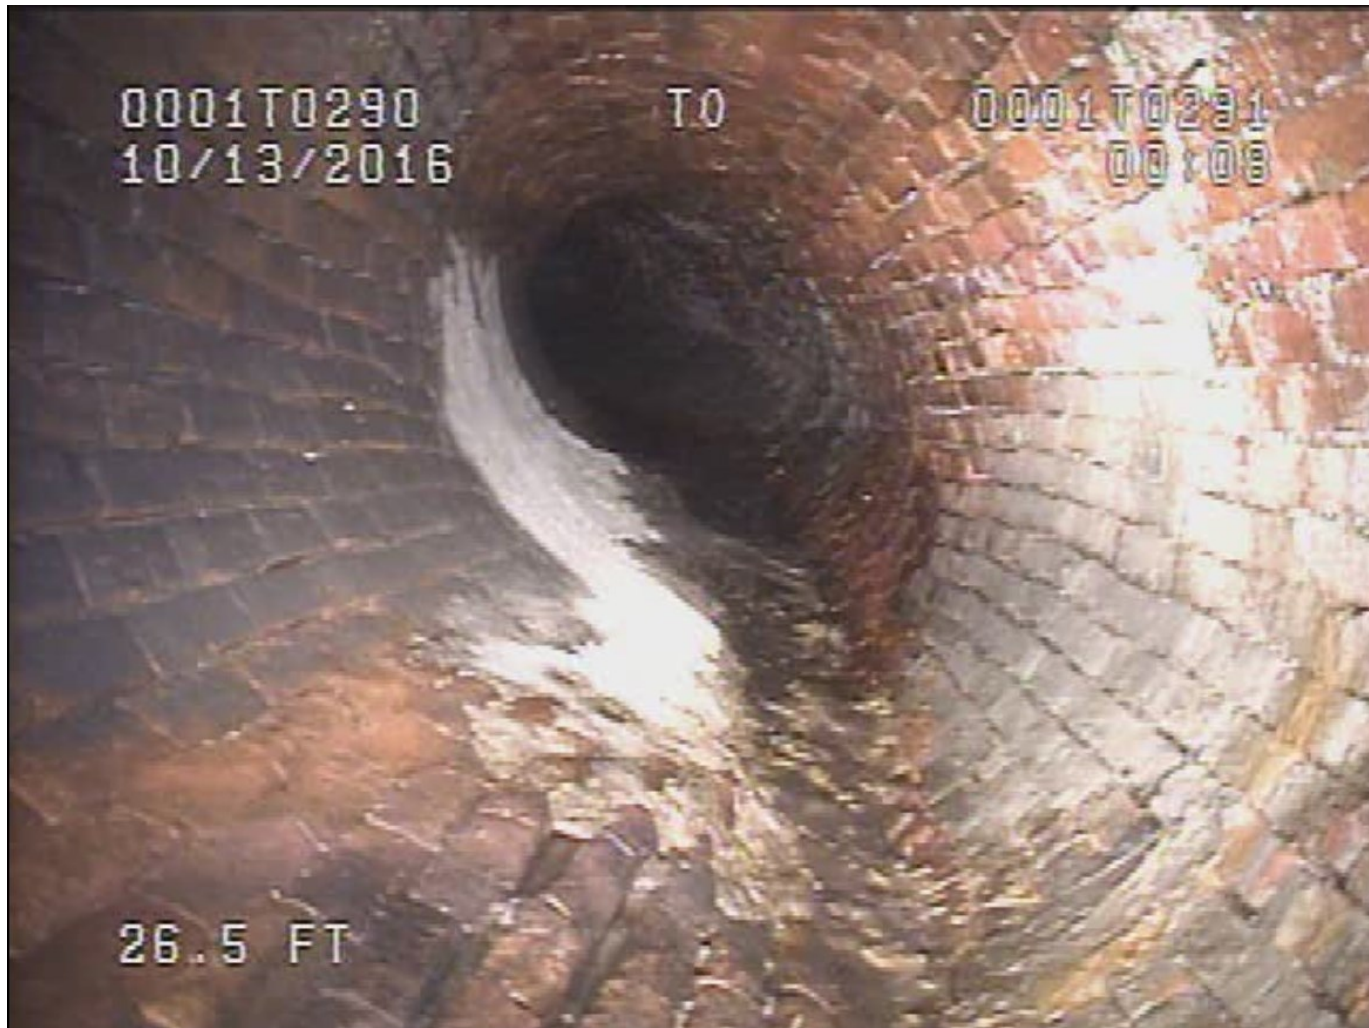
Buckling

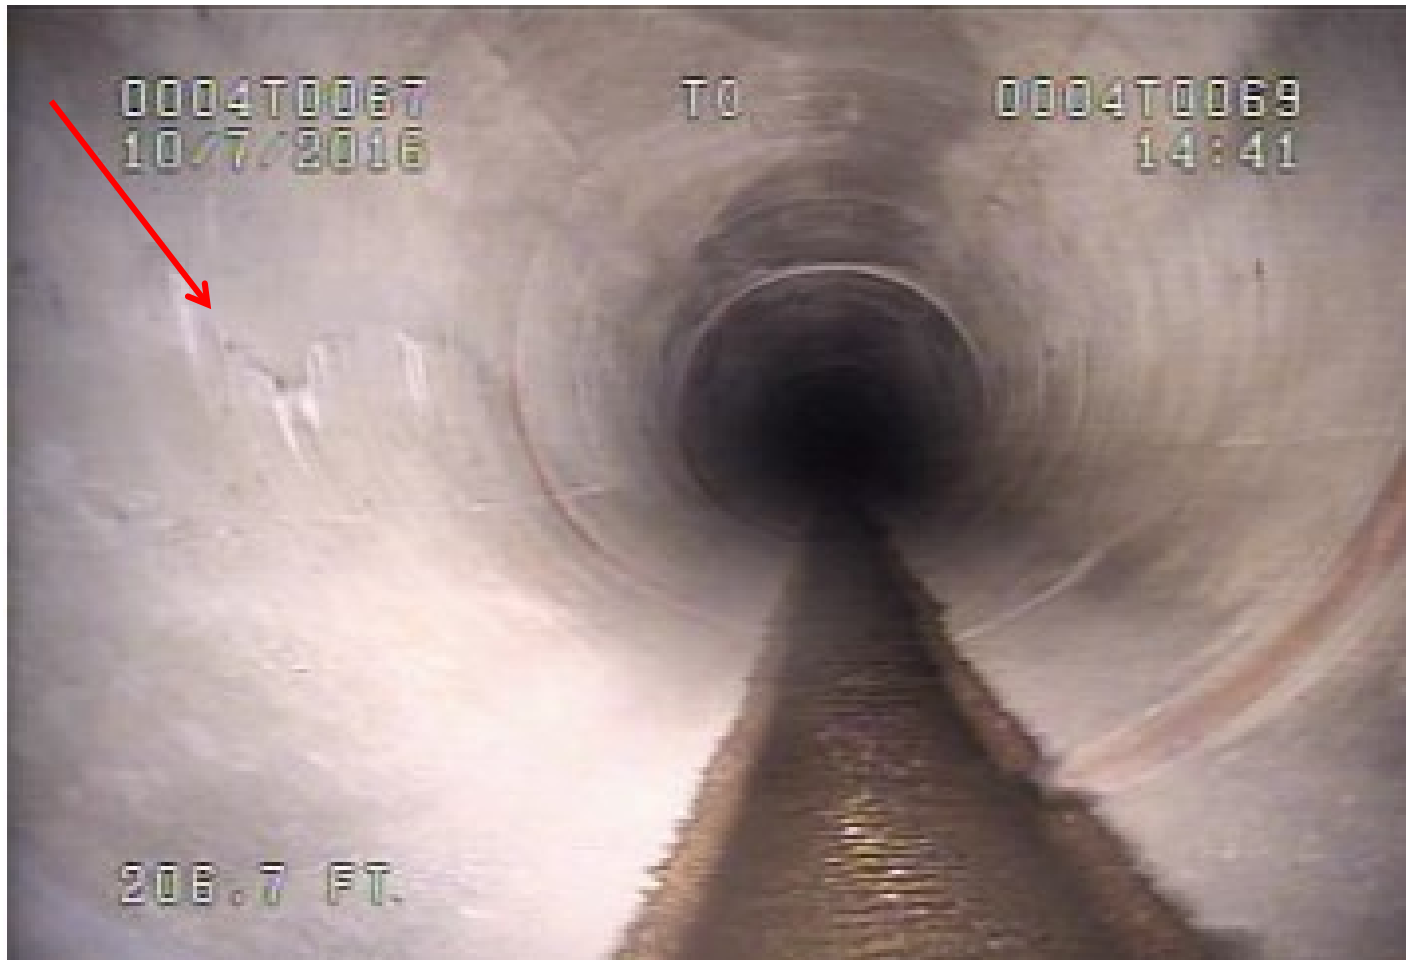
Cracks/Fractures

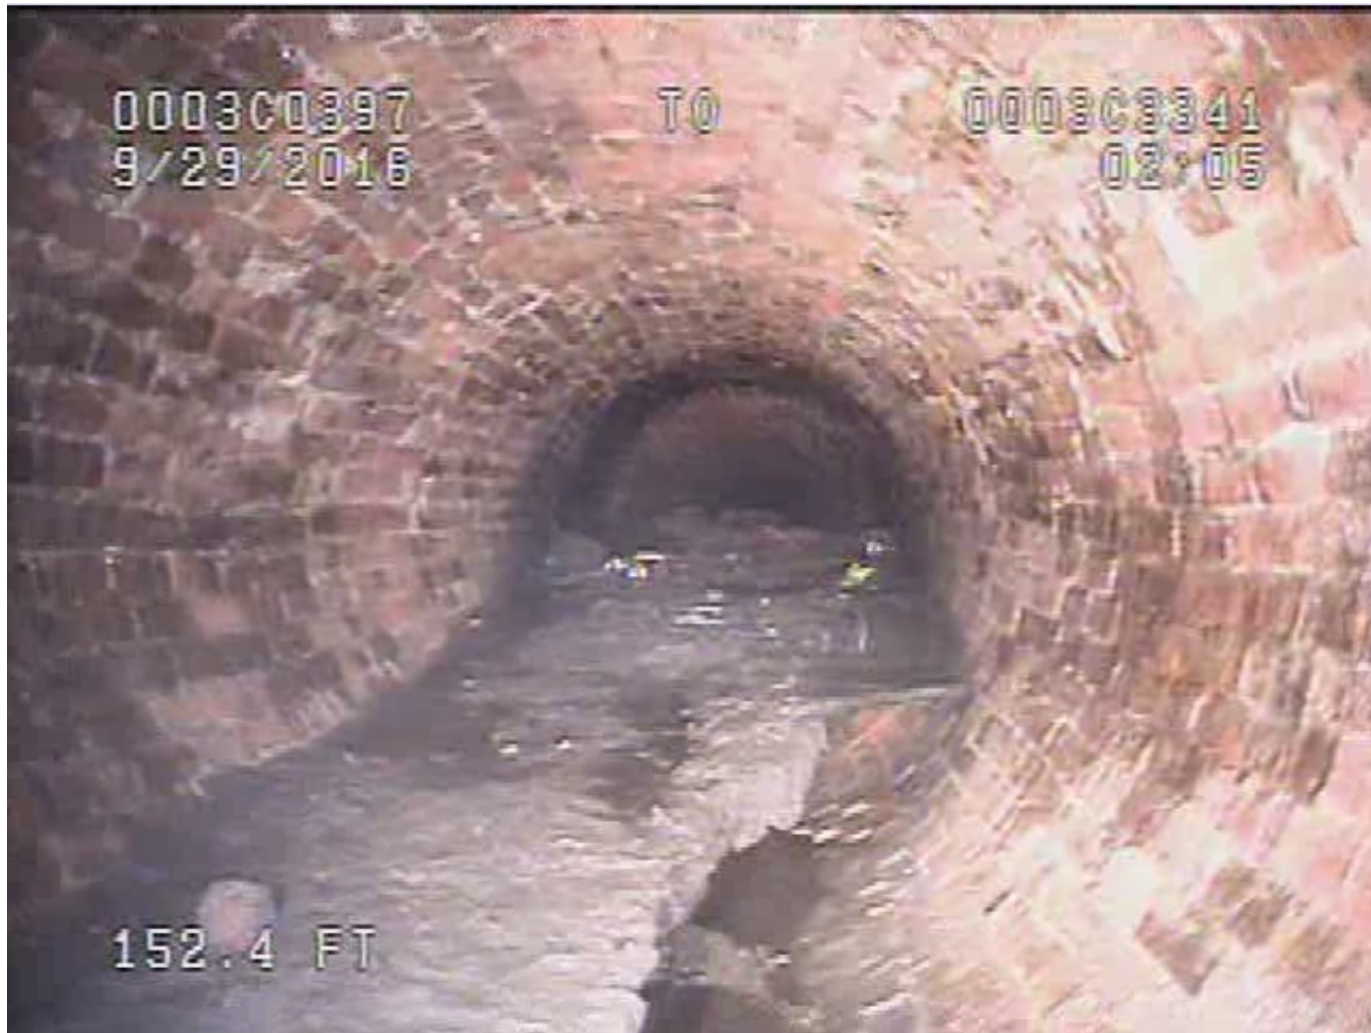
Debris Build-up
