June 27, 2019

BWARI Biofilter Rehabilitation Converting a Liability into an Asset

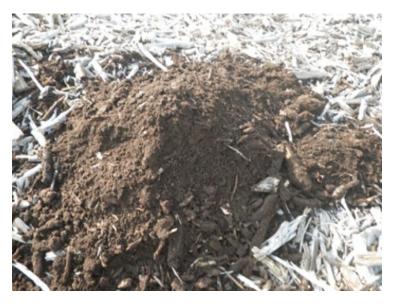
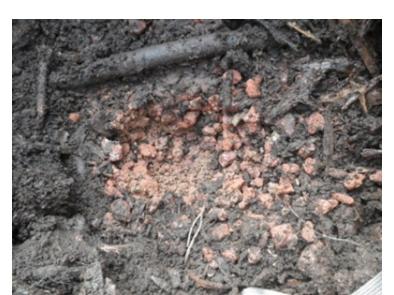
- Ductile Iron Drain Lines
- Foul Air Duct and Pipe
- Fan Maintenance
- Biofilter Media
- Biofilter Concrete
- Scrubber

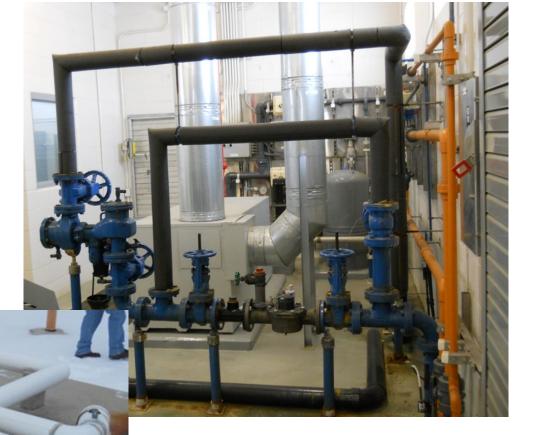
- Humidification System
 - NPW
 - Boiler
 - Spray Nozzles
 - Recirculation Pumps
 - Controls
- In-Bed Irrigation Failure

The system complexity resulted in numerous failures.

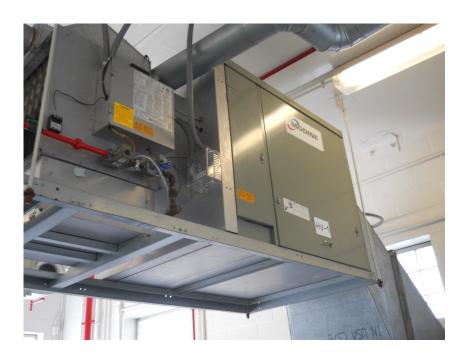
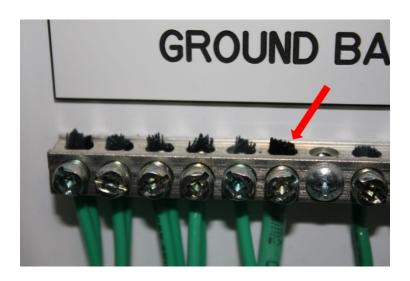
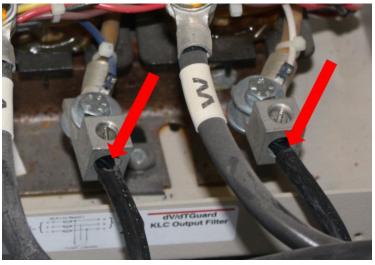
Fan Building

- MAU & Vent Fans
- Electrical Room A/C
- AFD
- Electrical Panels
- Instrumentation
- PLC

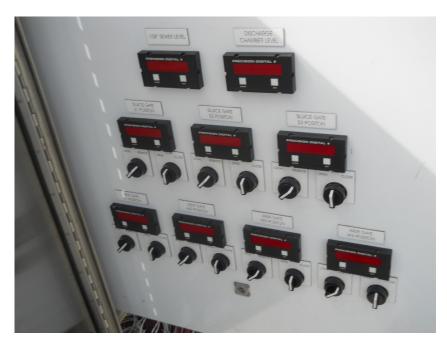
BBX

- Slide Gates & Weir Gates
- Level
- PLC & Radio
- Actuators
- RTC

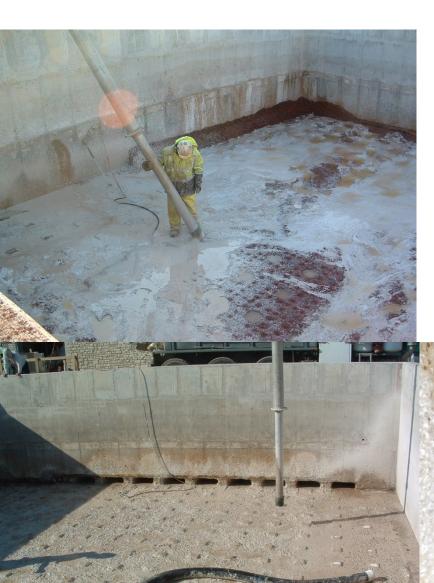
Concrete Corrosion

- Corrosion Significantly Worse Than Expected
 - 2-year Period Between Condition Assessment and Construction
 - Could Not Inspect Biofilter Floor
- Contract Included Significant Allowance

- Installed New Concrete Floor in Cells
- Changed to HDPE Liner
- Added FRP Pipe Header
- Hallsten Floor Replacement

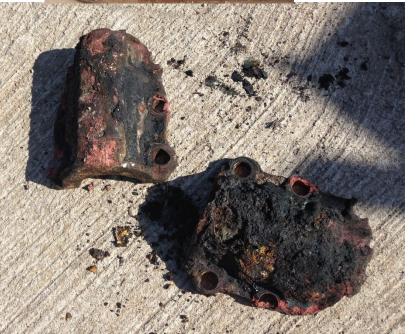
"Plumbing" Issues

- Tunnel Venting Through Building Plumbing Vents
 - Odors Prevalent at Site with Fans & Dampers Off
- Plumbing Vent Penetration in Electrical Room
- Added Trap on Sanitary Lateral
