A Tale of A Corroded Pipe: Failures, Analysis and Mitigation

Marissa Lauer – Brown and Caldwell
Mike Erkkila – Lake County Department of Utilities
June 26, 2019

- Located in Concord Township (Lake County)
- ~4,500 LF of 3"/4" ductile iron sanitary force main
- Begins at the Far Hills Pump Station
- Installed in 1993 (25 years old)
- Lake County hired Brown and Caldwell (BC) in Spring/Summer 2018 to investigate the Far Hills force main and its recent failures

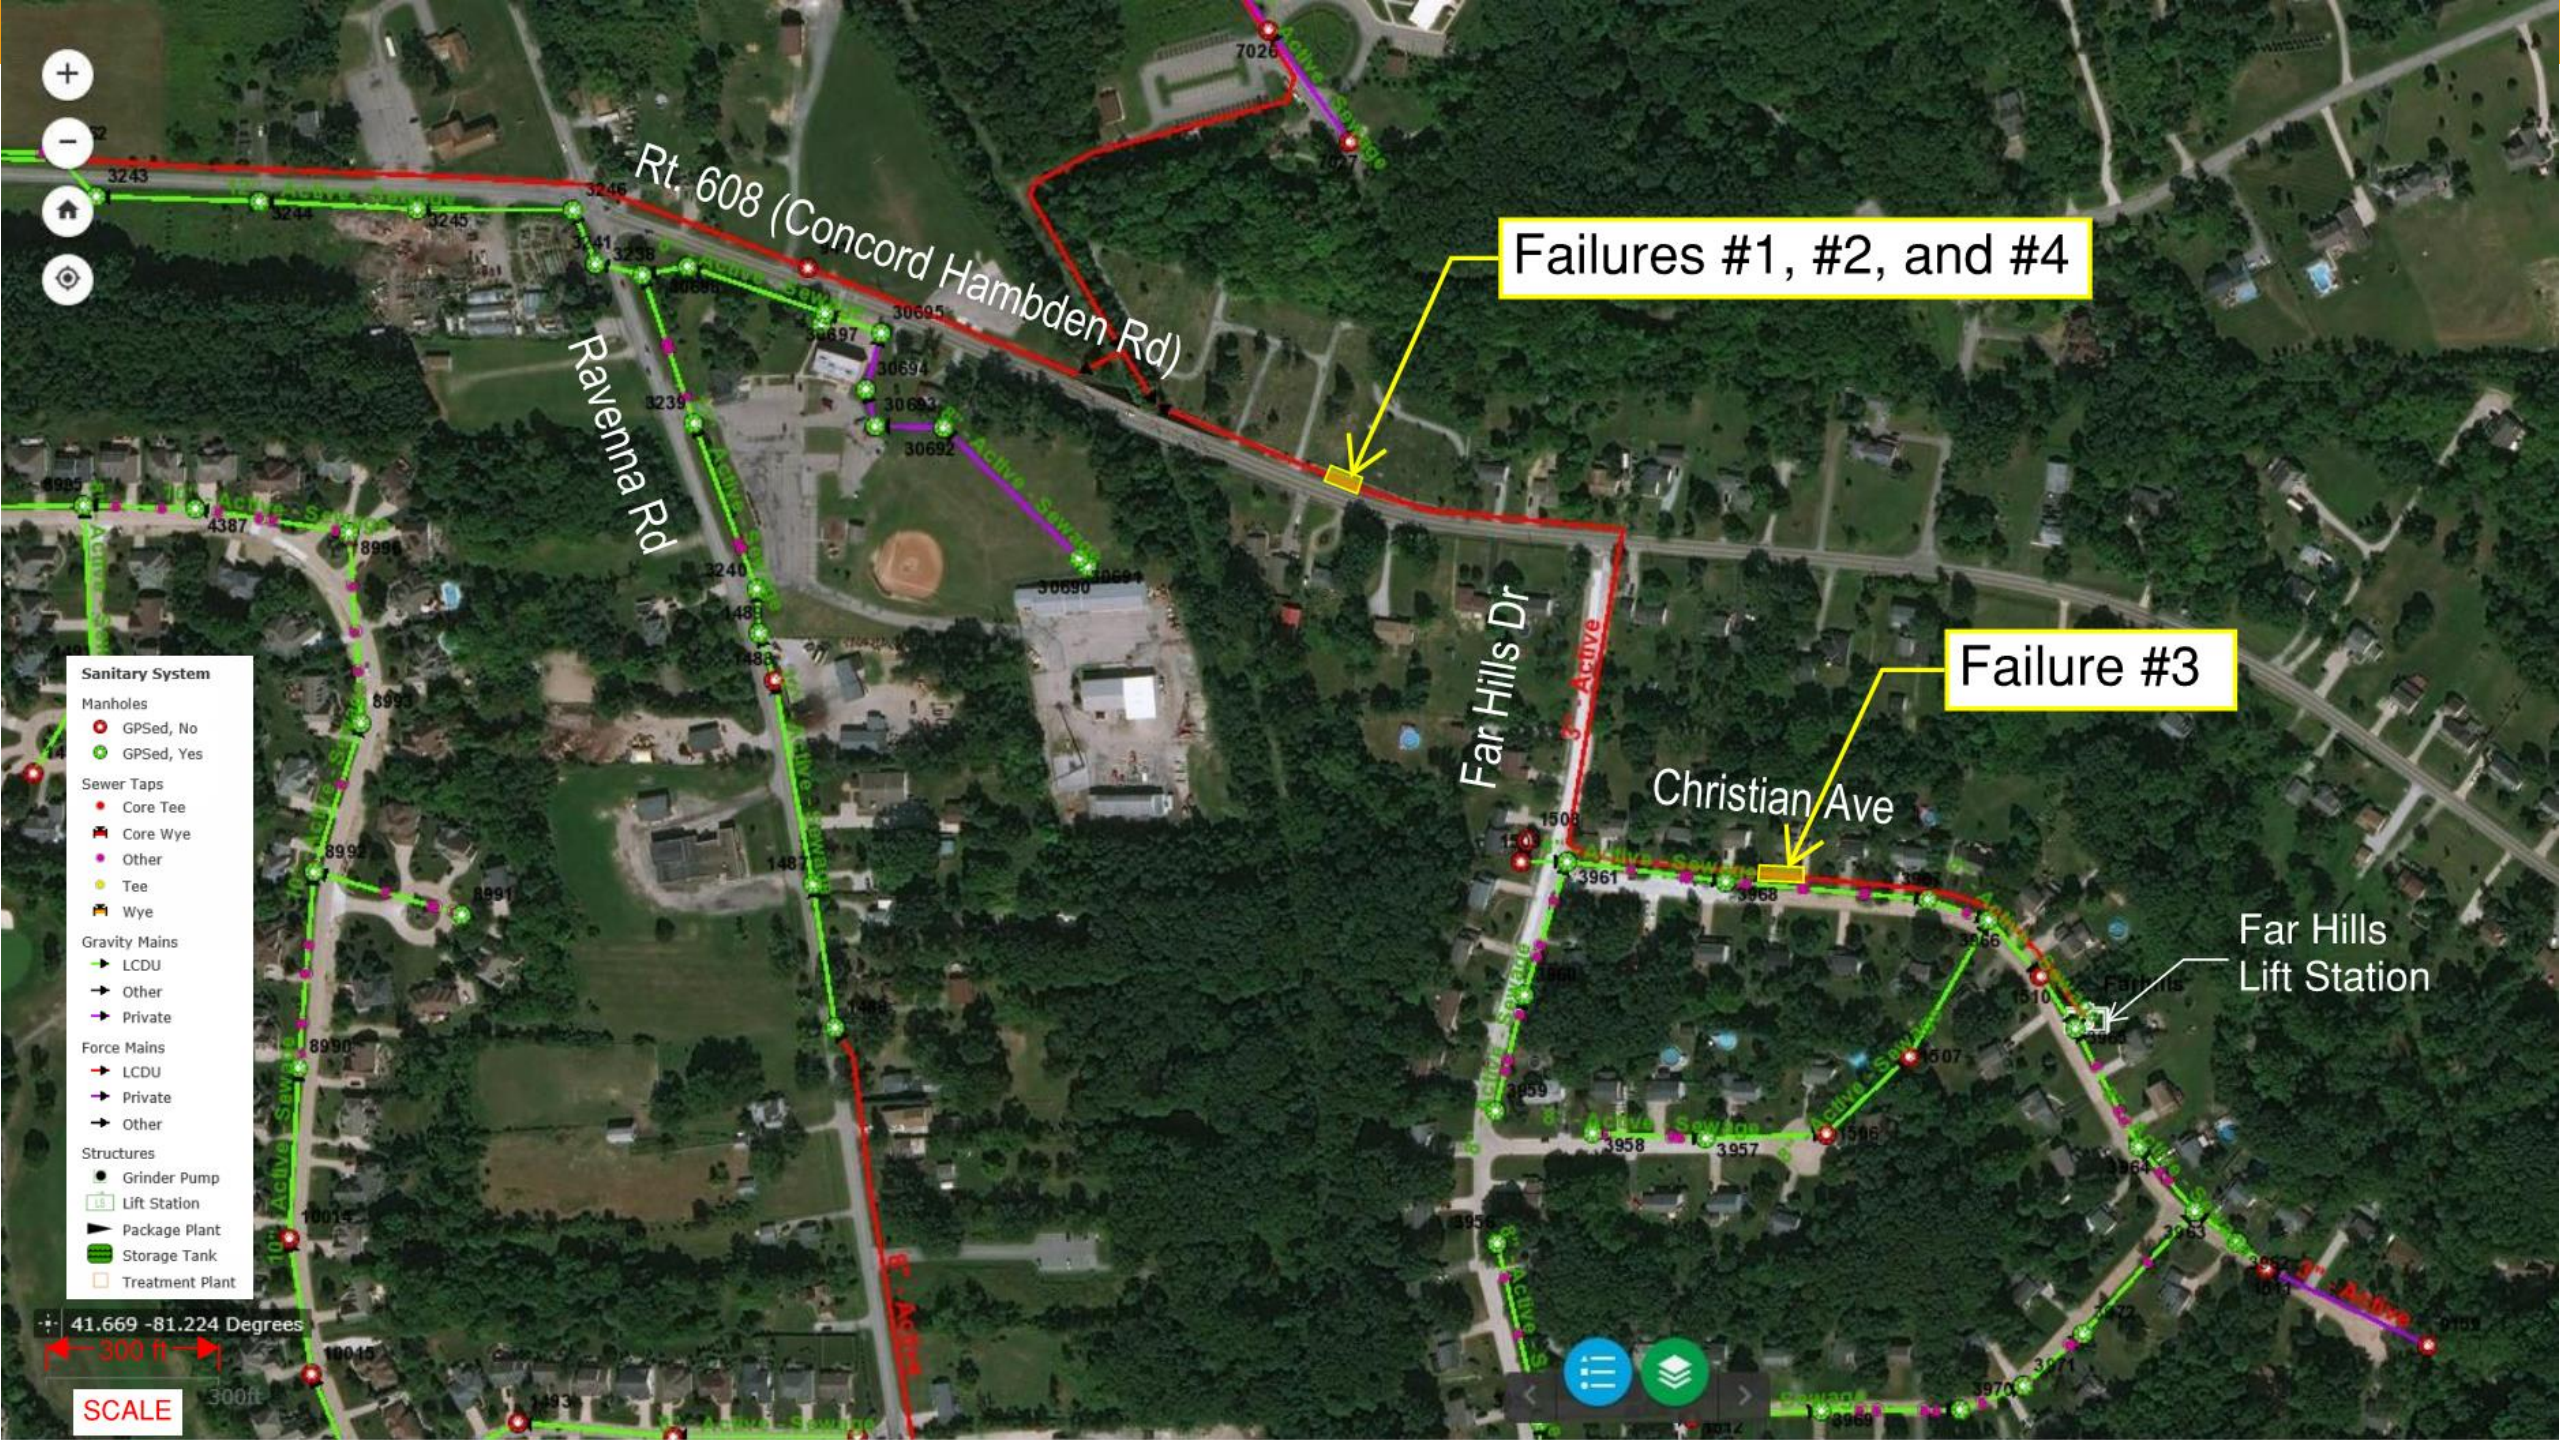
Apparent Cause: Exterior Corrosion (“Differential Aeration Cell”)

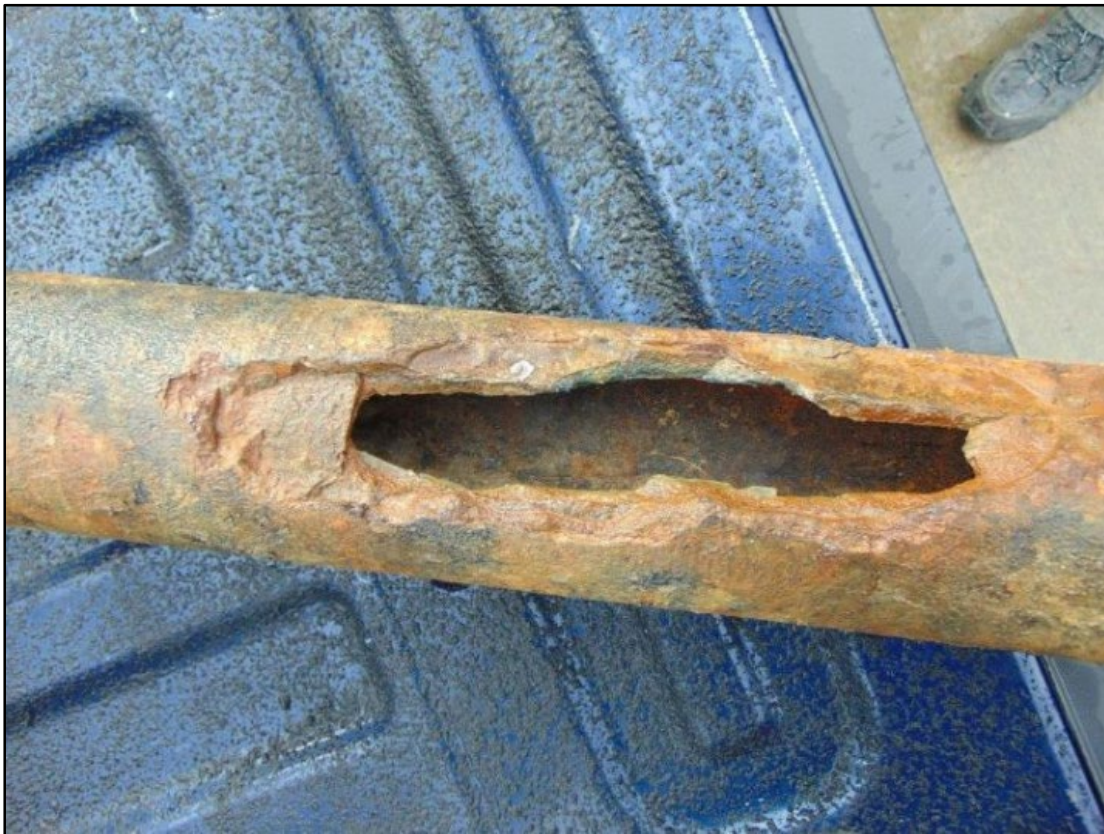
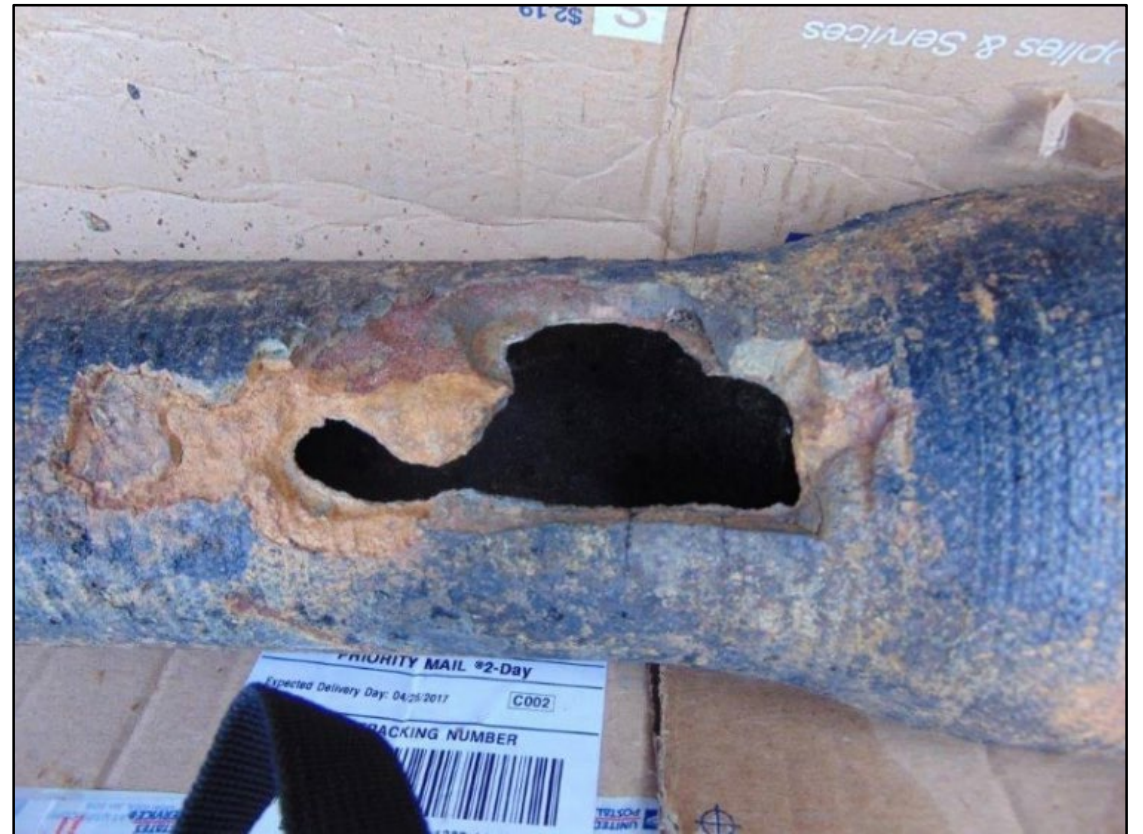
All failures occurred at the pipe invert

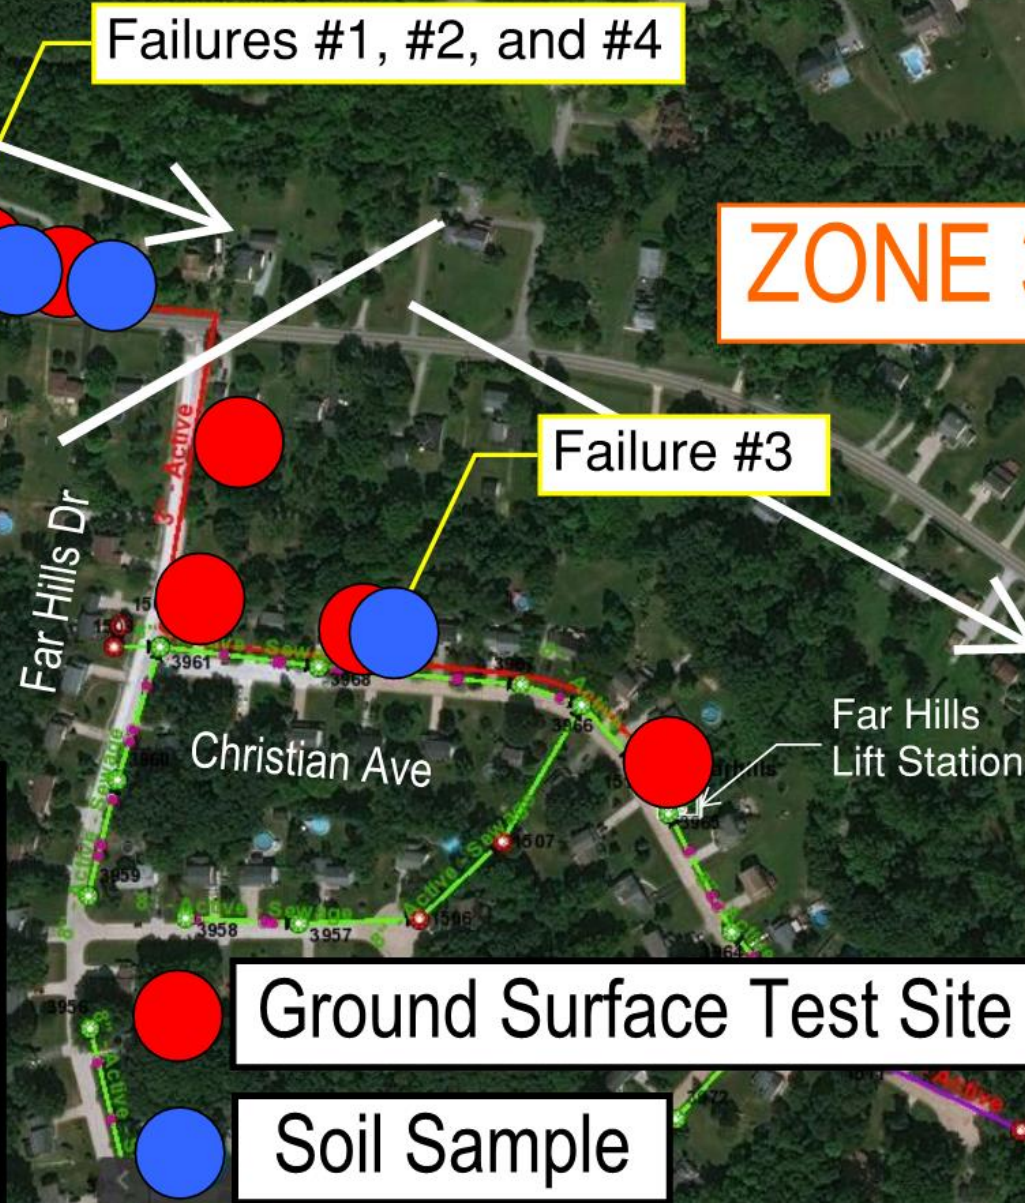
3 "Zones" of Soil Resistivity

Soil Resistivity / Corrosivity Classifications:
 Zones 1 and 3 = **More moderate to mild**
 Zone 2 = **More severe**

All soil samples = aggressive
 Acidic pH and weakly aerated / aerated soils

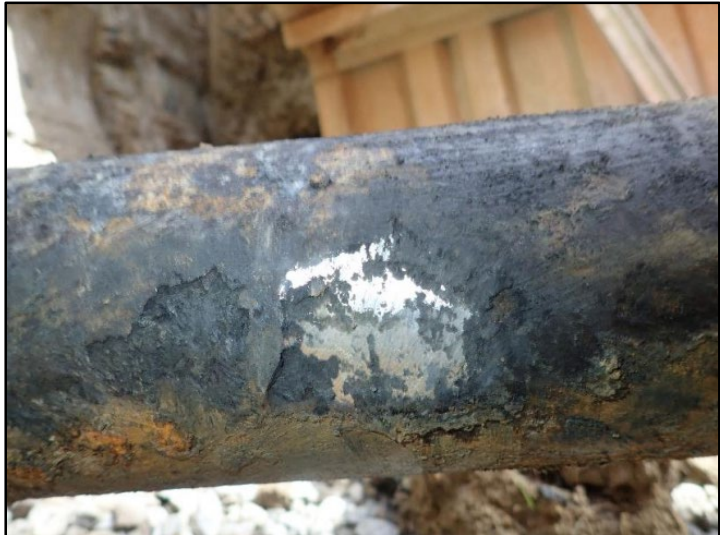
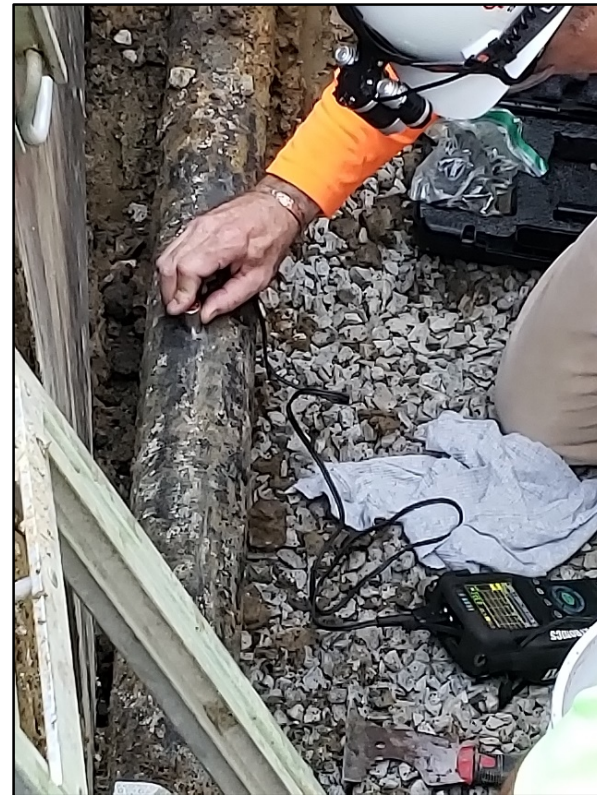
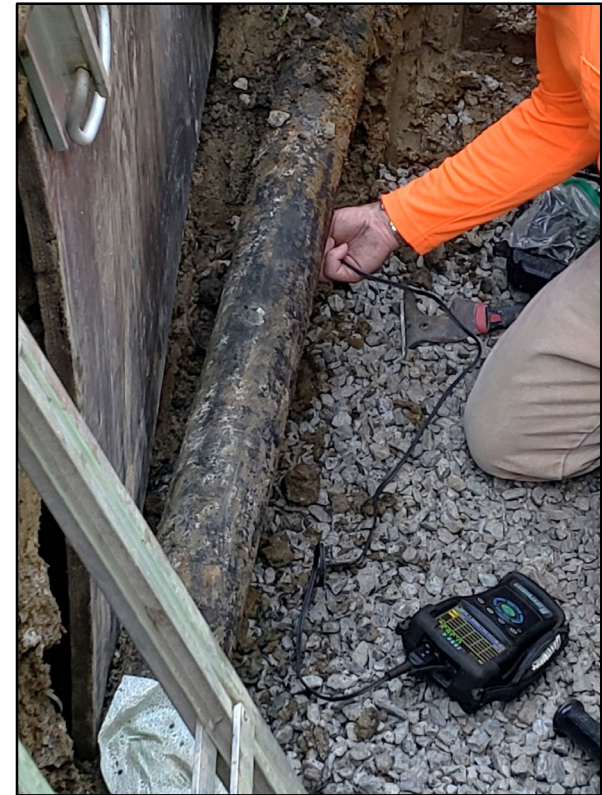
- Visual observations
- Wall thickness measurement using an ultrasonic gauge (UT Testing)

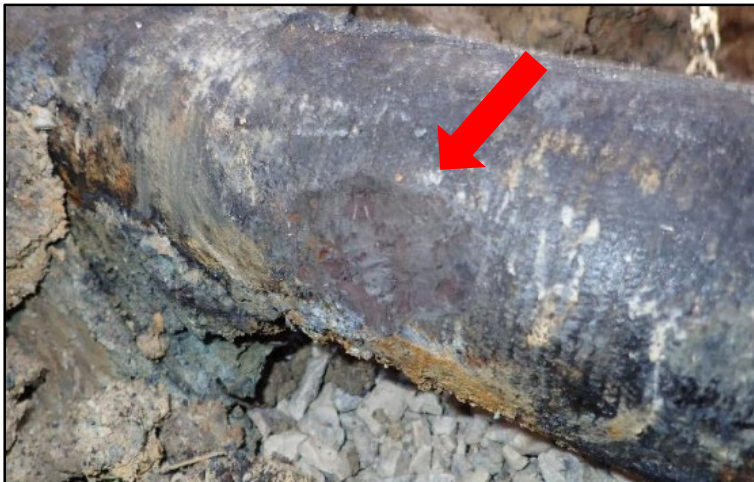
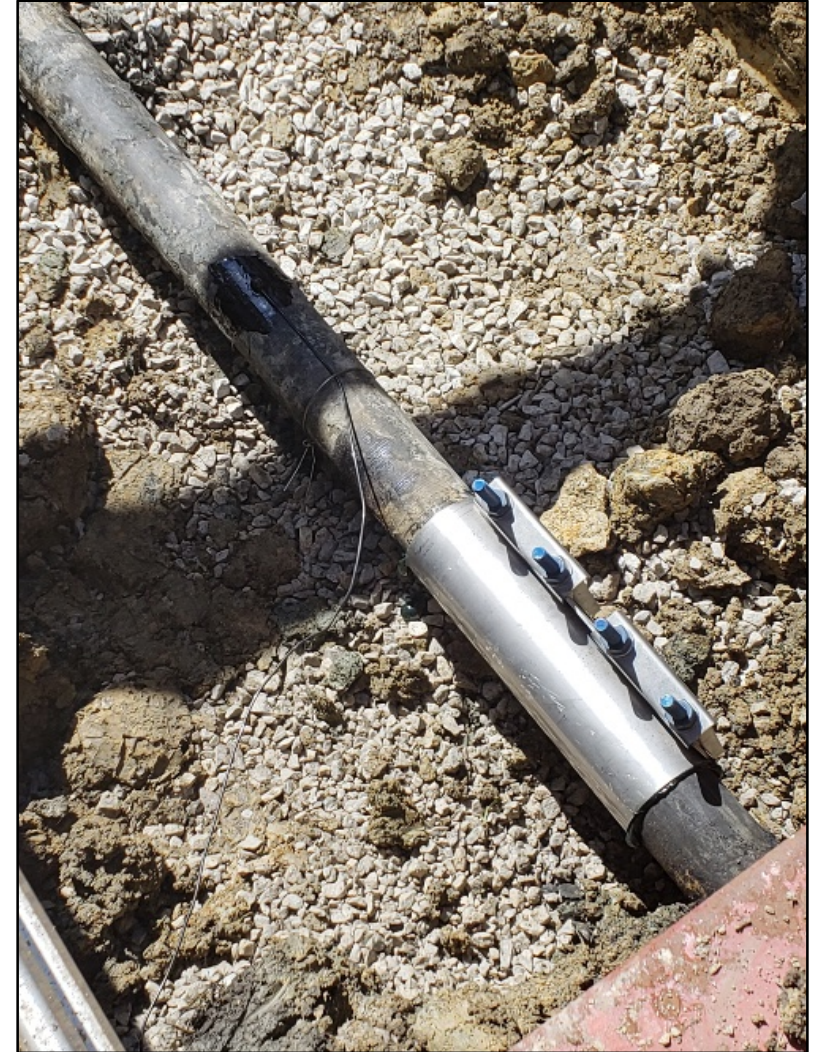
- The original surface texture of the pipe was still visible in most areas, but some pitting corrosion was found at the pipe invert
- The pitting was observed to be very deep and soft
- A repair clamp was installed over top of a pipe area nearing failure

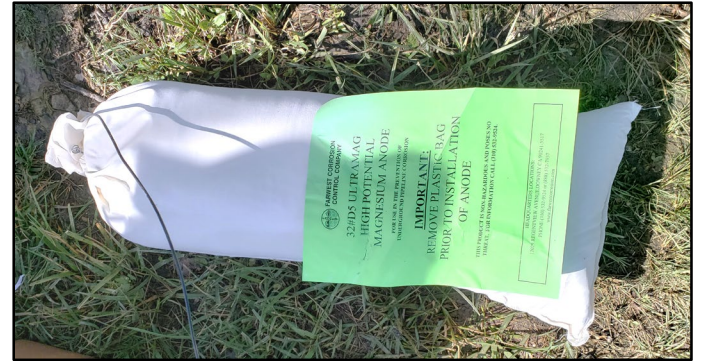
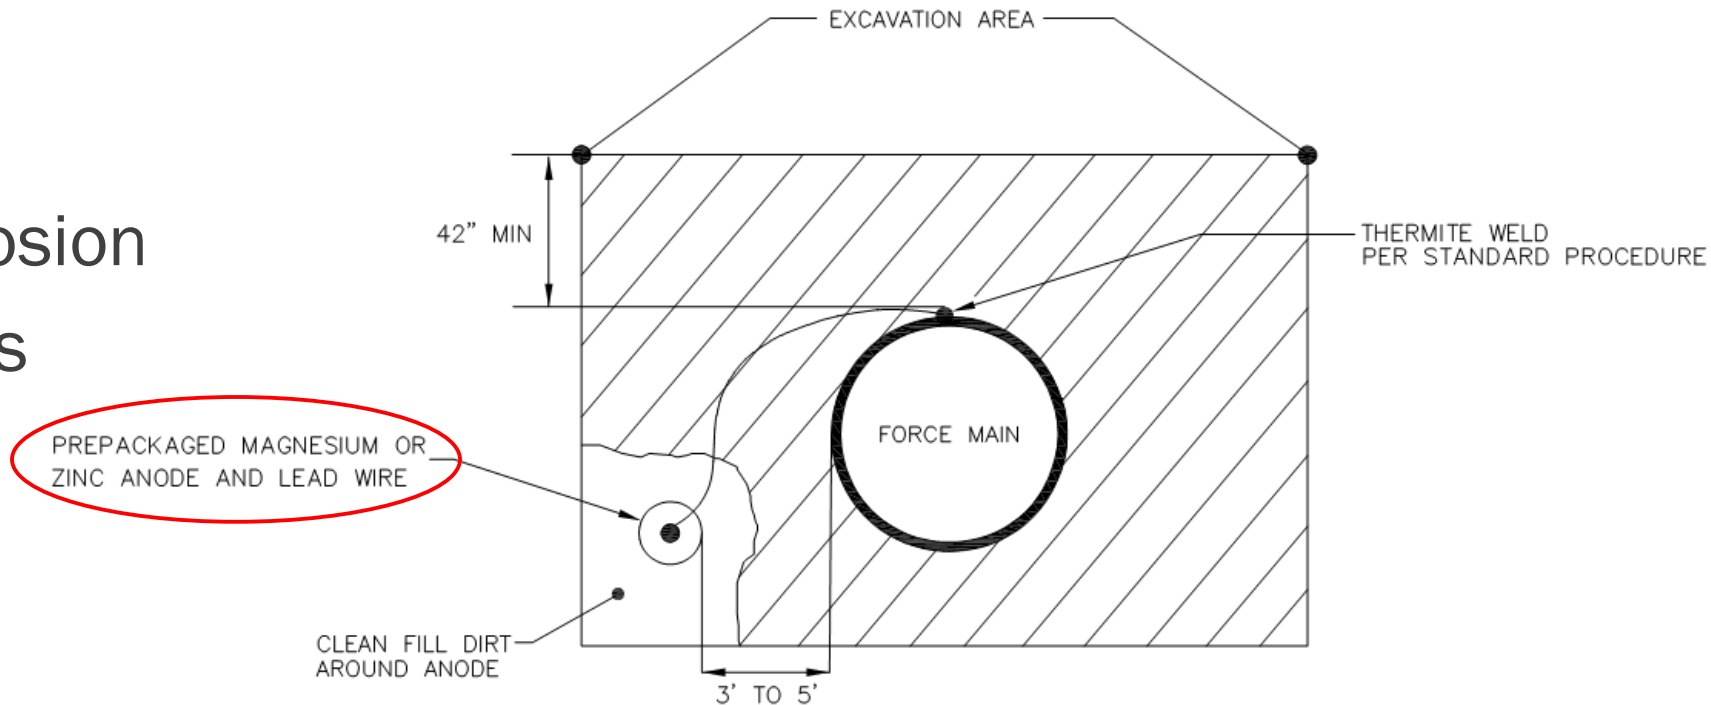
3 sacrificial magnesium anodes (32 lbs.) were provided and installed on the force main to provide cathodic protection

- Slow the rate of corrosion
- Prevent future breaks
- Prolong service life

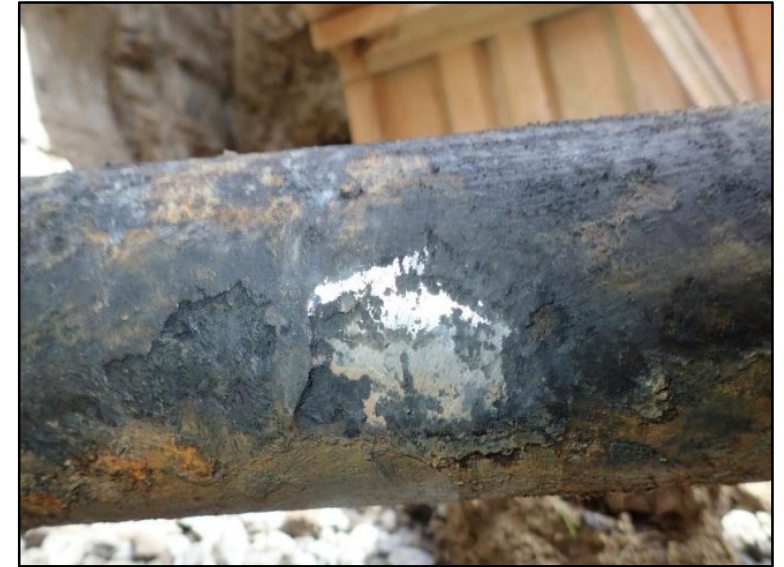
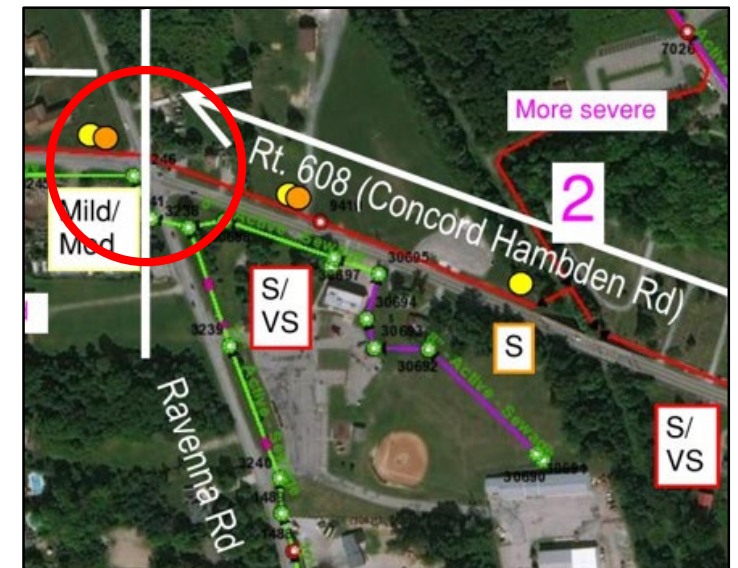
- Microbiological influenced corrosion (MIC) may also be occurring on some sections of the pipe exterior
 - Black scale/slime (possibly iron sulfide) on pipe exterior
 - UT measurements suggested general pipe thinning
- De-icing salt is heavily applied at the intersection of Rt. 608 and Ravenna Rd (“Zone 2”)
 - De-icing salt can lead to corrosion as it leaches into the soil and increase chloride and sulfide content, reduce resistivity
 - Observations were consistent
