# EXPEDITED SEWER REHABILITATION USING PROGRESSIVE DESIGN - BUILD

River Valley Highlands Sewer

June 26, 2019

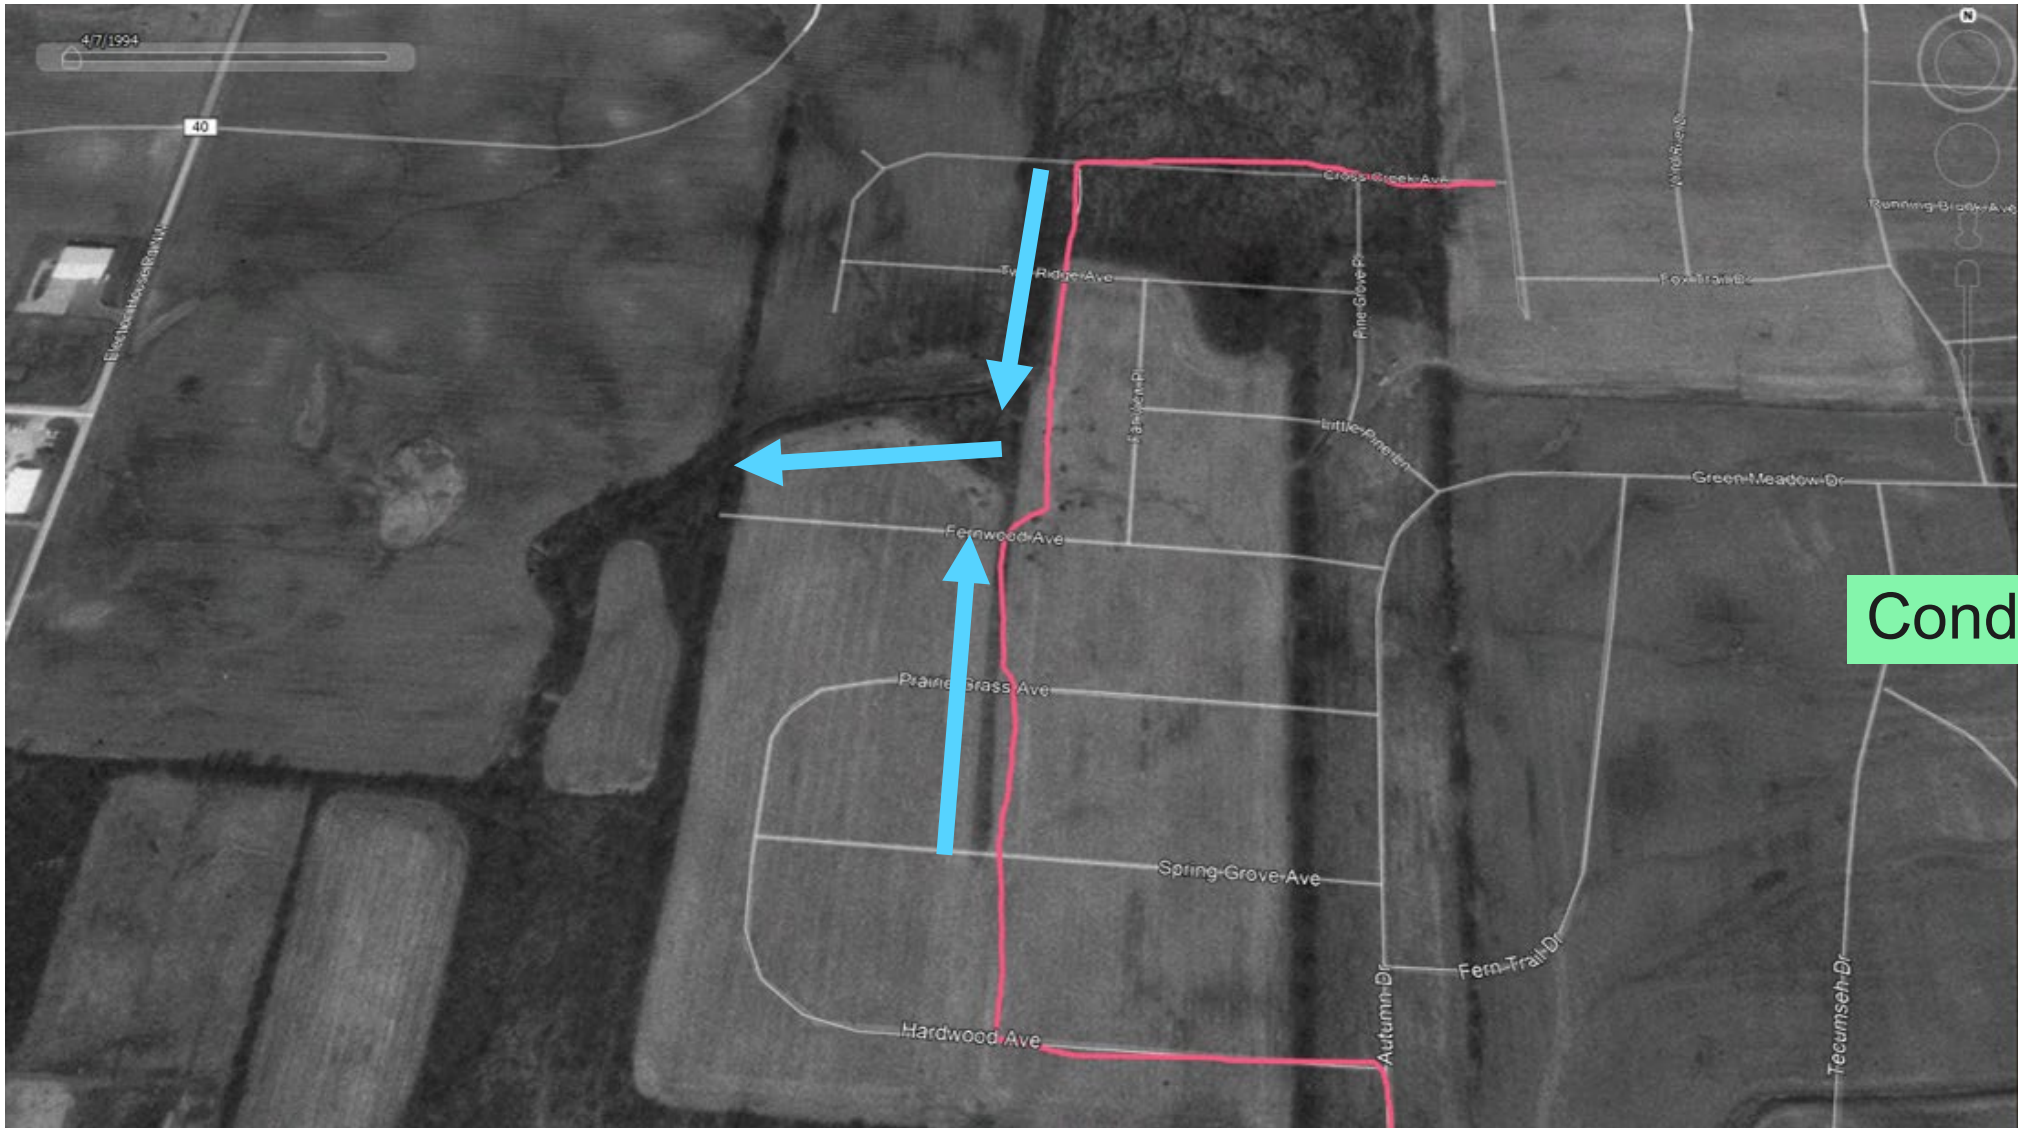
Conditions in 2004

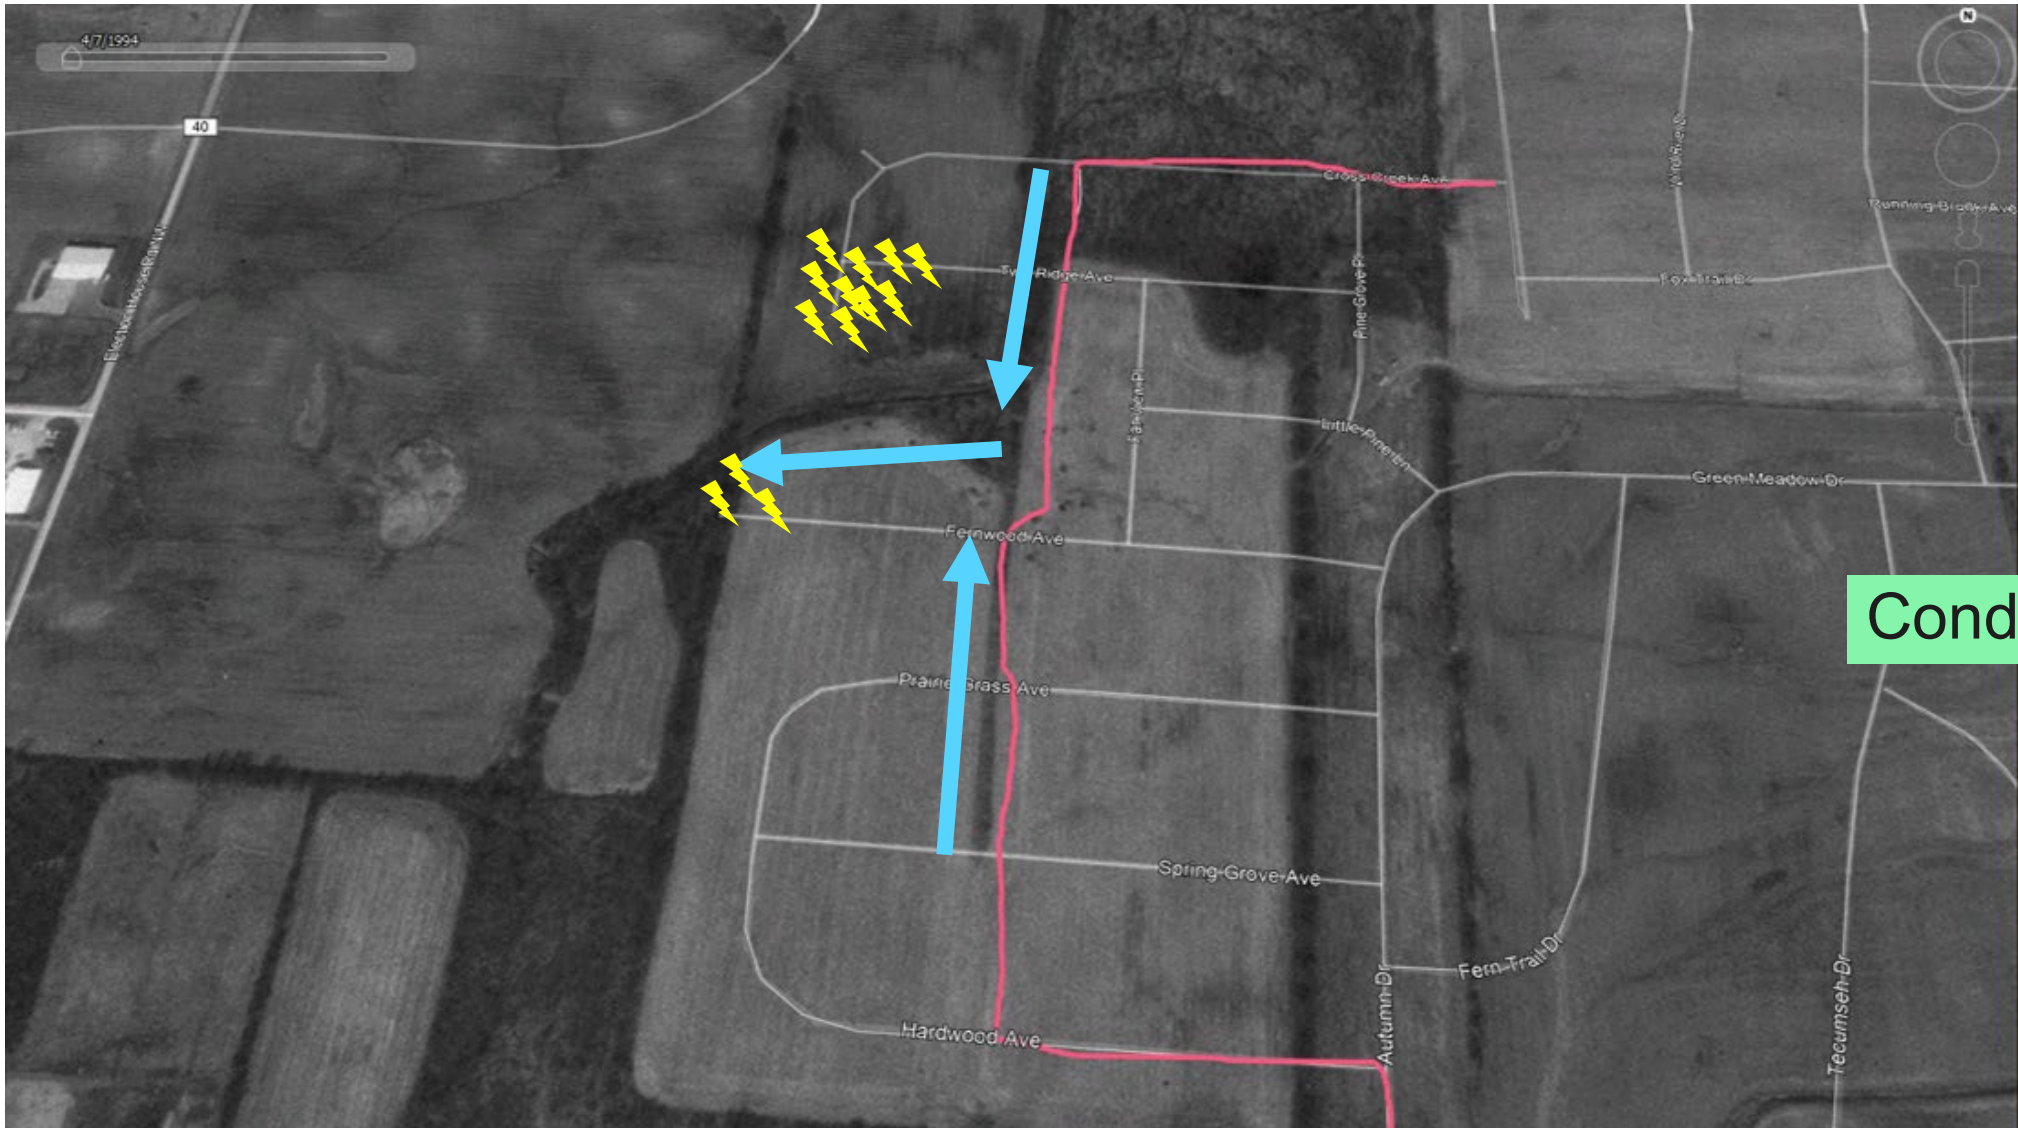
Conditions in 2004

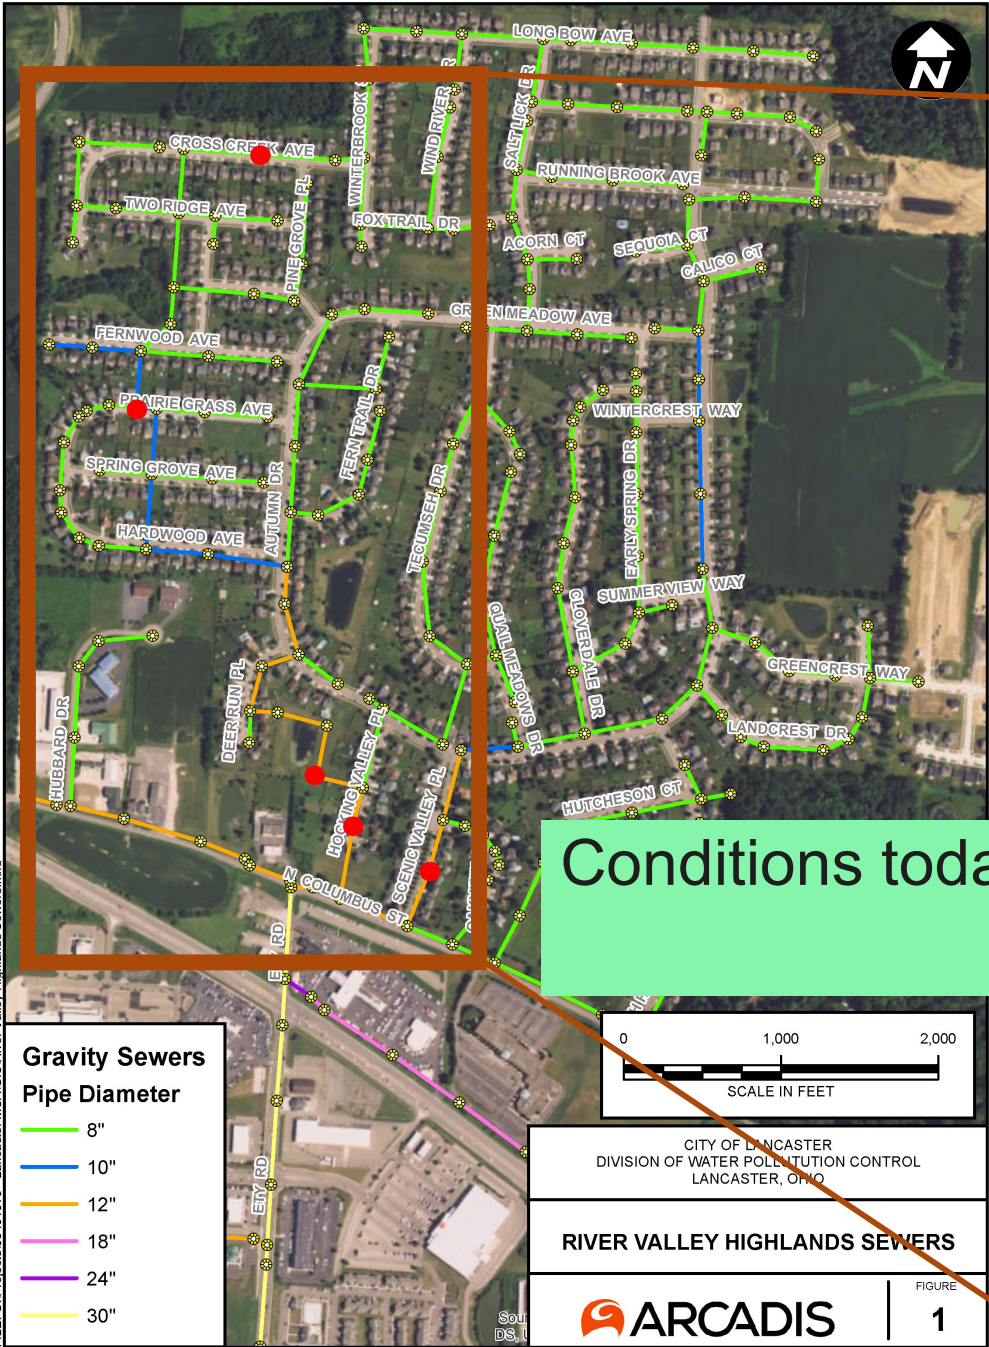
Conditions today

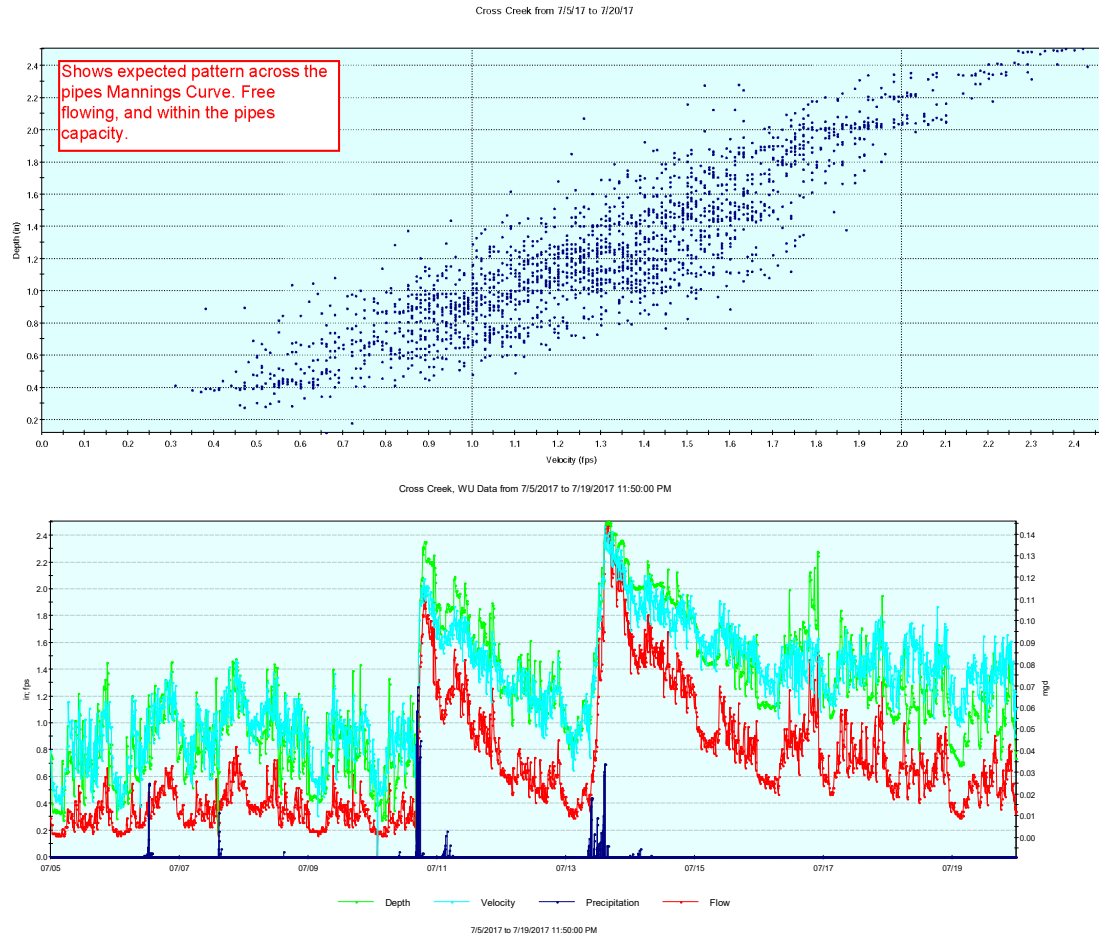
# Cross Creek Conclusions

- Extremely high levels of I&I (14X Peak on 2" rain)
- Days to recover to normal levels
  - Something is acting like French drain
  - Second storm impact was immediate and doubled
- No blockage or pipe restriction
- Some form of immediate leakage
  - Roof Drains
  - Sump Pumps
  - Ponded RII
  - RII

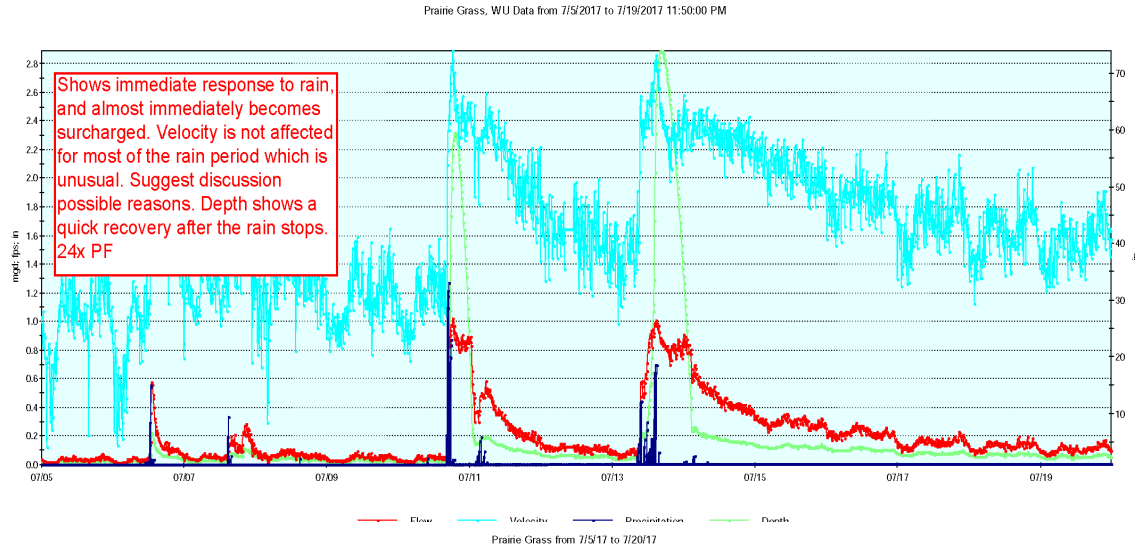
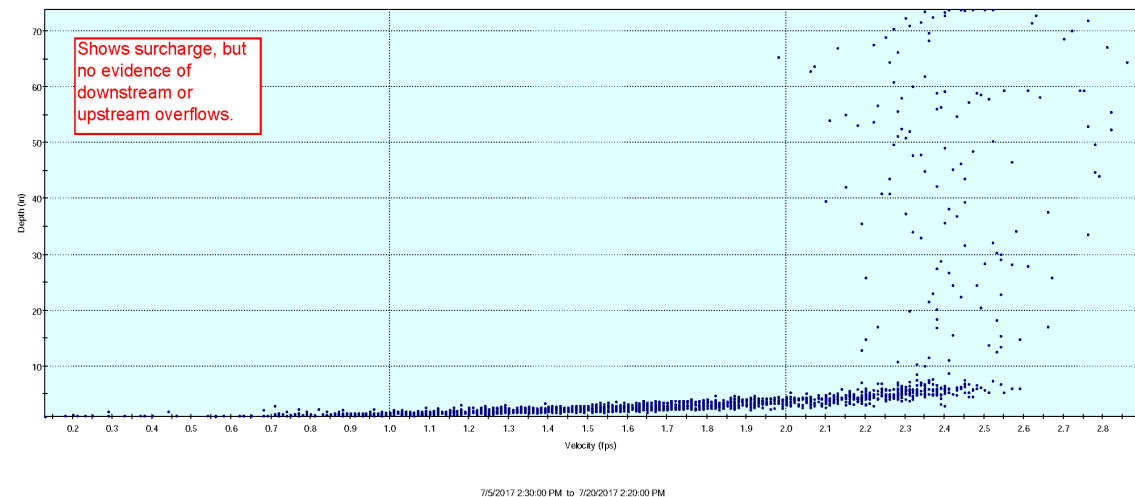
# Prairie Grass Conclusions

- Extraordinary levels of I&I (24X Peak on 2" rain)
- Days to recover to normal levels
  - Something is acting like French drain
  - Second storm impact was immediate and doubled
  - Old swales probably bad actors
- No downstream pipe restriction, just very high wet weather loading
- Some form of immediate leakage
  - Roof Drains
  - Sump Pumps
  - Ponded RII
  - RII

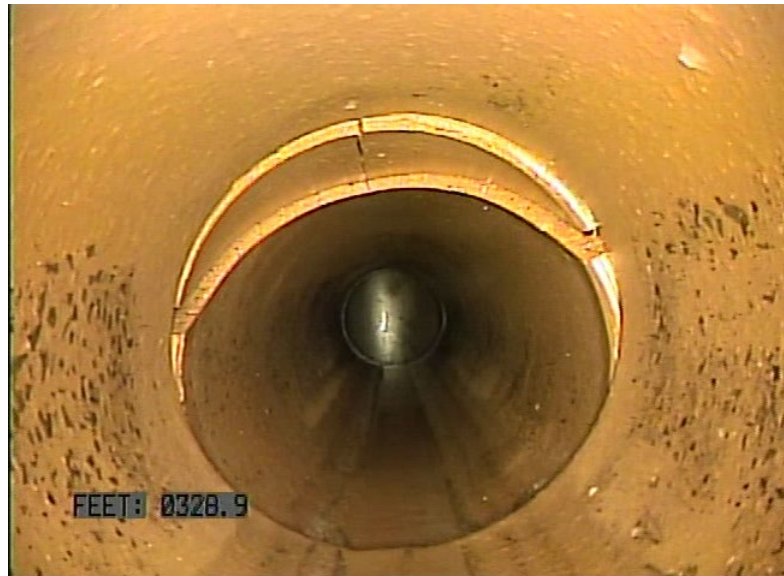
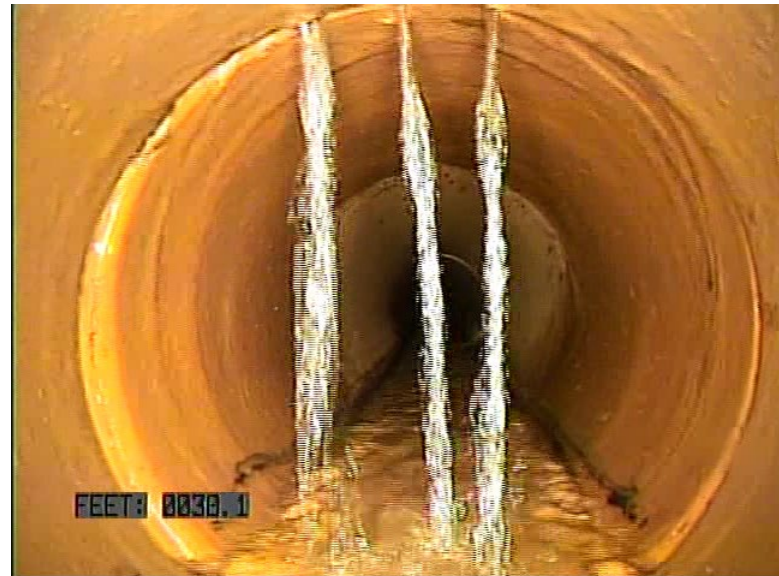
# Pipe Findings

- 1 fracture only
- Half pipes had 1 – 7 visibly leaking joints
- 20% of laterals had visibly leaking joints

- Pipe is structurally in great shape
- Contractor just didn't know how to joint clay pipe properly
  - *So, rebuild the defective gaskets rather than replace/reline the pipe*

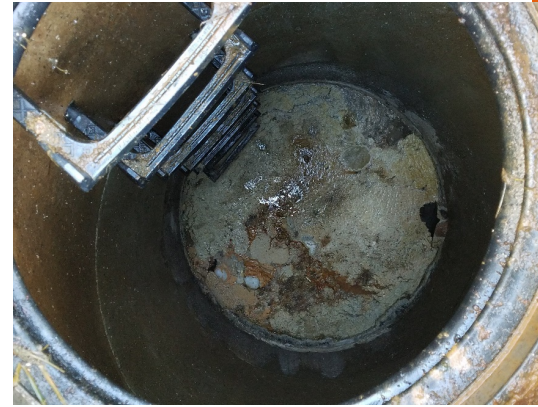
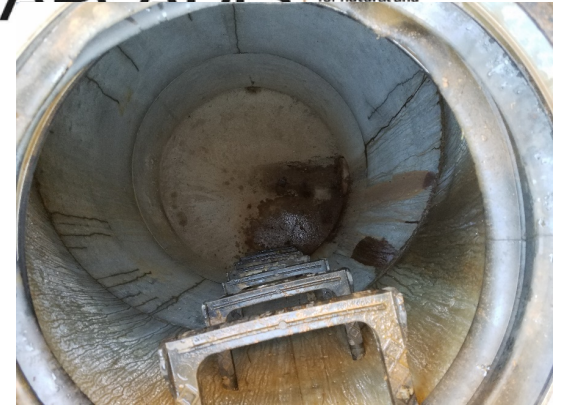
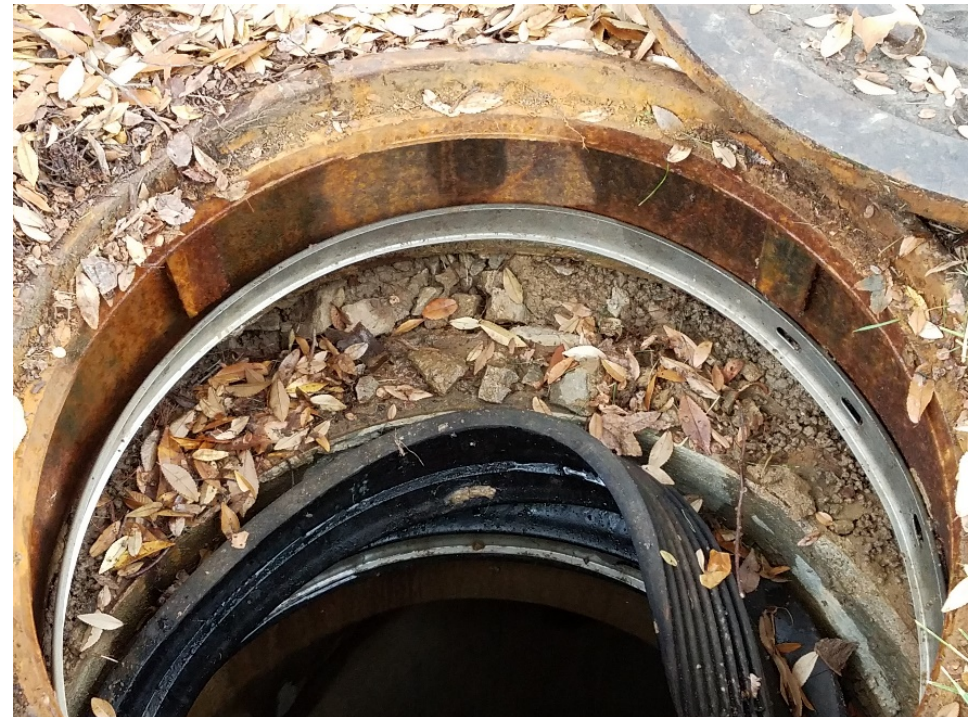
# Manhole Findings

- 8 manholes with minor joint leakage
- Offset chimneys with failed mechanical chimney seals
- Sags in several sections (low land swamp areas)
- One manhole sunk ~1'

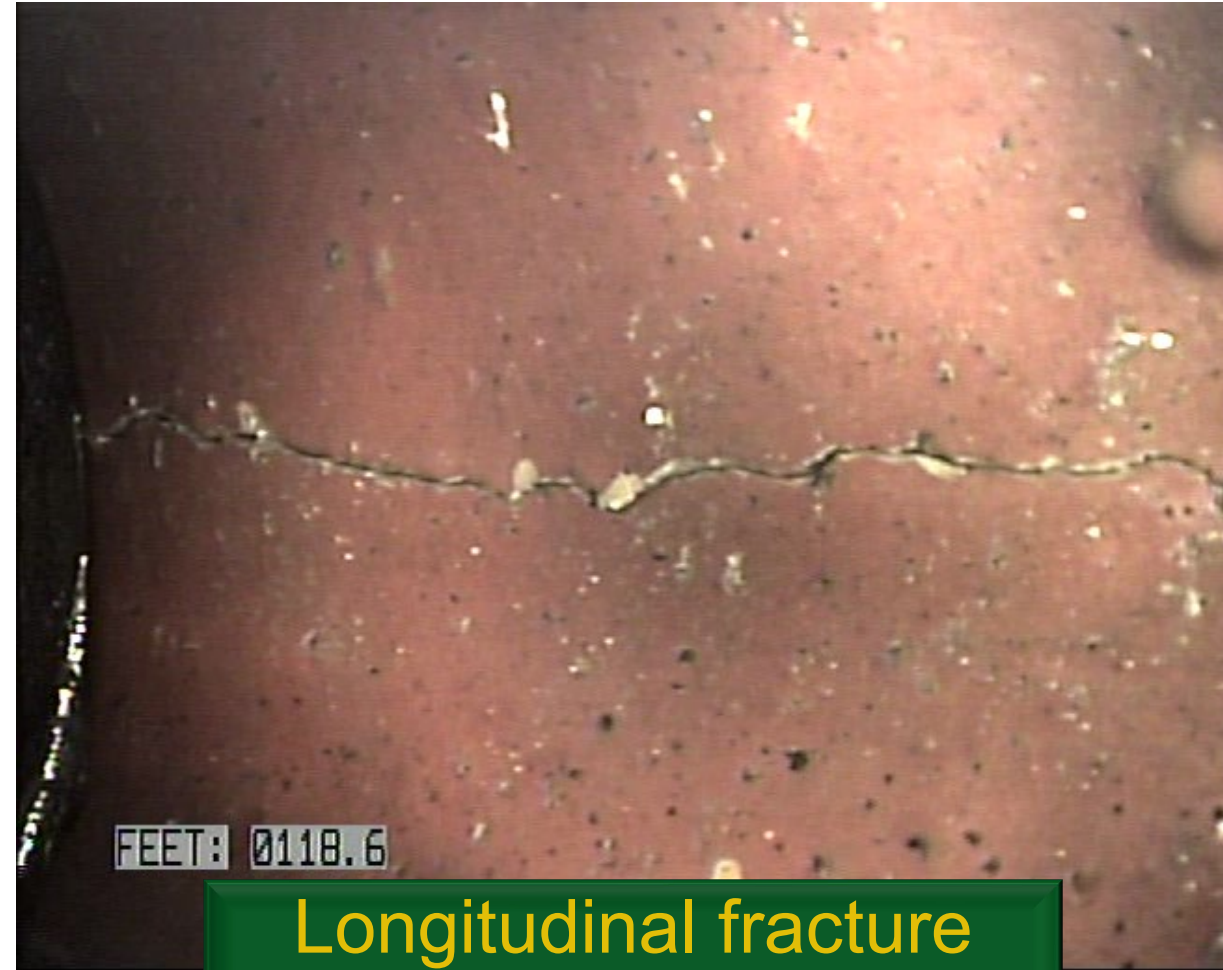
Longitudinal fracture before rehabilitation

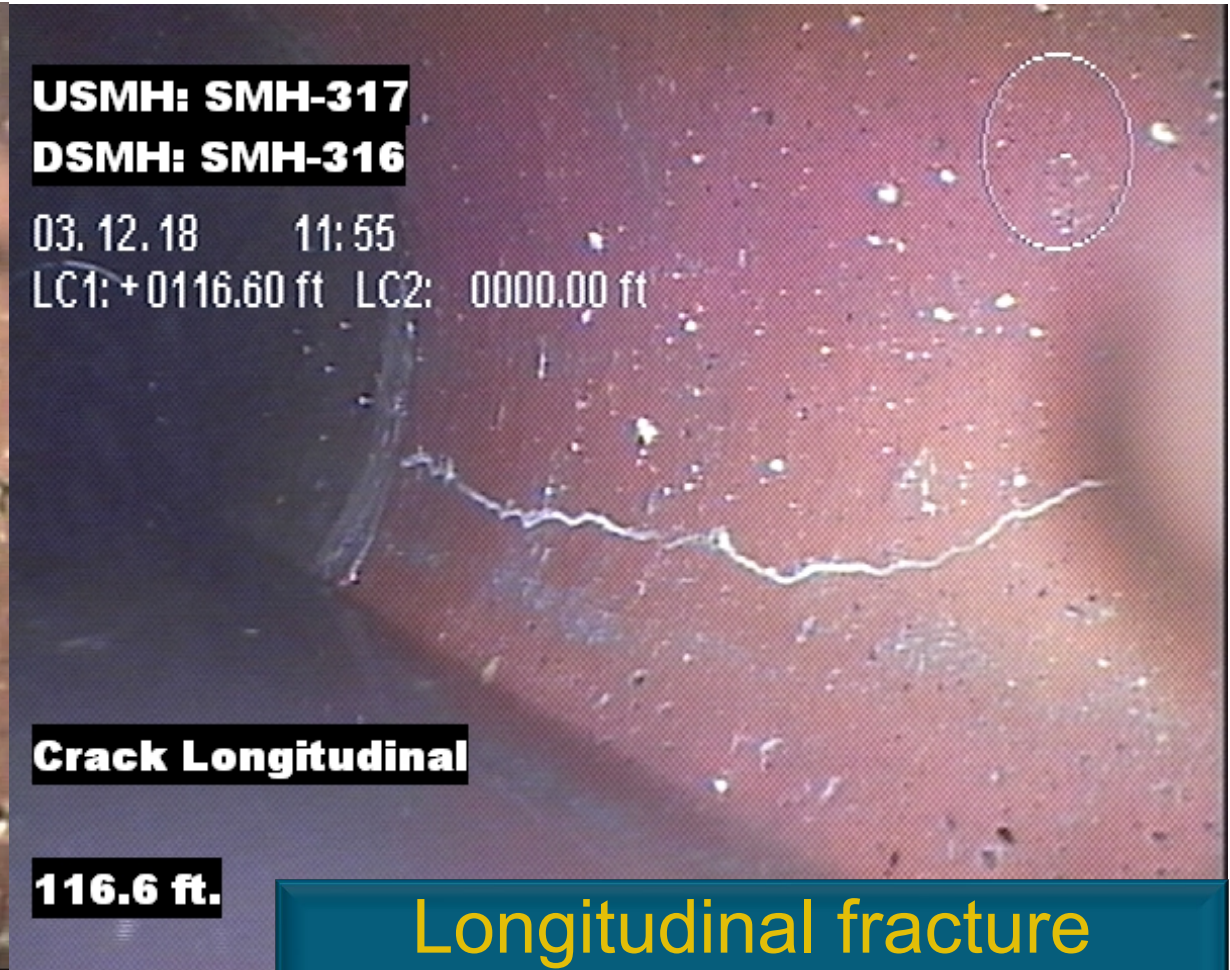
Longitudinal fracture grouted – 18 months later

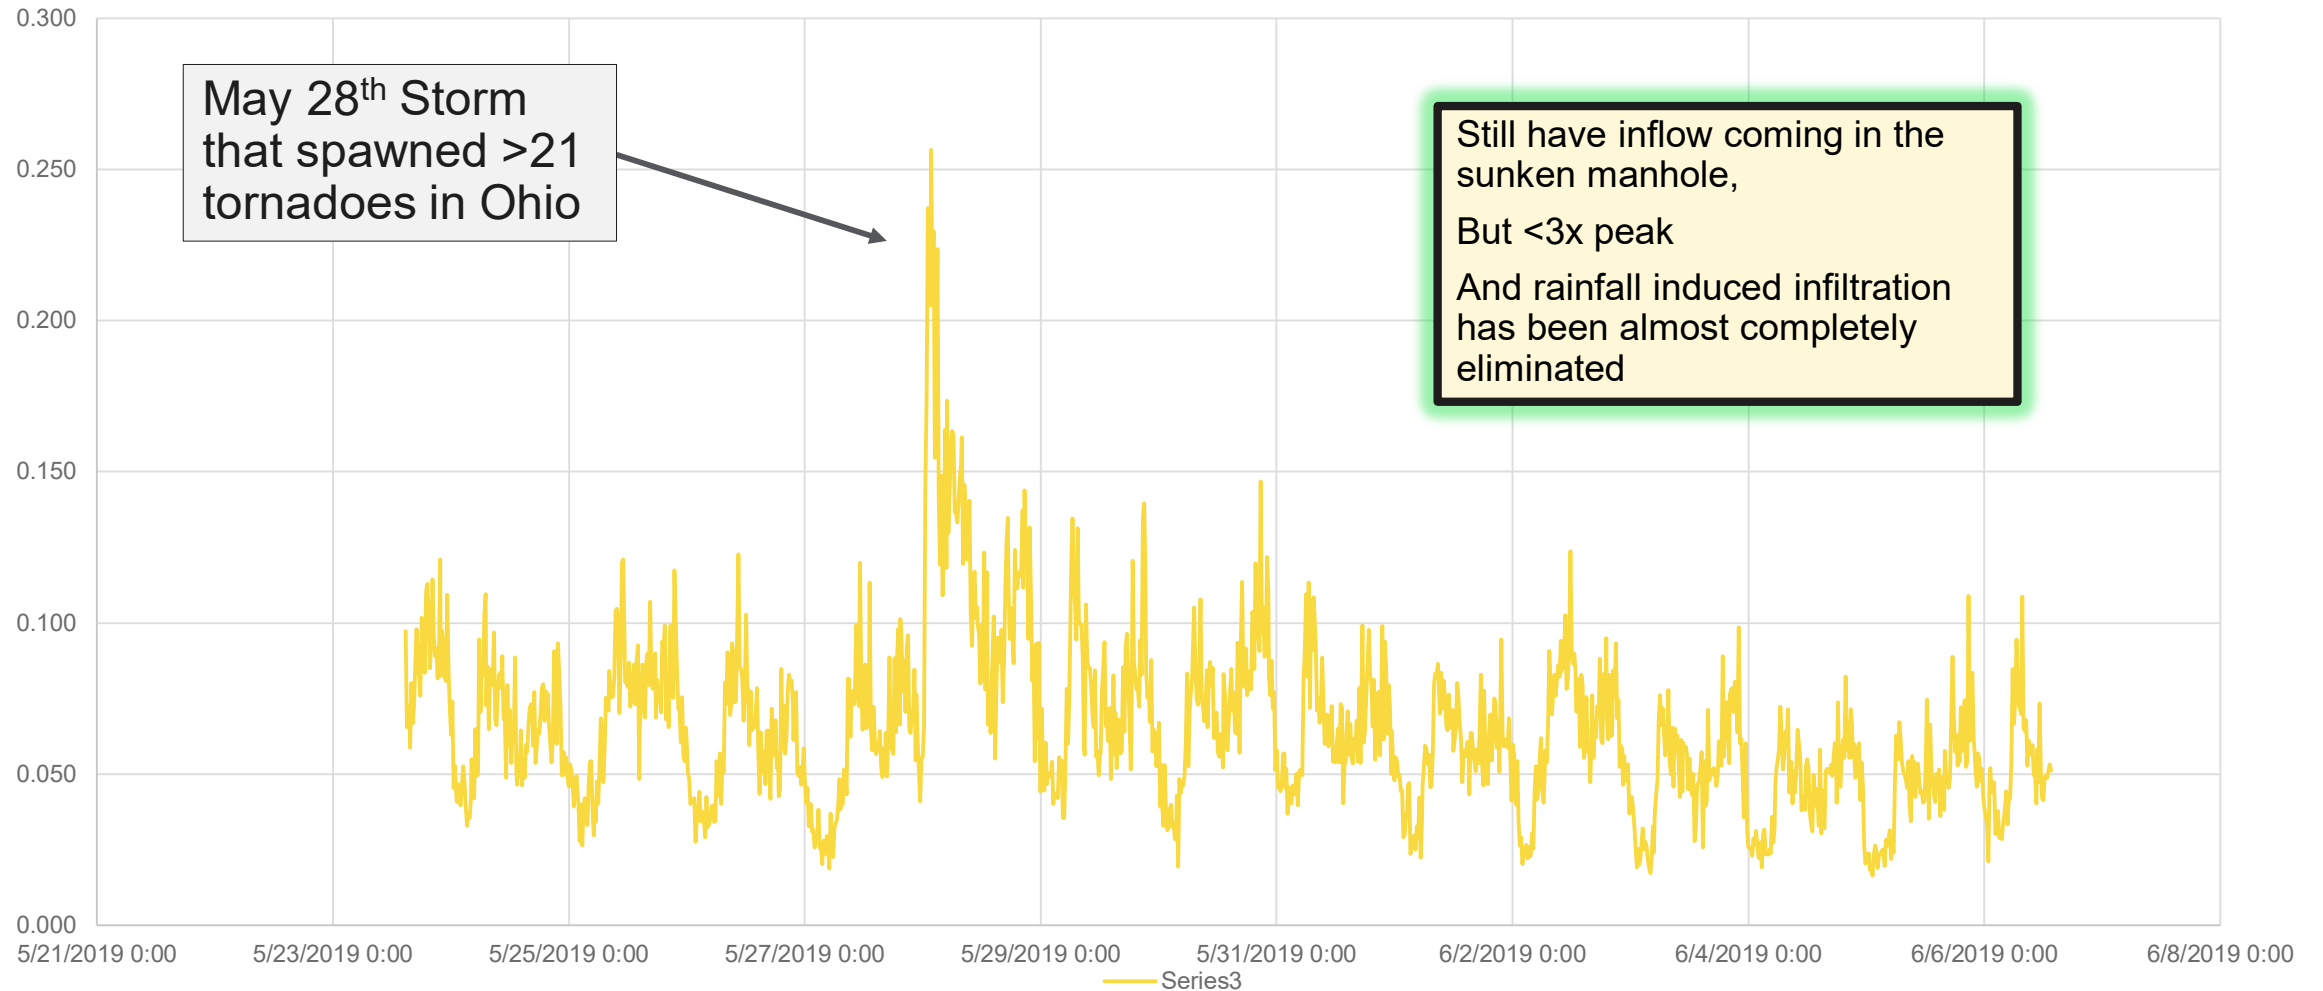
May 28<sup>th</sup> Storm  
that spawned >21  
tornadoes in Ohio

Still have inflow coming in the  
sunken manhole,  
But <3x peak  
And rainfall induced infiltration  
has been almost completely  
eliminated
