System-wide Sewer Rehabilitation: Efficiency in Design

OWEA Collection Systems Specialty Workshop

Eric Dunn, PE – Brown and Caldwell

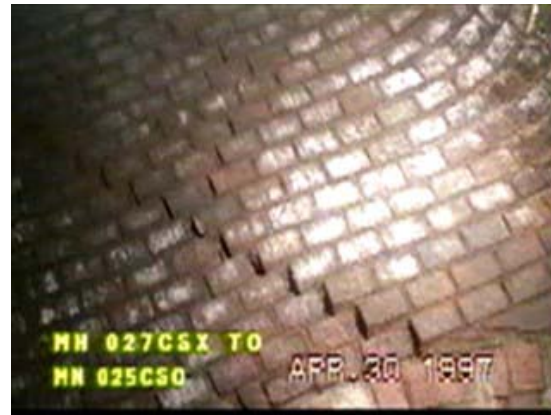
East Wall 1997

- One important advantage of collecting new inspection data during rehabilitation design is ability to compare past defect data to newly collected information
- Evaluate the rate of deterioration of certain defects.

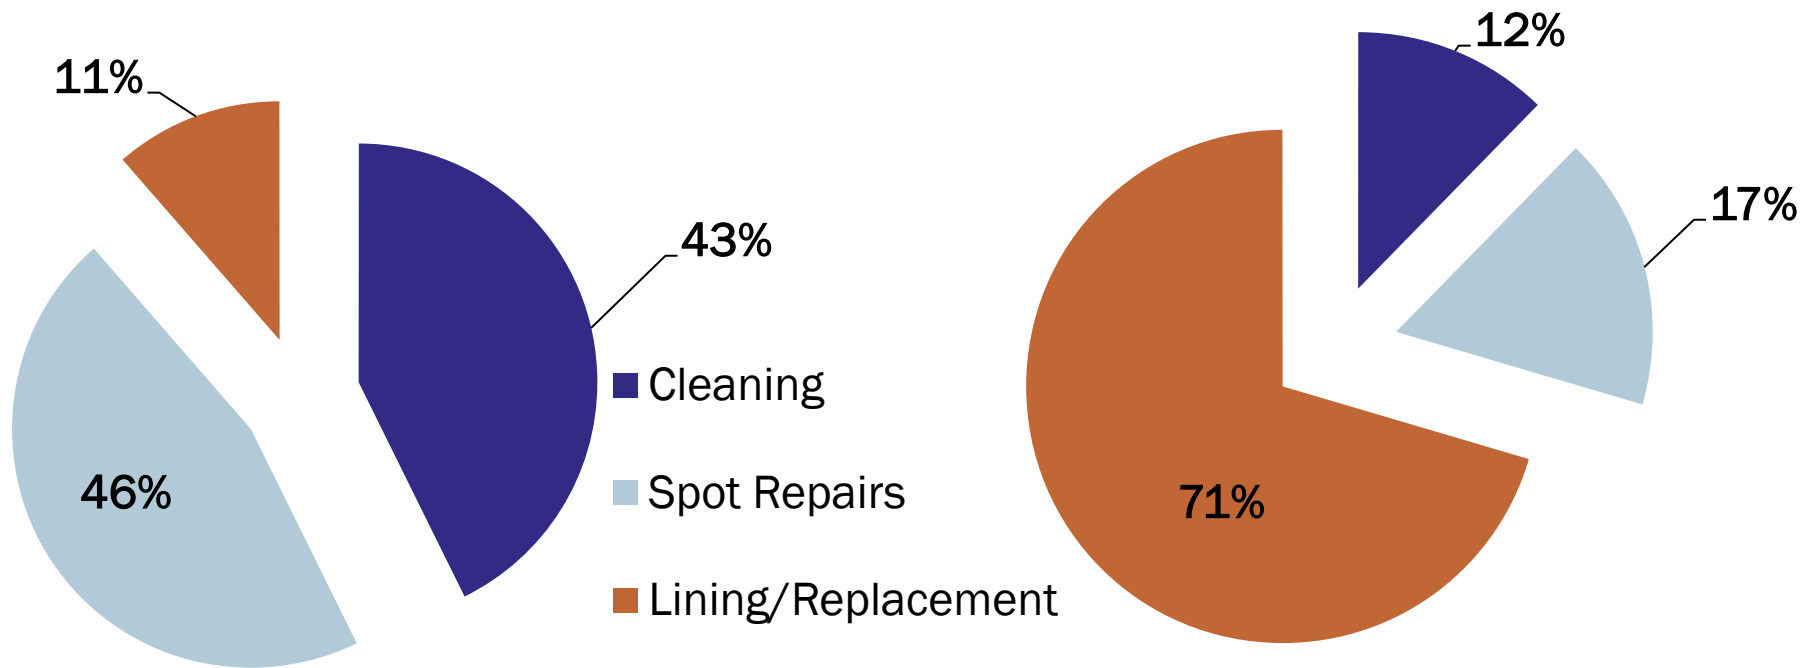
- The amount of field information required for a successful sewer lining project is the most extensive and the accuracy of the data is the most critical.
- The relining and replacement contracts made up ~71% of the overall rehabilitation construction costs, but accounted for only ~11% of the overall rehabilitation footage.
- The amount of re-inspection was relatively small in the overall Interceptor Rehabilitation Project but considered to be well worth the cost.

Project Types by Total Footage

Project Types by Construction Cost

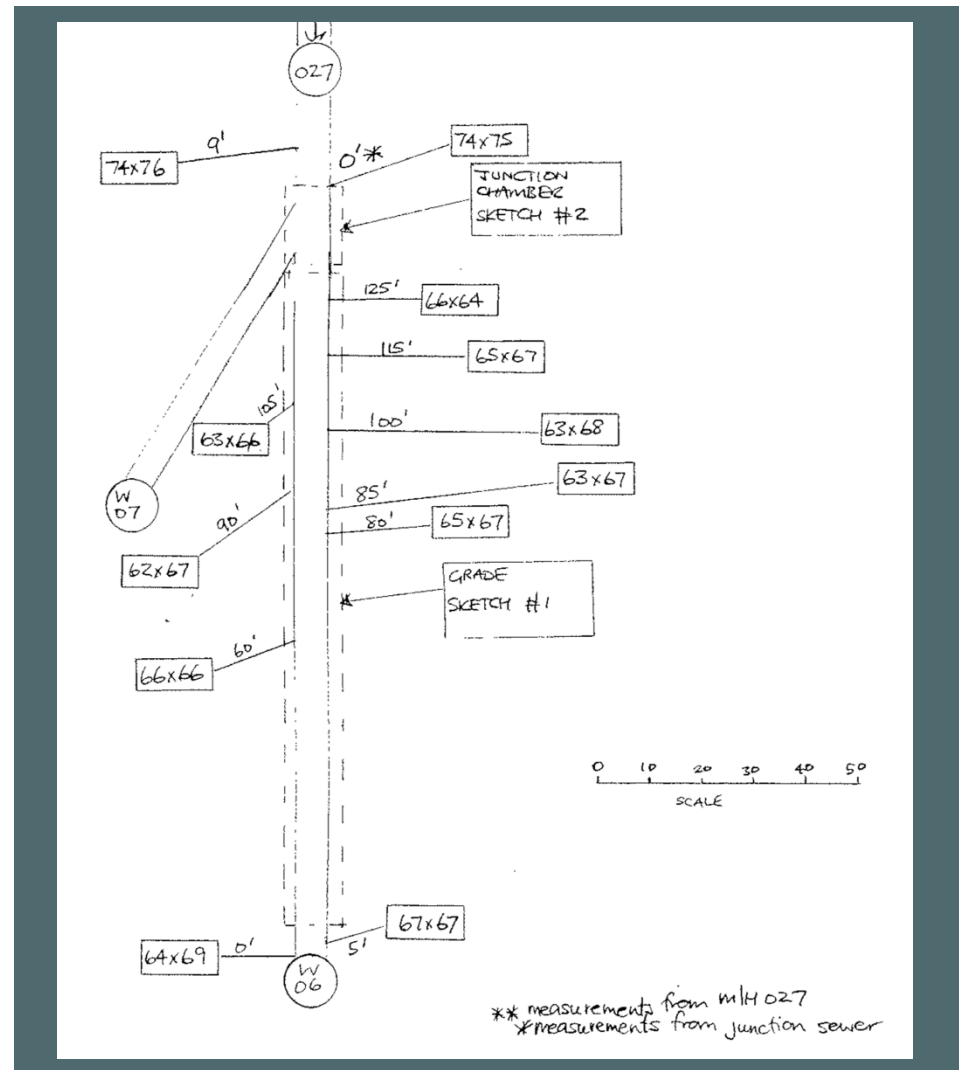
Relining and Replacement Contracts Design Approach – Pipe Inspections

- Full re-inspection of all pipe reaches
- Gather the critical data
 - Changes in Pipe Size
 - Changes in Pipe Configuration
- Not included in typical PACP inspection, but is easy and cost-effective for crews to gather

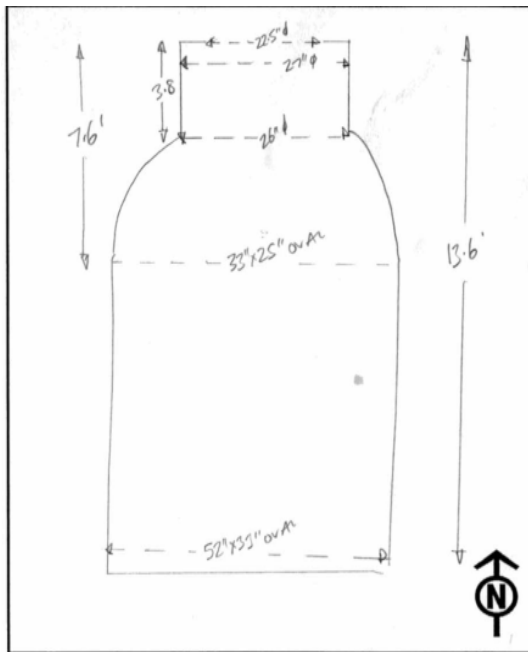
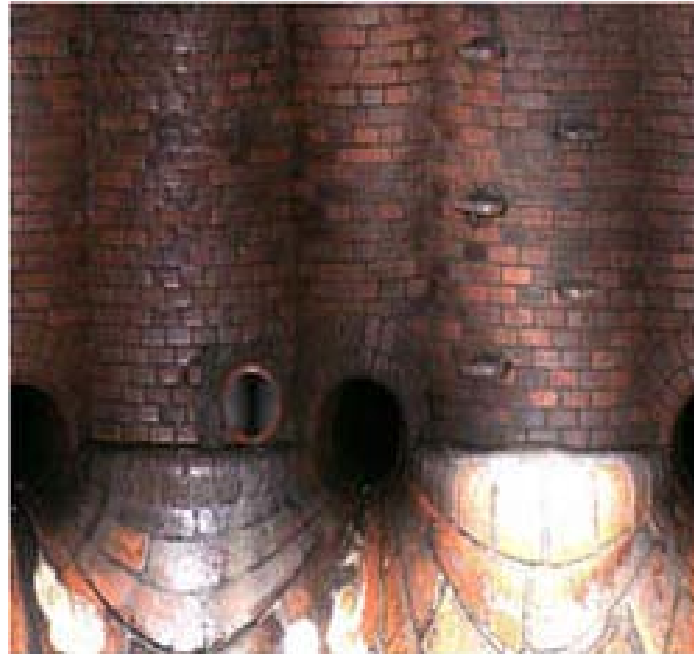
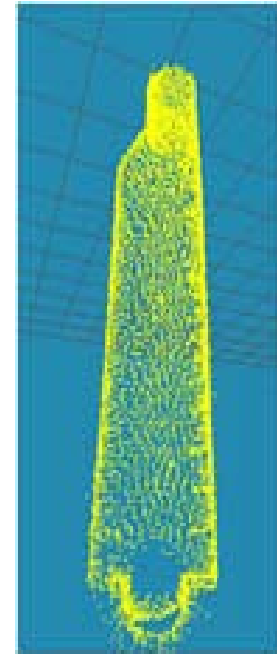
Relining and Replacement Contracts Design Approach – Manhole Inspections

- Where the contractor is using existing manholes to perform the lining work, the size and configuration of the structure is critical.
