**Evaluating River-Influenced
Groundwater Infiltration and Sewer
Rehabilitation Effectiveness**

Hazen

Miami Shores LS Study Area

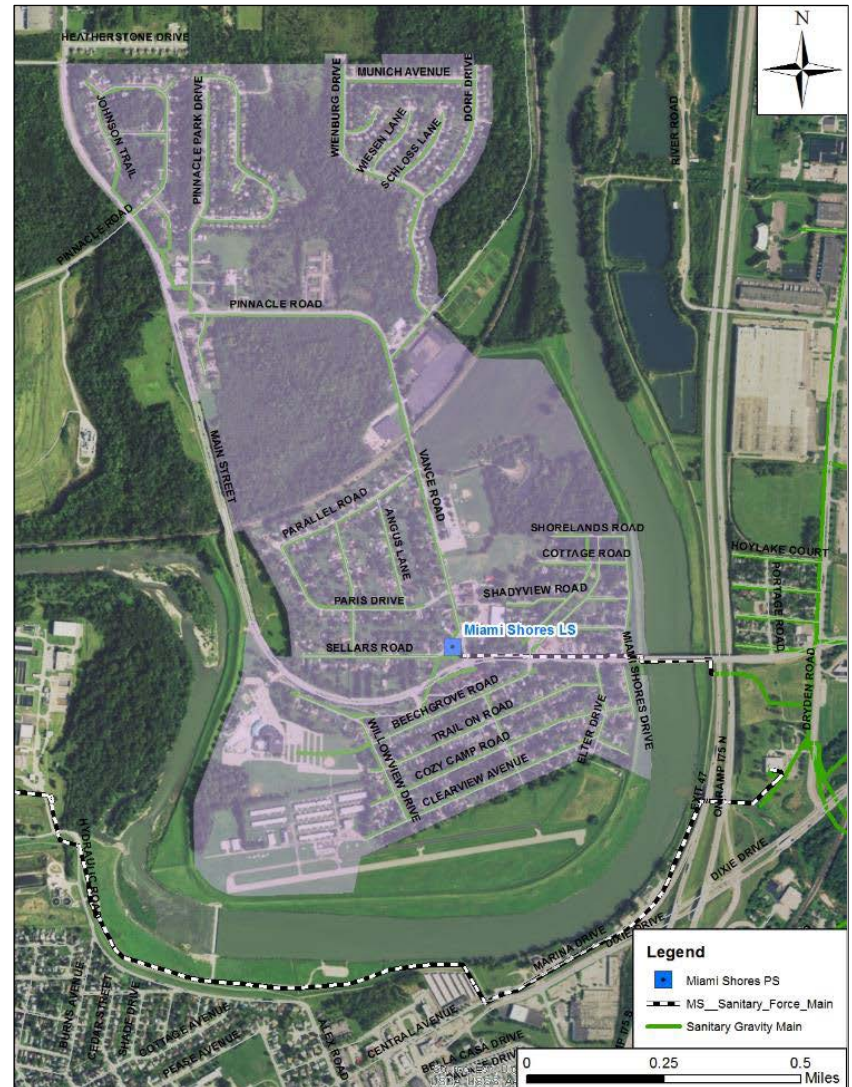
Montgomery County, OH

- 575 acres
- 10 miles gravity sewer
- 1,400 customers
- 0.90 MGD ADF

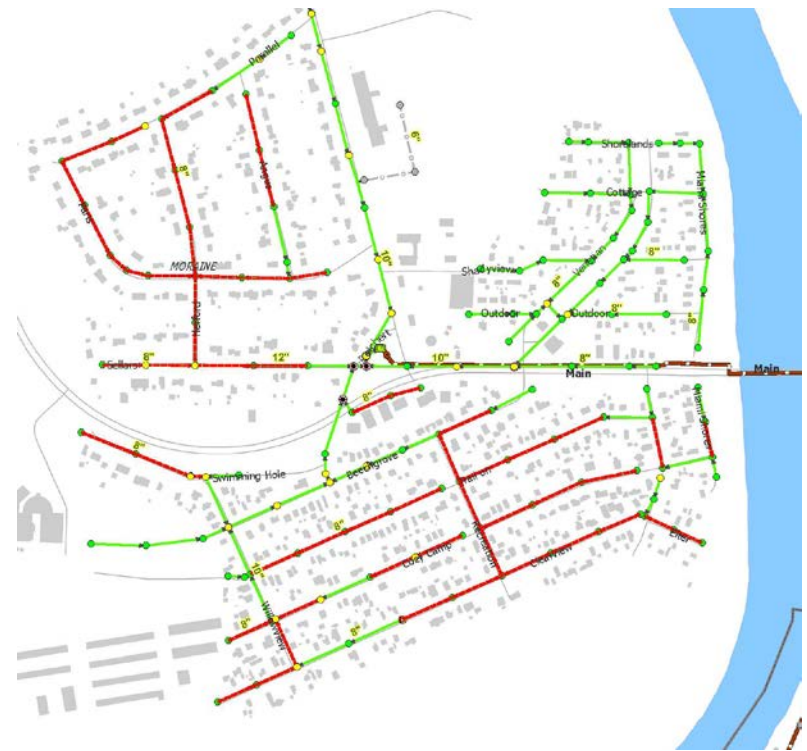
Miami Shores LS

- Significant I/I upstream due to high groundwater exceeding LS capacity.
- Only 1 pump operated at a time due to electrical and force main capacity limitations
- Some sewers upstream/downstream of LS undersized
- Sewer and manhole rehab work previously done upstream of LS

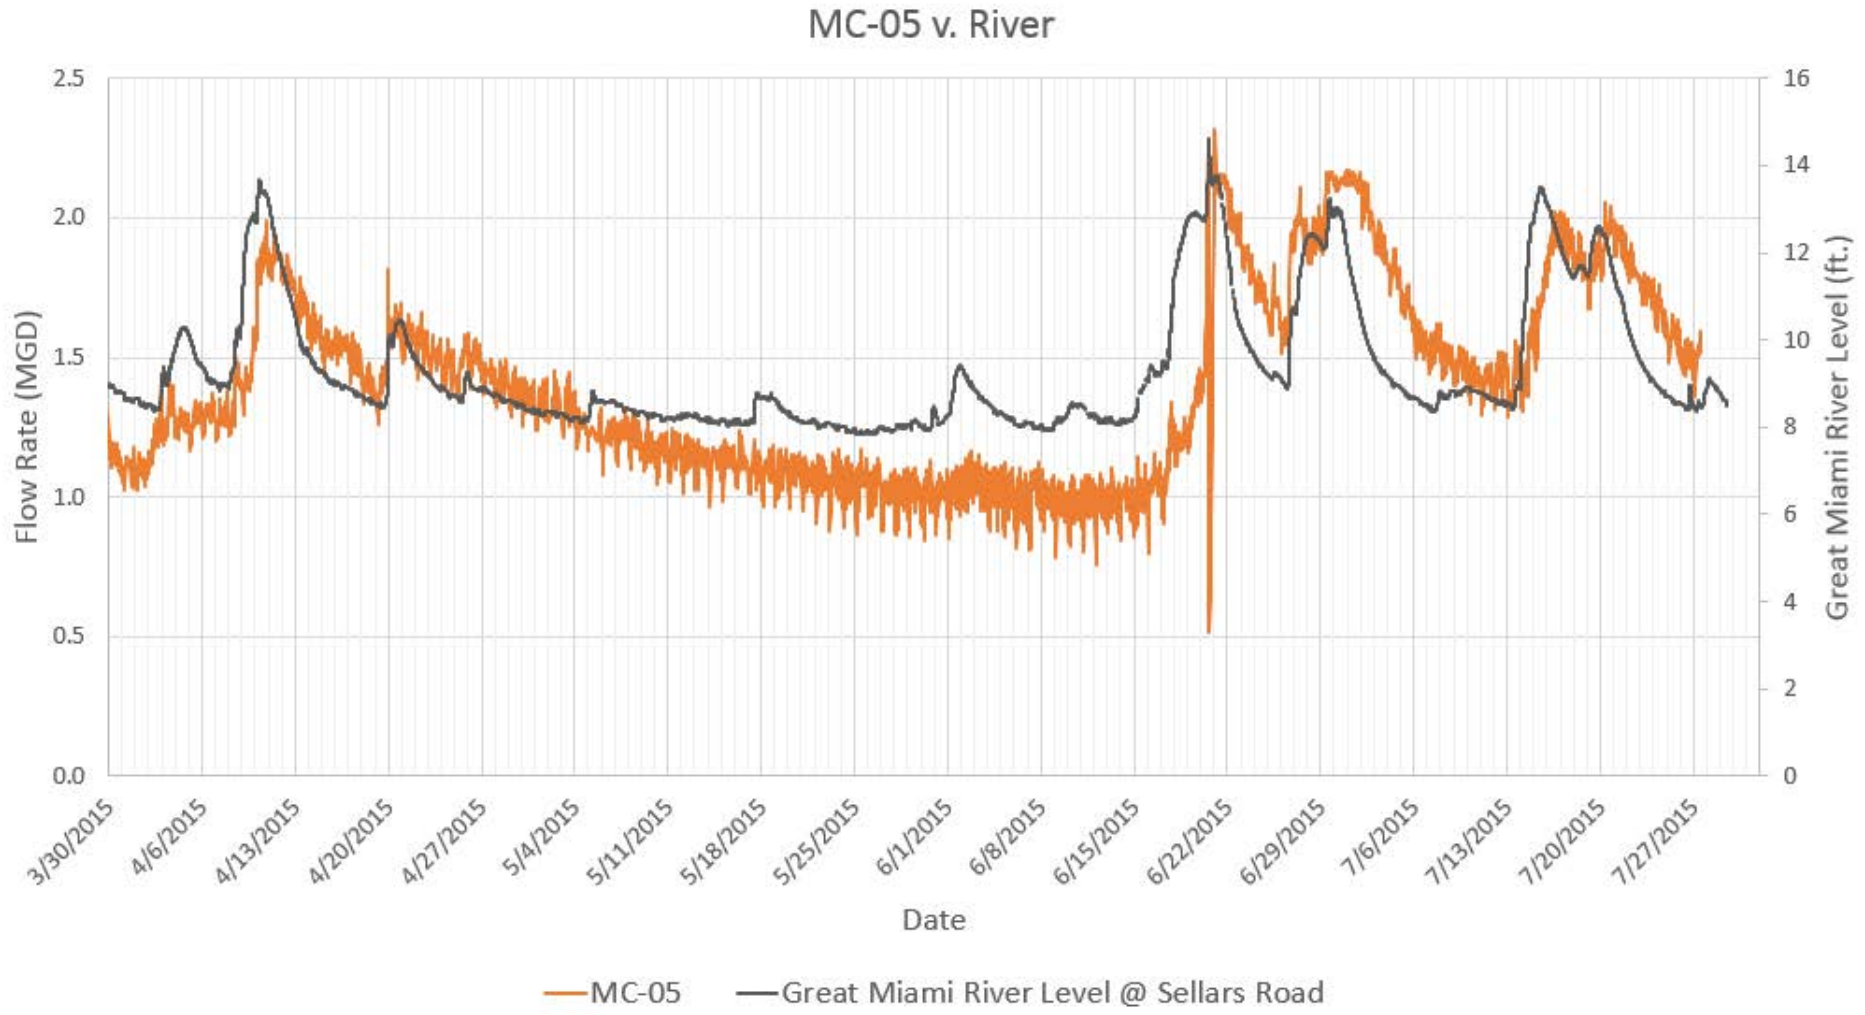
Miami Shores LS Flow Rate

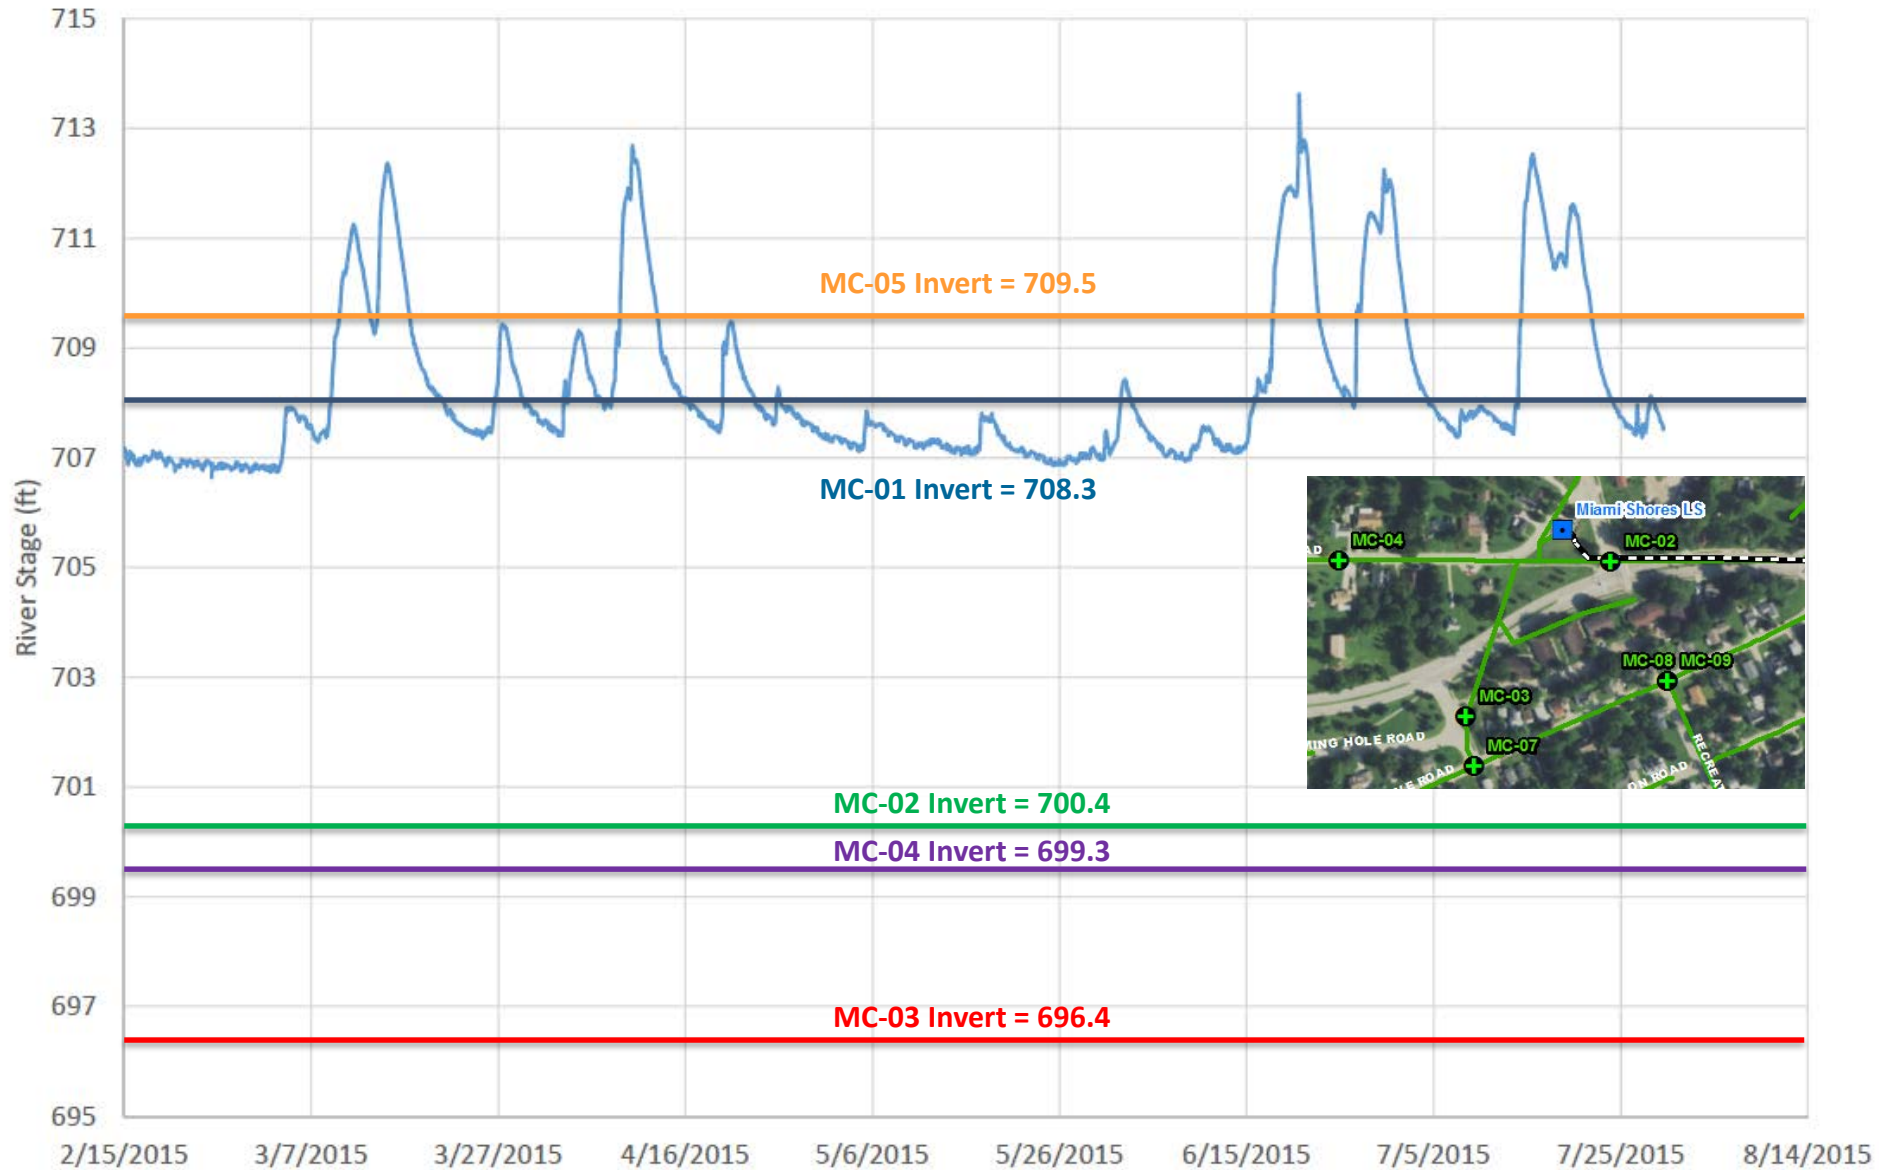
USGS 03271207 – Great Miami River at Sellars Rd.

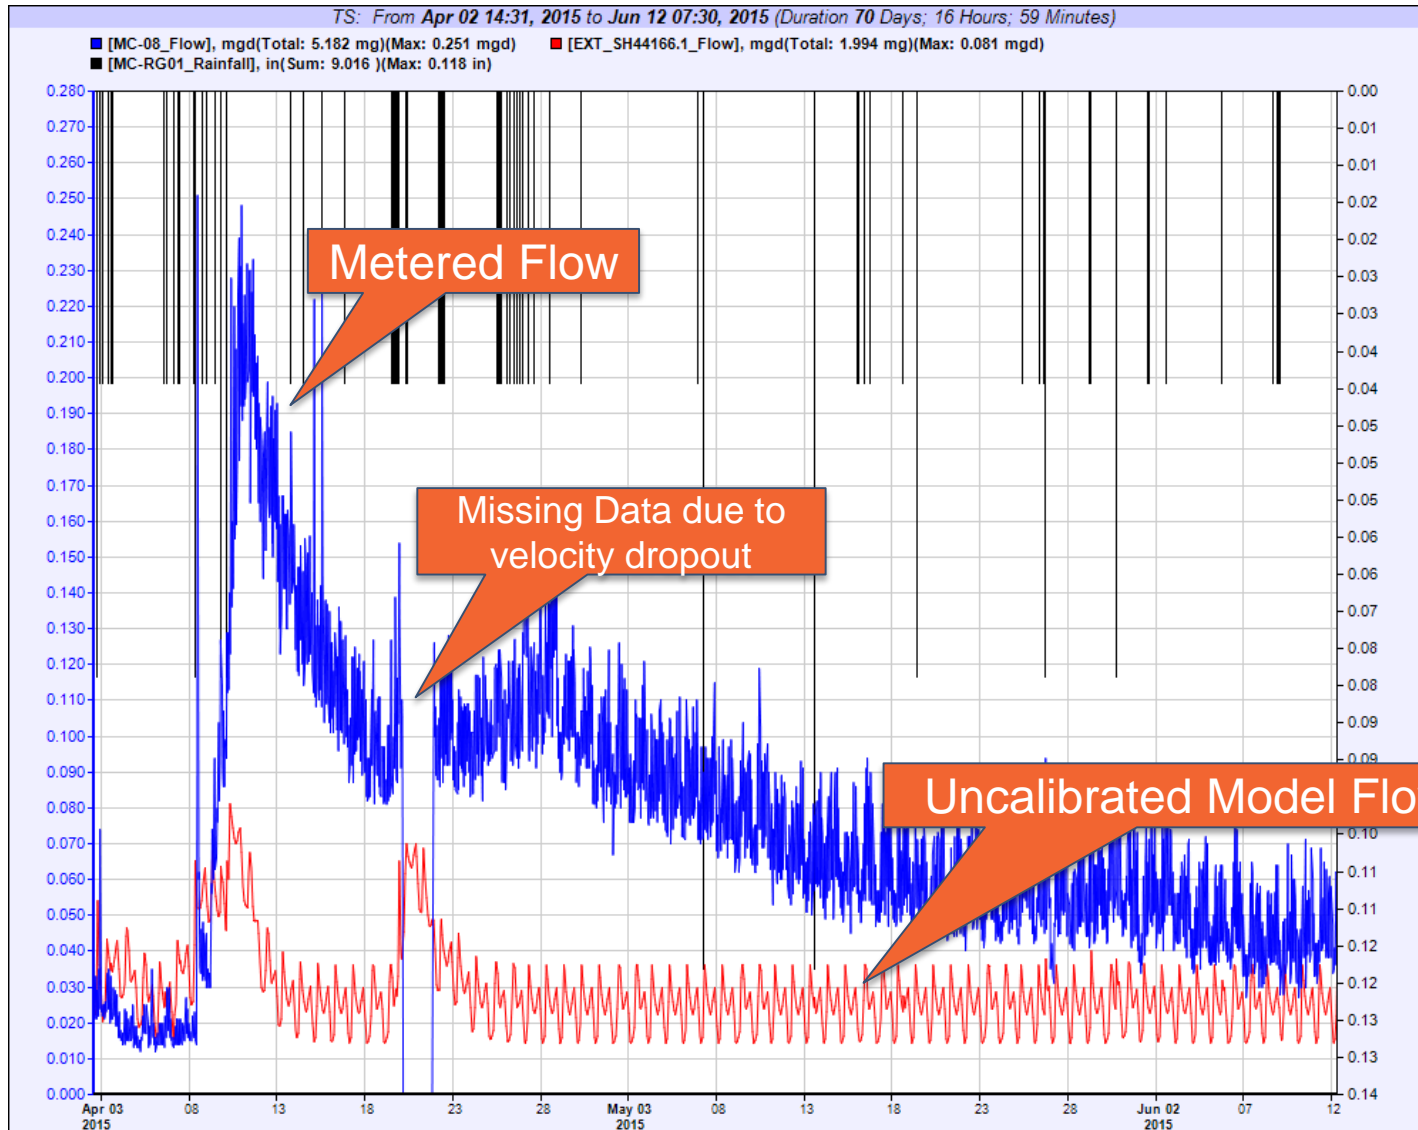
River-Influenced Infiltration – MC-08

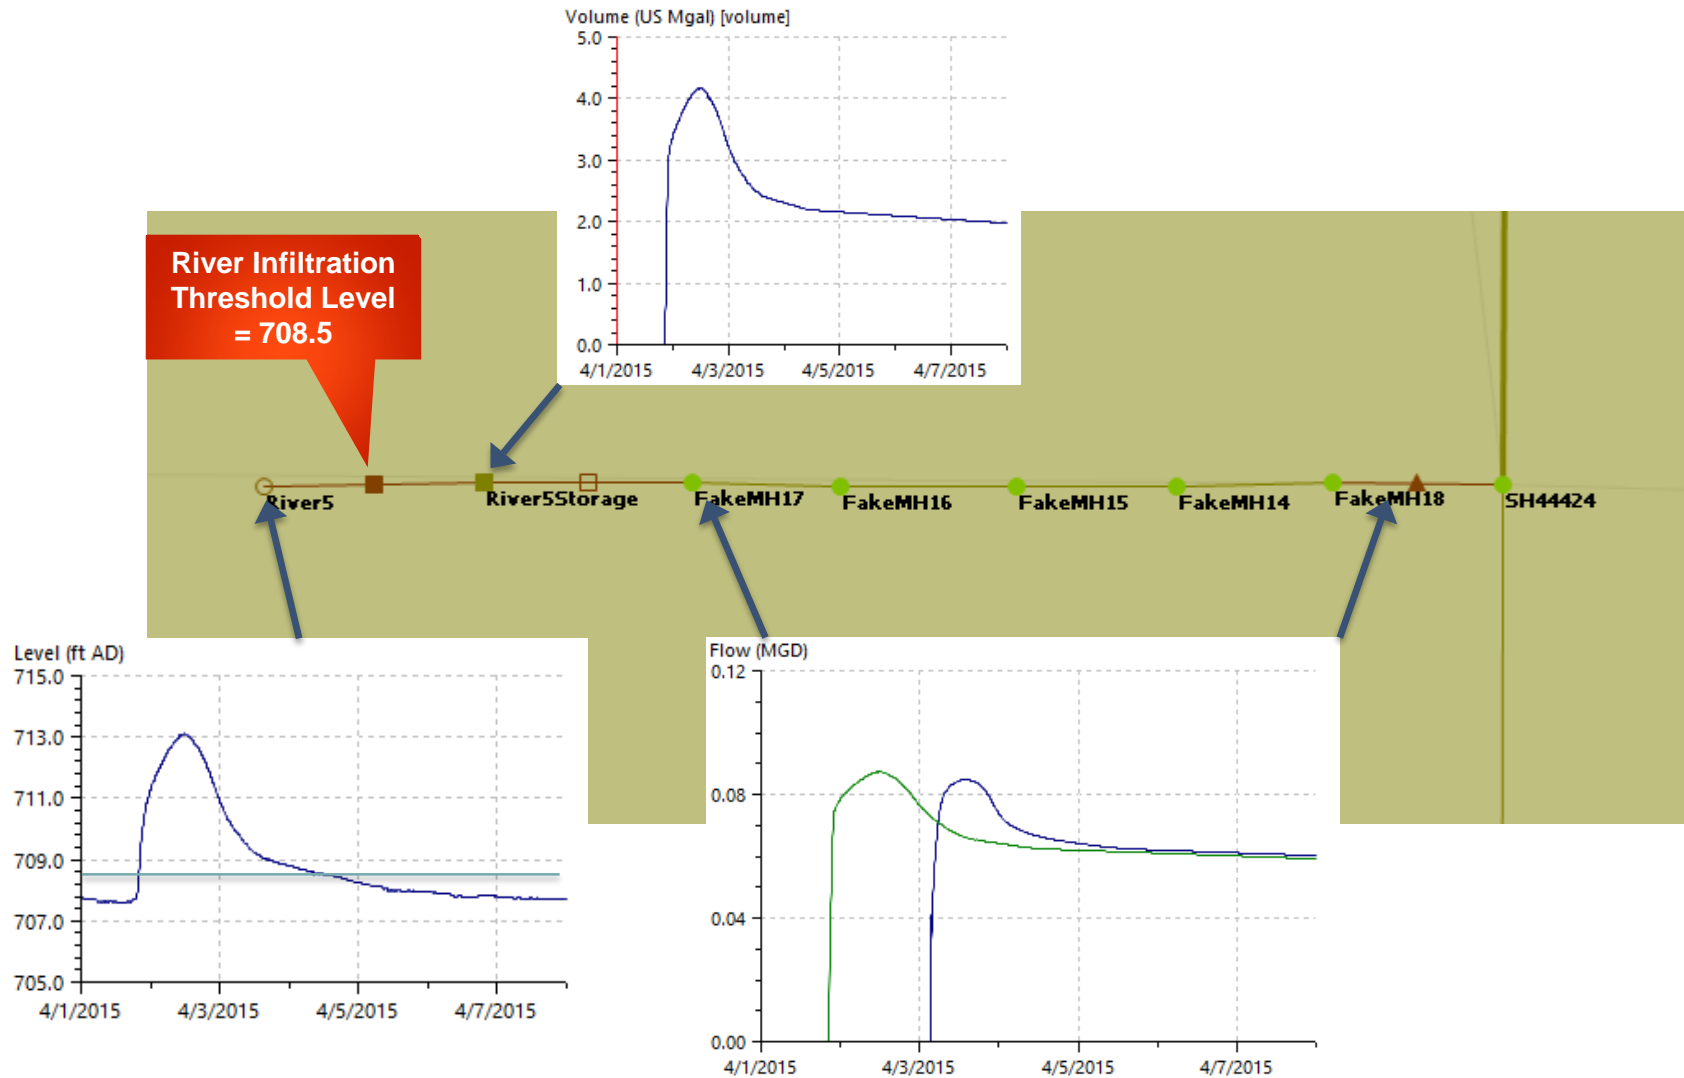
Model Representation of River Influence – MC-09

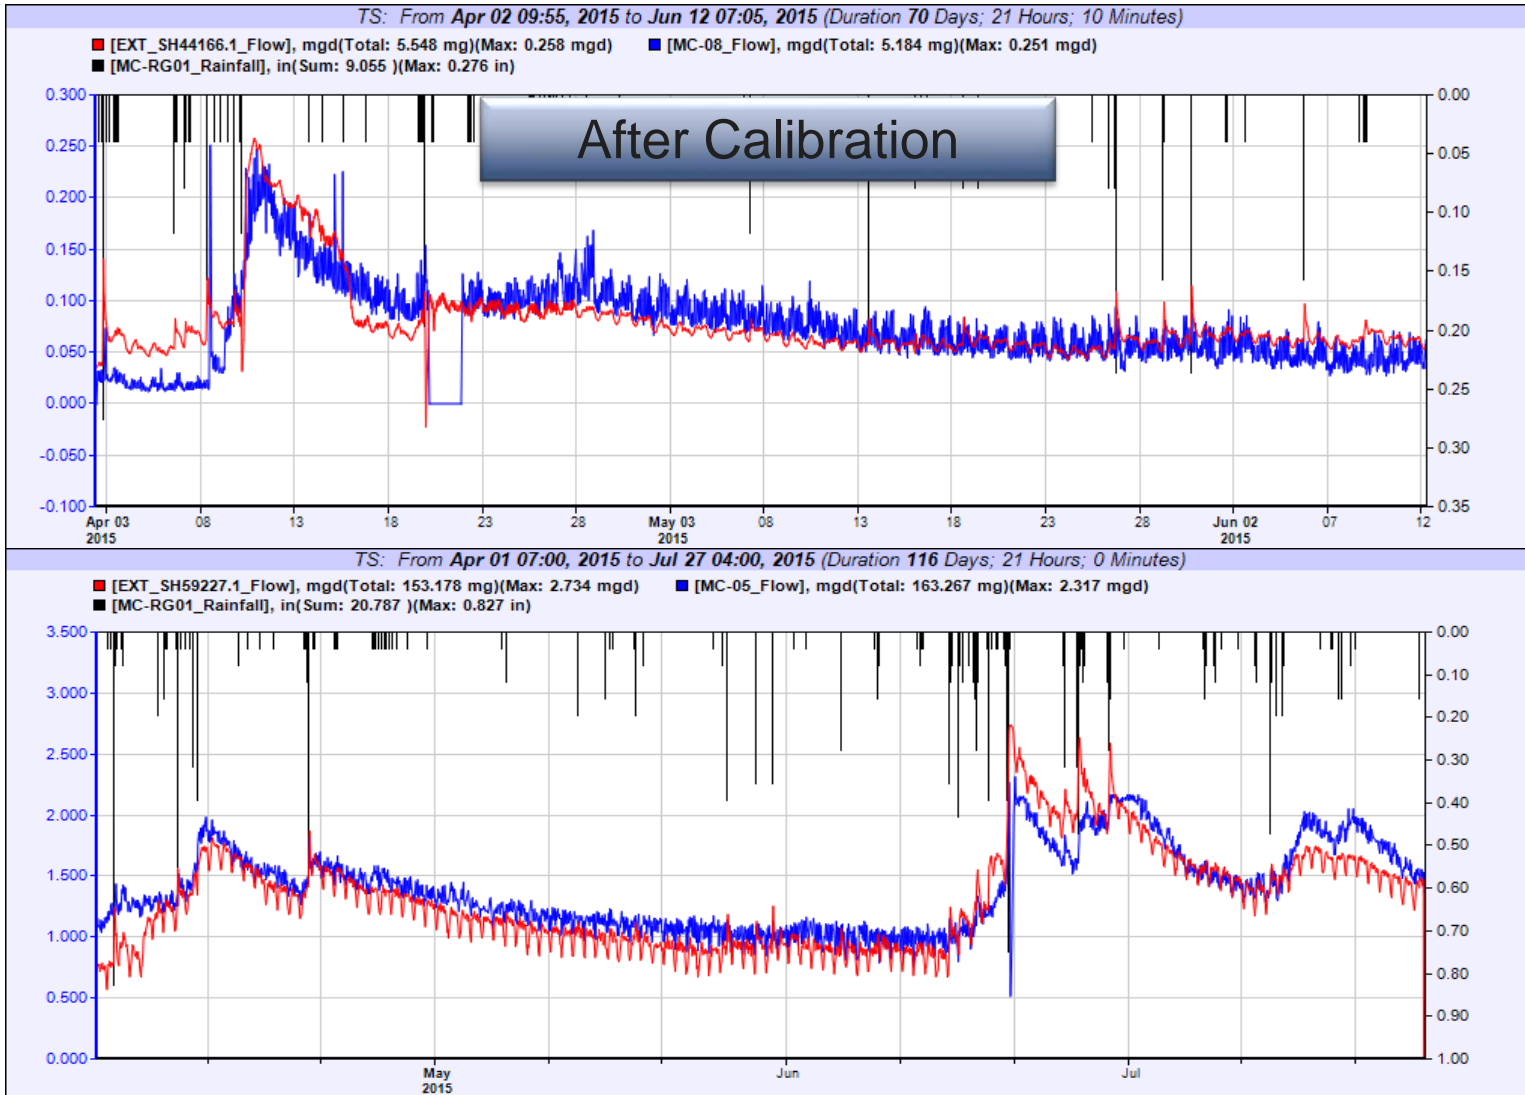
MC-05 & MC-08 Calibration Results

Flow Meter	Model Volume (MG)	Meter Volume (MG)	% Difference	Model Peak Flow (MGD)	Meter Peak Flow (MGD)	% Difference	Model Level (ft.)	Meter Level (ft.)	Difference (ft.)
April 10 – May 25, 2015 (high river levels)									
MC-01	14.76	11.43	+29%	0.62	0.79	-22%	0.47	0.88	-0.41
MC-02	3.41	3.81	-10%	0.226	0.225	0%	0.34	0.39	-0.05
MC-03	Bad Meter Data								
MC-04	1.03	0.91	+13%	0.08	0.09	-11%	0.18	0.25	-0.07
MC-05	51.44	60.35	-15%	1.90	2.22	-14%	0.80	0.79	0.01
MC-07	21.59	18.91	+14%	0.73	0.70	+4%	5.09	5.09	0.01
MC-08	3.91	4.05	-3%	0.26	0.25	+4%	3.99	3.87	0.11
MC-09	4.70	4.09	+15%	0.16	0.37	-57%	1.98	1.81	0.17
June 19 – June 22, 2015 (nearly 2YR6HR storm)									
MC-01	1.69	1.48	+14%	1.22	1.00	+22%	1.32	0.84	0.48
MC-02	0.51	0.48	+6%	0.35	0.27	+30%	0.69	0.40	0.29
MC-03	3.27	2.83	+16%	1.37	1.44	-5%	8.90	6.17	2.72
MC-04	0.10	0.07	+43%	0.08	0.10	-20%	1.82	0.22	1.60
MC-05	5.49	4.92	+12%	2.42	2.60	-7%	8.42	10.71	-2.29

MC-10	0.86	0.74	+16%	1.29	1.25	+3%	0.33	0.46	-0.14
MC-11	0.79	0.66	+20%	0.63	0.47	+34%	1.04	0.91	0.13
June 28 – July 26, 2015 (high river levels)									
MC-01	10.77	8.51	+27%	1.05	0.71	+48%	0.73	0.55	0.18
MC-02	4.39	4.44	-1%	0.26	0.30	-13%	0.35	0.44	-0.09
MC-03	25.90	25.46	+2%	1.18	1.26	-6%	5.91	6.94	-1.04
MC-04	1.34	1.40	-4%	0.09	0.12	-25%	0.18	0.22	-0.03
MC-05	42.79	48.86	-12%	2.40	2.30	+4%	0.80	0.80	0.00
MC-10	6.39	6.72	-5%	0.76	0.47	+62%	0.24	0.25	-0.01
MC-11	4.00	4.05	-1%	0.37	0.51	-27%	0.59	0.51	0.08

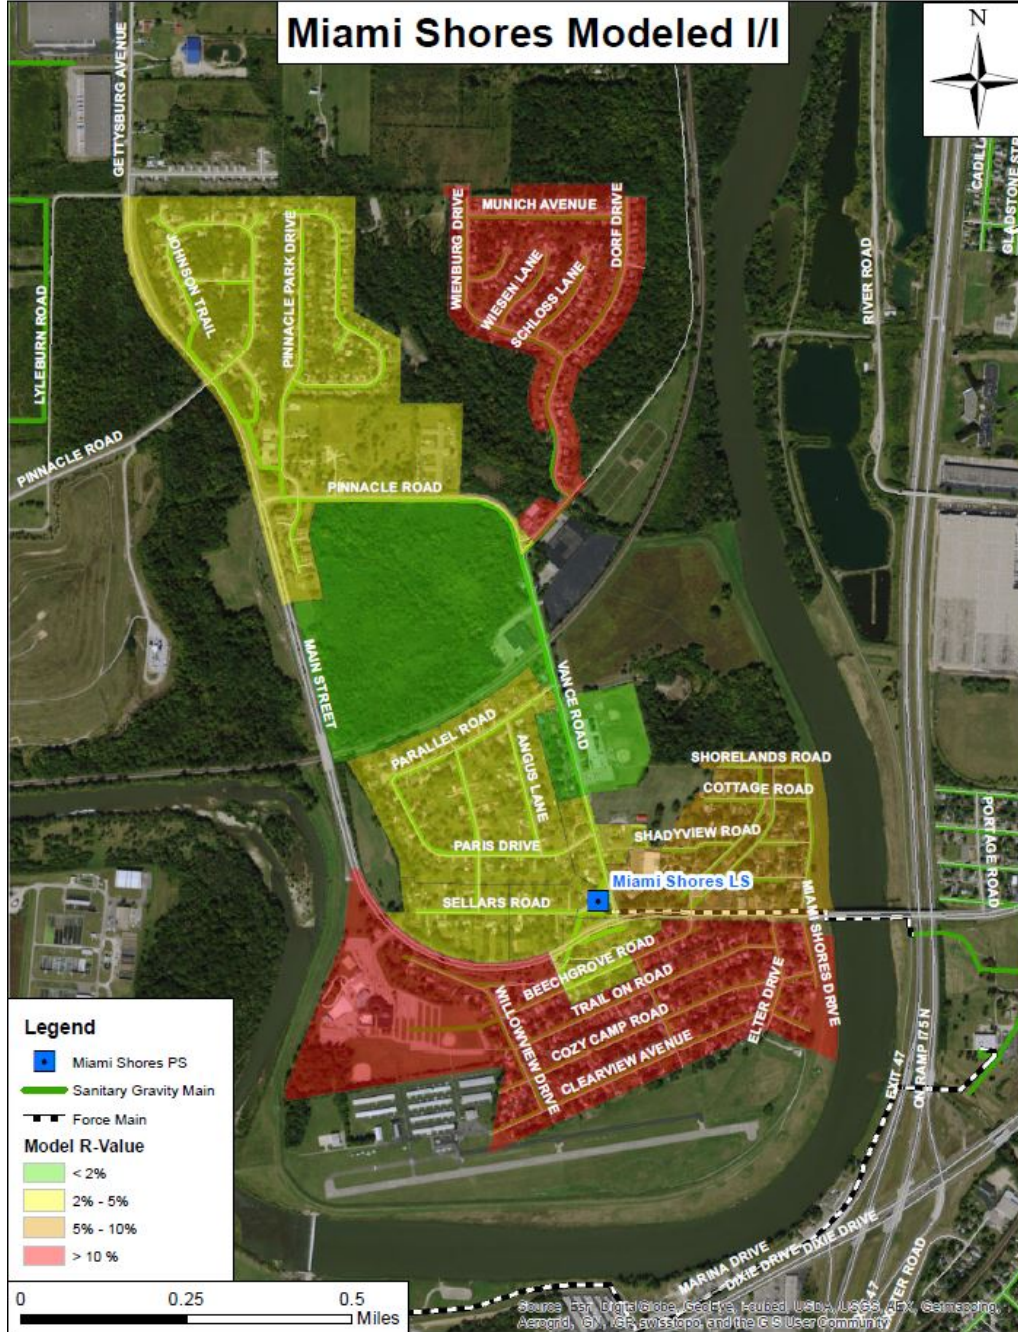
Miami Shores Modeled I/I

Model R-Value

- < 2%
- 2% - 5%
- 5% - 10%
- > 10%

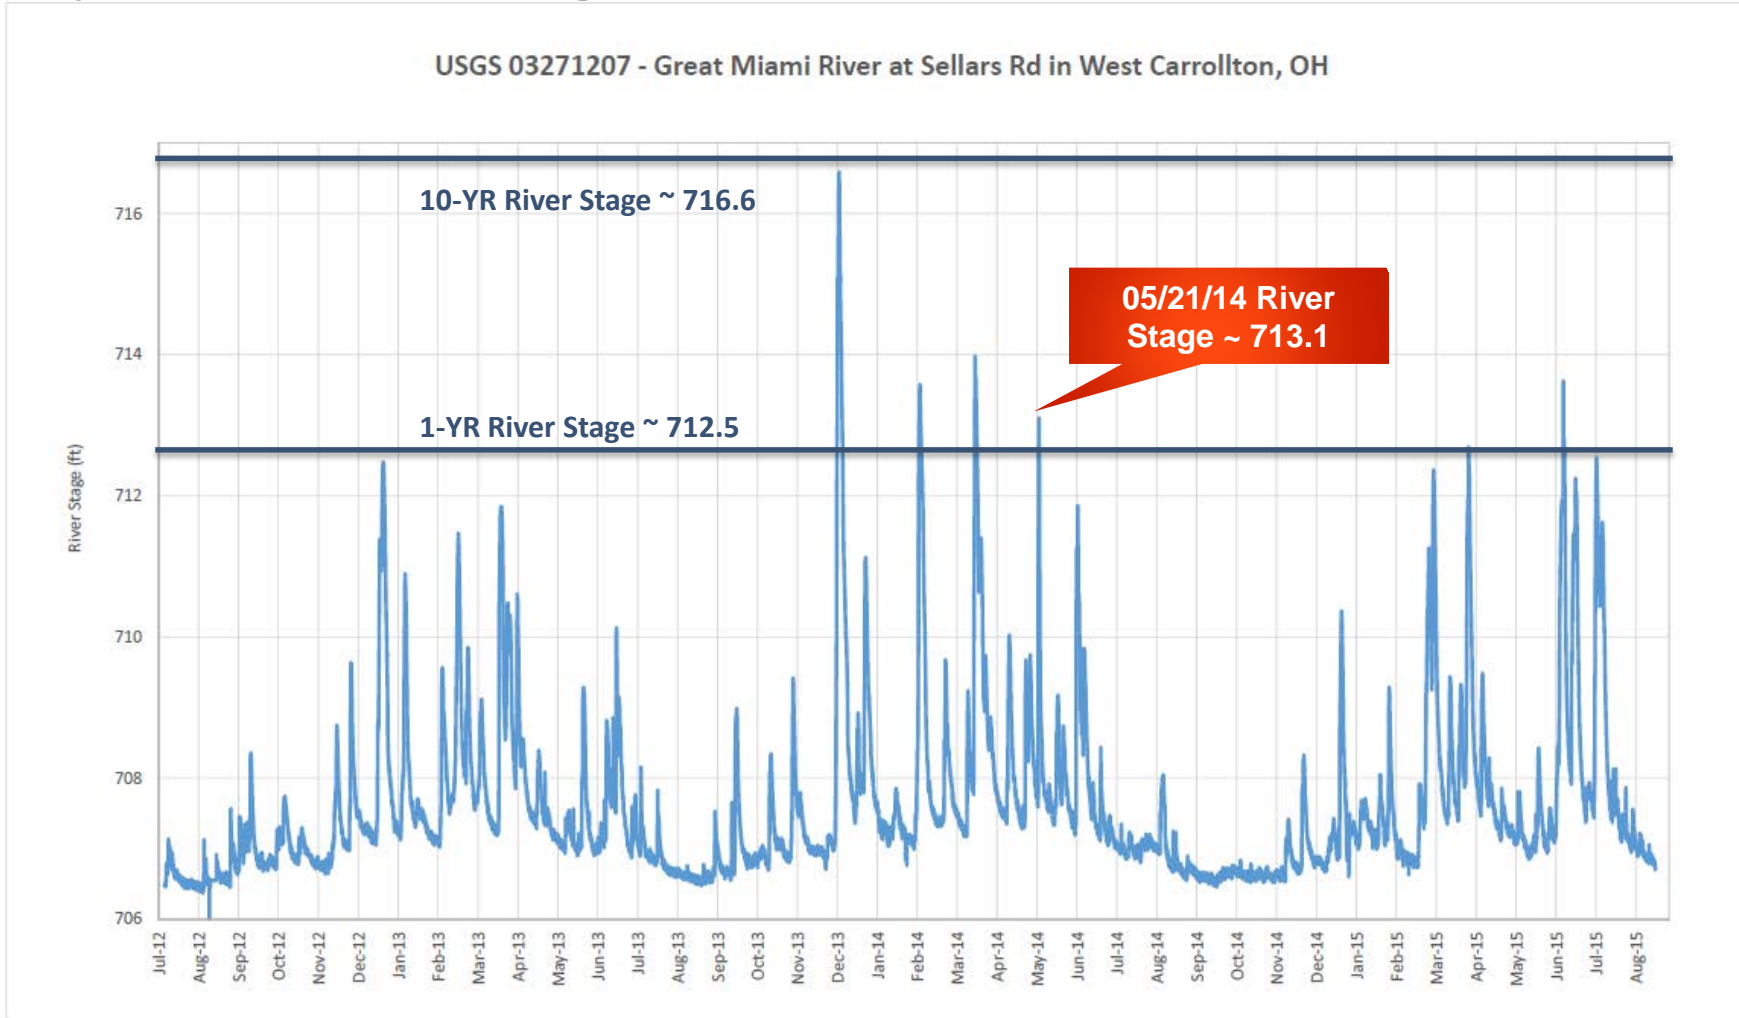
Capacity Analysis River Level

May 21, 2014 ~ 5YR River Stage

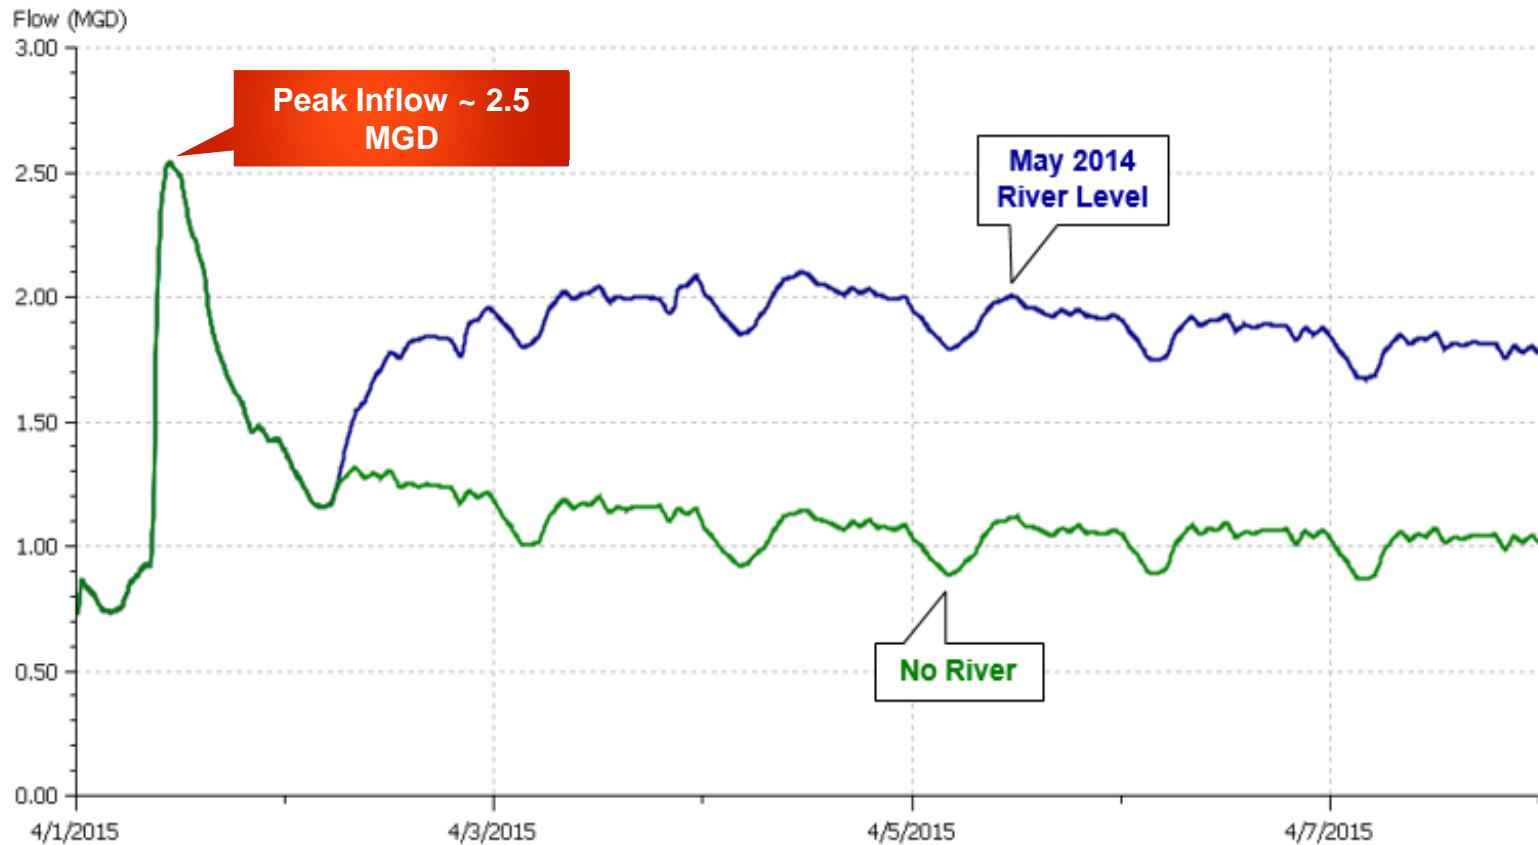
Miami Shores 5YR6HR Influent

Scenario	Peak Flow (MGD)
Existing Pipes, Existing Flows	2.54
Upsized Vance Rd, Existing Flows	2.75
Existing Pipes, Future Flows	2.82
Upsized Vance Rd, Future Flows	3.03

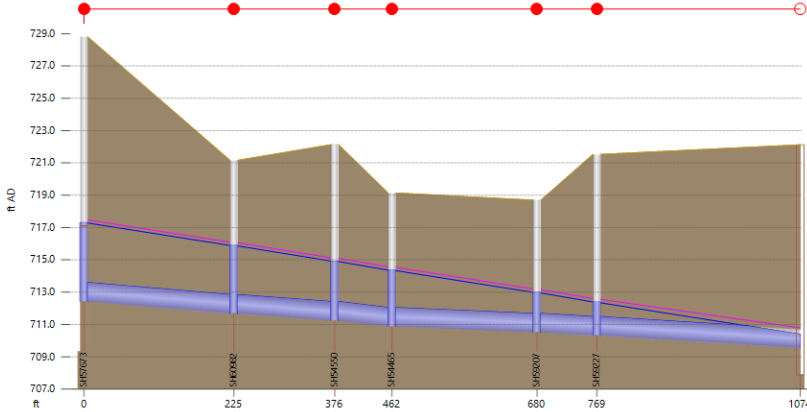
Miami Shores LS

Link	SH57673.1	SH60982.1	SH54550.1	SH54465.1	SH59207.1	SH59227.1	
width (in)	14.0	14.0	14.0	14.0	14.0	14.0	
grad (%)	0.333	0.284	0.432	0.165	0.223	0.253	
DS flow (MGD)	2.7123	2.7123	2.7123	2.7123	2.7123	2.7123	
Node	SH57673	SH60982	SH54550	SH54465	SH59207	SH59227	SH55835
ground (ft. AD)	728.800	721.160	722.130	719.140	718.700	721.530	722.120

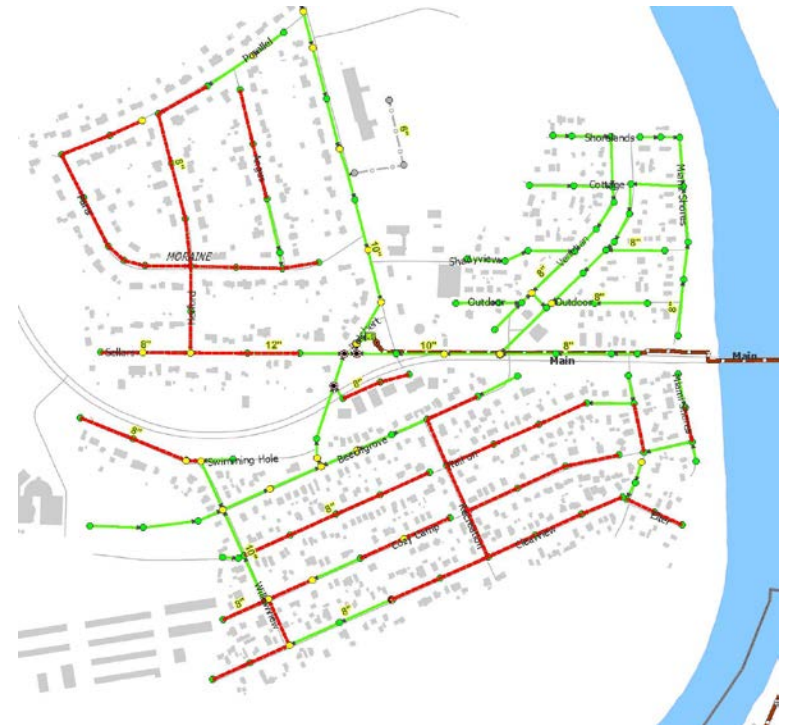
Prior Rehabilitation Efforts

- 14,600' of gravity sewer; 27 manholes upstream of Miami Shores LS.
- Full length CIPP with seals at each end
- Manholes lined with cementitious liner

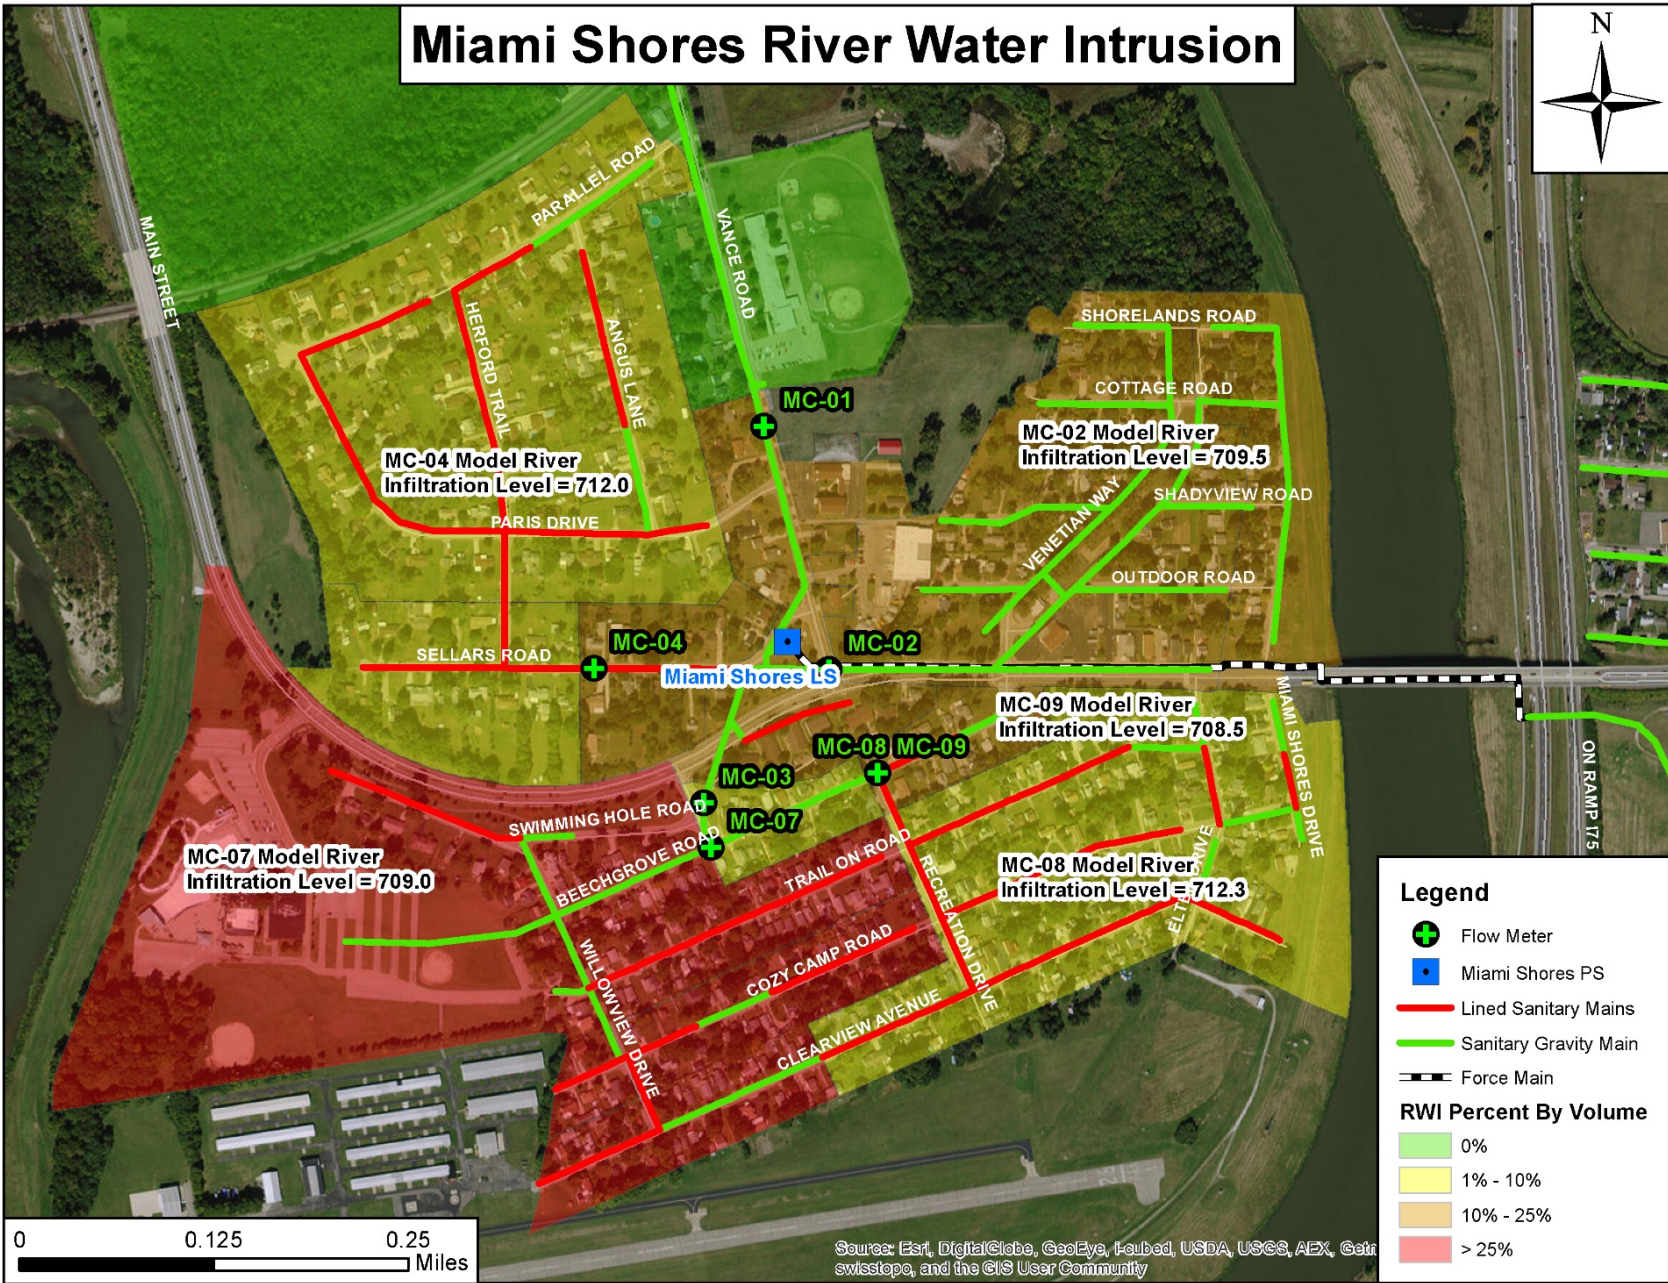
- No flow data prior to rehab
- Pump run times not usable due to pump replacements and bypass pumping
- Prior rehabilitation appears effective at reducing RWI where >75% sewer length lined
- I/I (R-values and RWI) still high, even in most basins with < 75% lined sewers
- Other than grouting first 3', laterals were not rehabilitated, which reduced effectiveness

Miami Shores River Water Intrusion
