Sean P. O'Rourke, PESenior Principal Engineer

Miamisburg: CMOM, Inspection, and Rehabilitation Program

Hazen

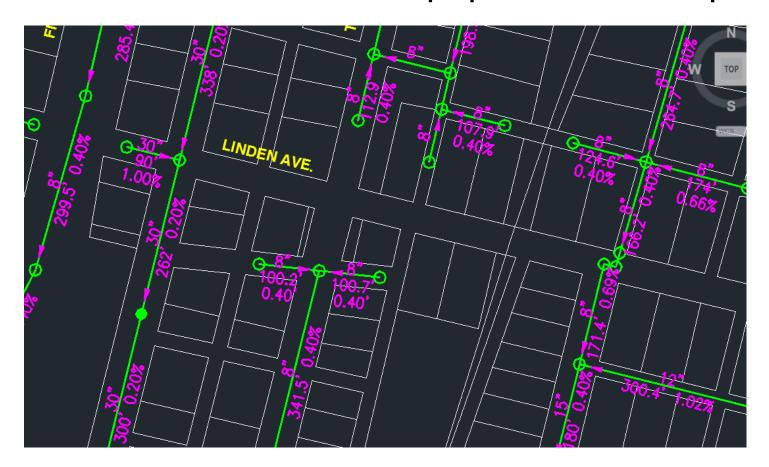
Delineate sewer sheds from paper & CAD maps

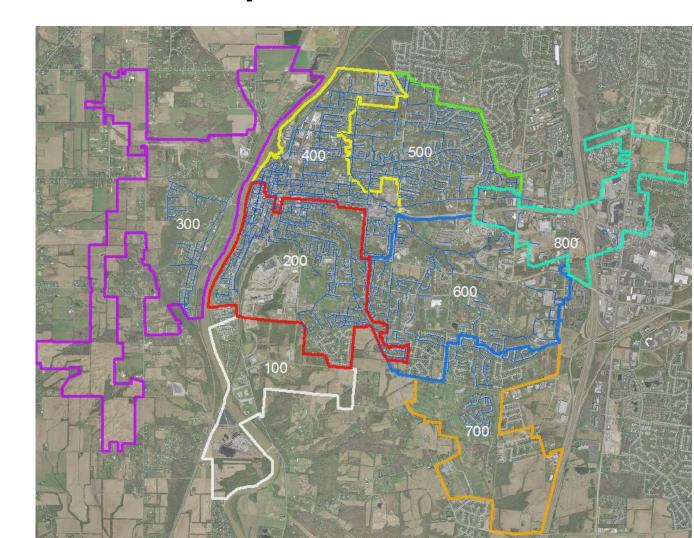
Sewer basins used for unique asset IDs

8 basins named: 100, 200, 300...

Ex: 155th MH in Basin 100 = SANMH100155

Ex: D/S sewer = SANGS1001550

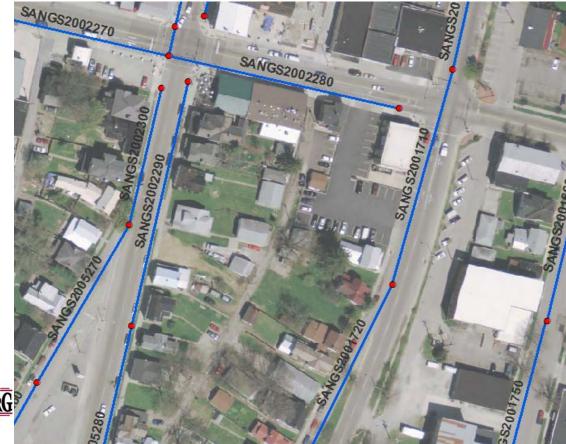
Benefits for City Staff:

- Each asset has a unique ID
- Asset inventory (size, depths, material, slope)
- Identify areas of low slopes
- Print out maps
- Develop maintenance plans
- Organize work orders

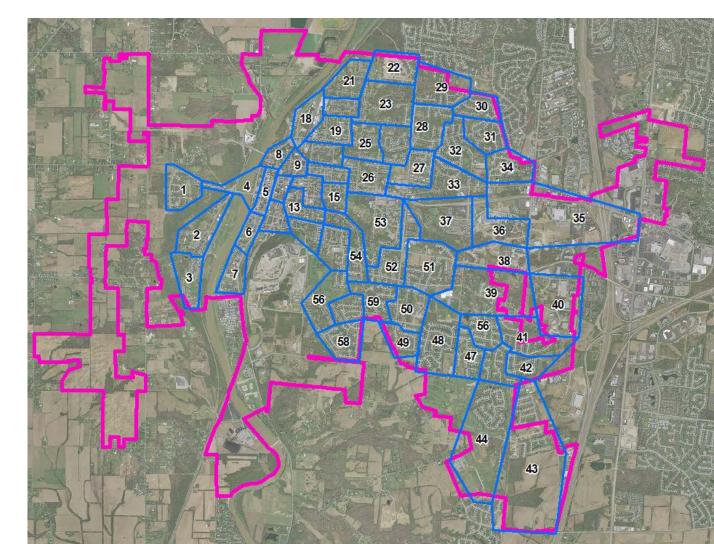
5-year sewer cleaning plan (i.e. 60 equal length areas)

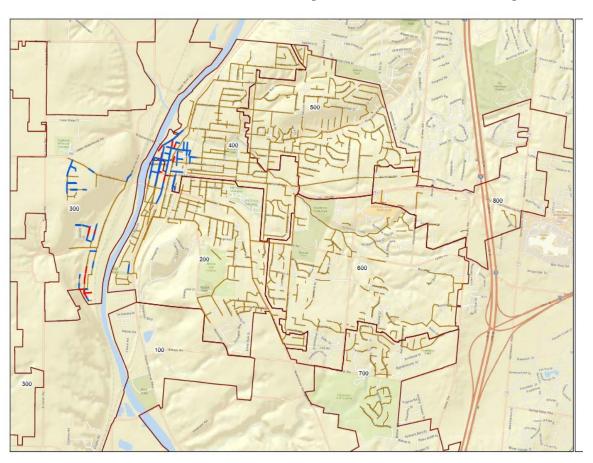
Structural Defects (Grades 4 & 5)

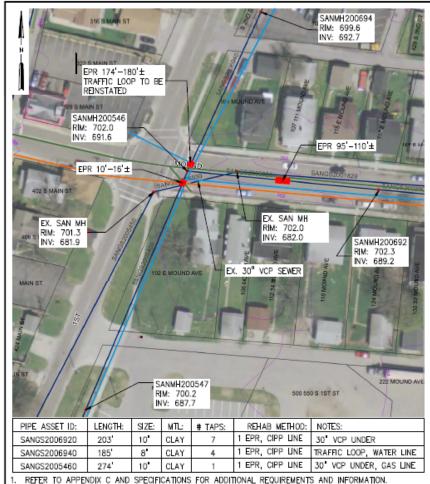
. REFER TO APPENDIX C AND SPECIFICATIONS FOR ADDITIONAL REQUIREMENTS AND INFORMATION.
2. DISTANCE SHOWN ARE FROM UPSTREAM MANHOLES.

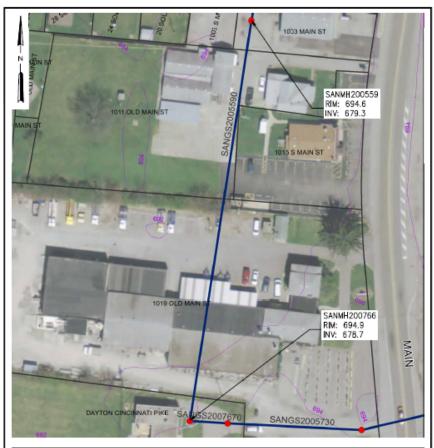
l	PIPE ASSET ID:	LENGTH:	SIZE:	MTL:	# TAPS:	REHAB METHOD:	NOTES:
l	SANGS2005590	427	18"	CLAY	2	CIPP MAIN & LATERALS	HEAVY INFILTRATION

REFER TO APPENDIX C AND SPECIFICATIONS FOR ADDITIONAL REQUIREMENTS AND INFORMATION.
DISTANCE SHOWN ARE FROM UPSTREAM MANHOLES.

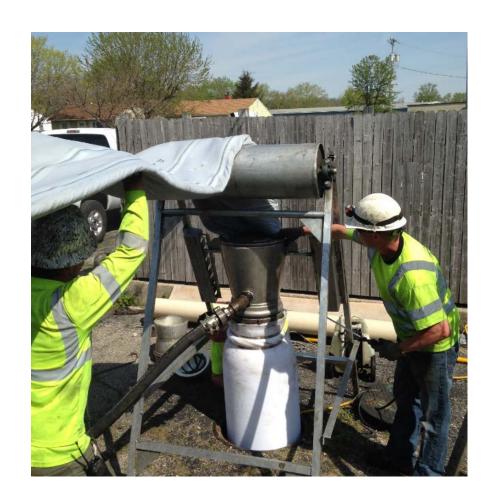
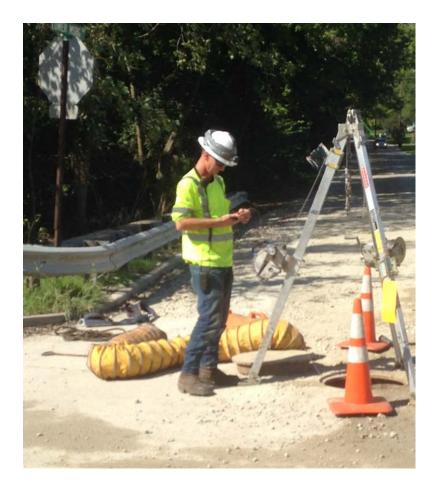
Miamisburg Year 1 – Rehabilitation

CITY OF MIAMISBURG	OCT 2015		
SA	NITARY SEWER REHAB:	HAZEN JOB NO.		
	YEAR 1	50071-102		
3	CONFORM SET	1/29/15		ASSET NUMBER
2	ADDENDUM 1	10/21/15	SP0	SANGS
1	BID SET	10/09/15	SP0	2005590
NO.	ISSUED FOR	DATE	BY	2000090

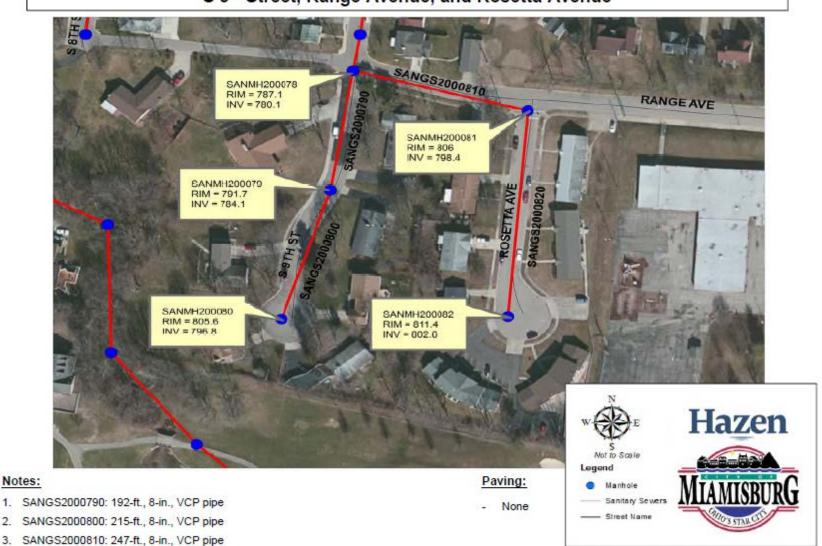
Map 55 of 73

SANGS2000820: 328-ft., 8-in., VCP pipe

SANGS2000790, SANGS2000800, SANGS2000810, and SANGS2000820 S 9th Street, Range Avenue, and Rosetta Avenue
