Infrastructure Protection through Stream Restoration

OWEA Watershed Workshop

November 12, 2015 Jim Turner, PE, CFM

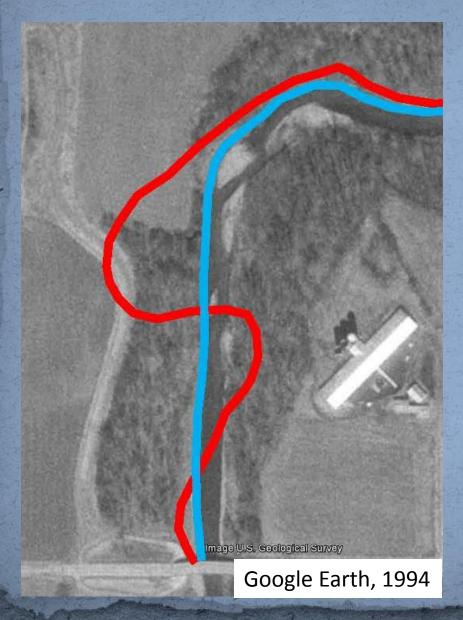
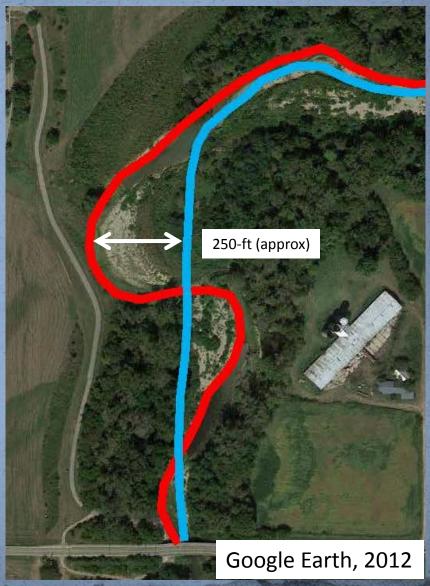
Streams Are Dynamic!!!

- Streams are dynamic systems that are subject to horizontal and vertical adjustments
- The rate of adjustment may be accelerated in disturbed streams (floodplain filling, hydrologic changes, channel straightening, etc.)
- At-risk infrastructure includes utility lines, transportation assets, and recreational assets (bike paths, shelters, etc.)

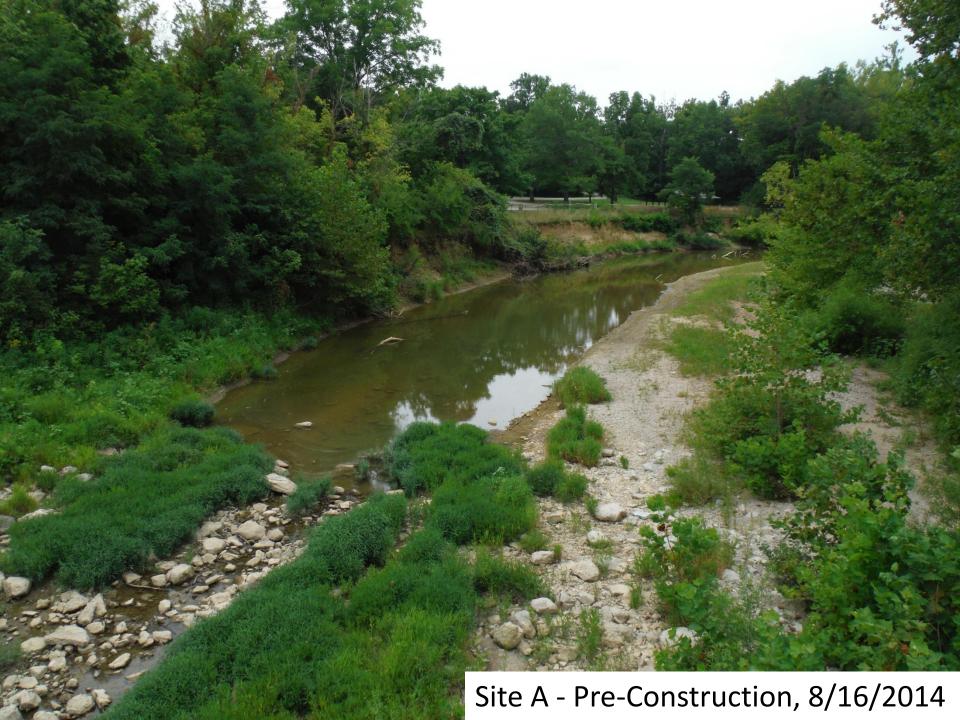
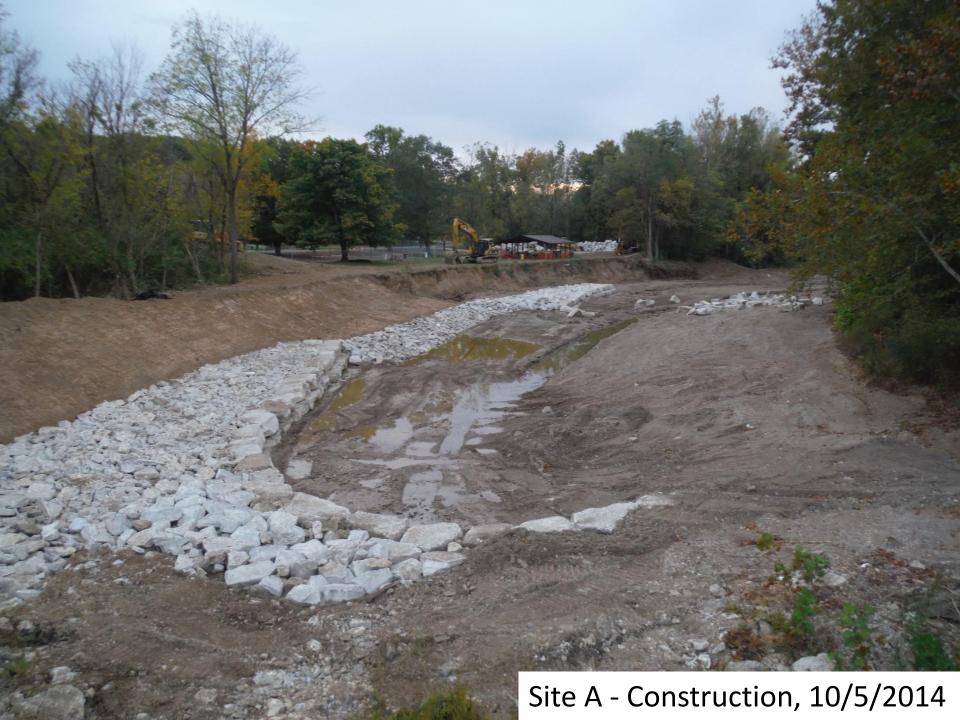
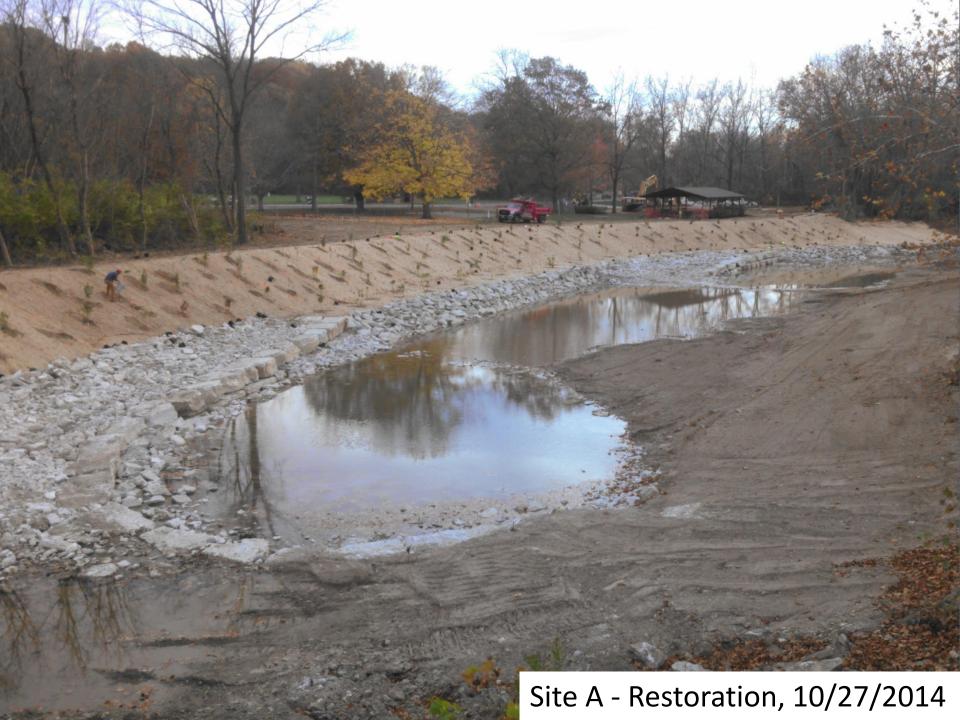
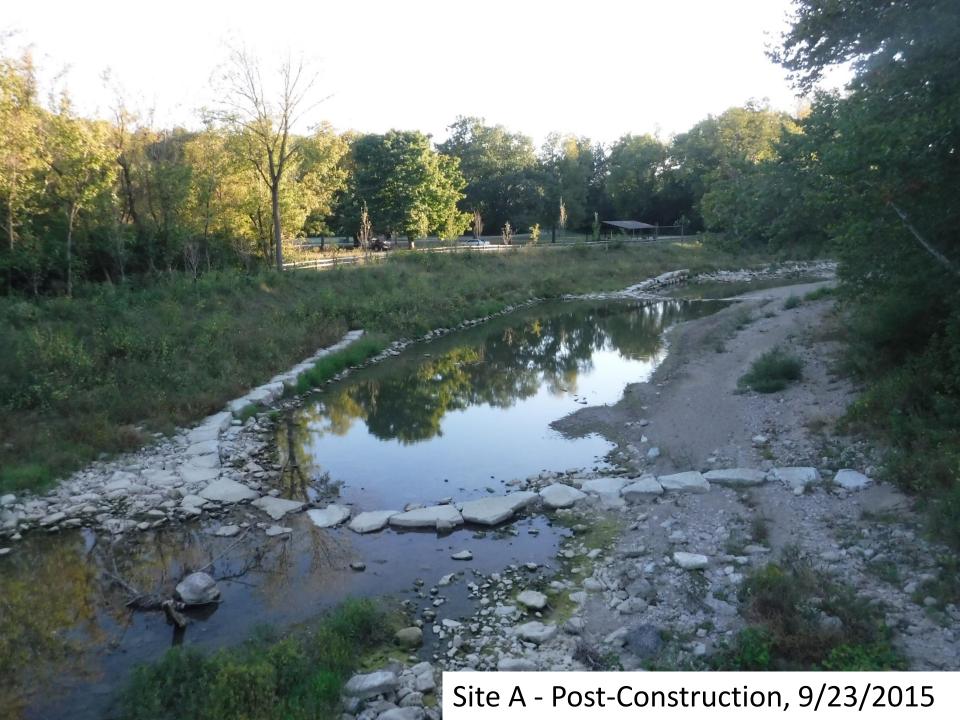
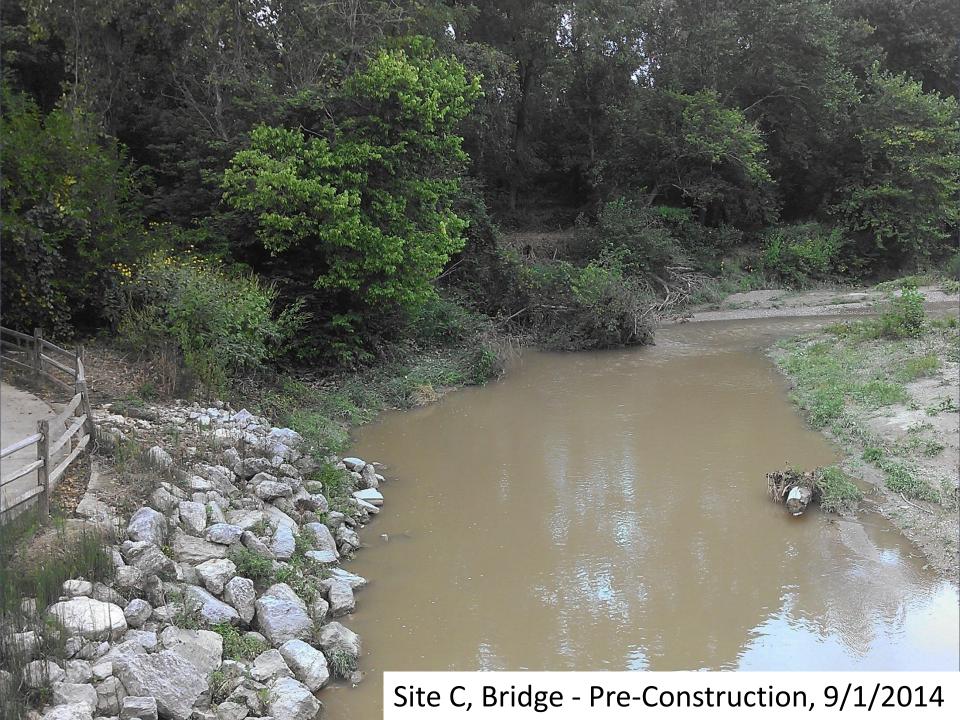
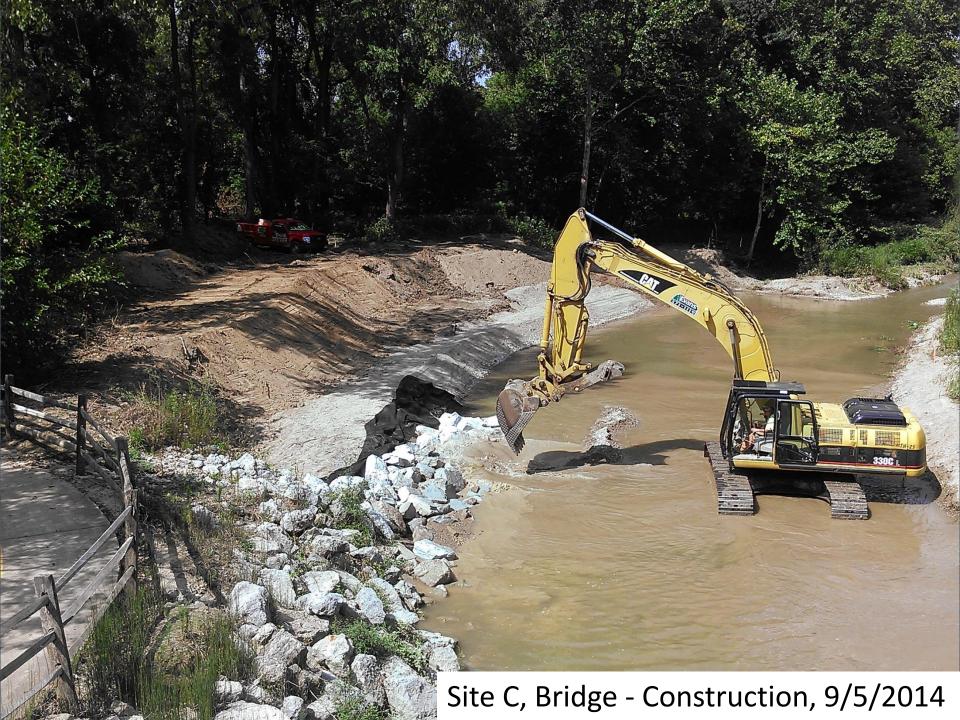
Case Study – Dry Fork Creek

- Project Owner: Great Parks of Hamilton County
- Project Goal: Restore and stabilize rapidly eroding streambanks that were causing property loss and creating risk for adjacent park infrastructure (shelterhouse, bike path)
- Funding Source: Clean Ohio Fund Ohio Public Works Commission
- Stream Characteristics: alluvial soils, watershed area of 77 mi²
- Principal Design Elements:
 - 3,300 cys of excavation
 - 1,600 cubic yards of toe rock
 - J-Hook structures (5 total)
 - Constructed Riffles
 - Native plantings (seeding, shrubs, trees, live stakes)
- Total restoration length: approximately 1,400-ft
- Construction Cost: \$597,800 (Evans Landscaping, 6 bids received)
- Construction Schedule: July to December, 2014

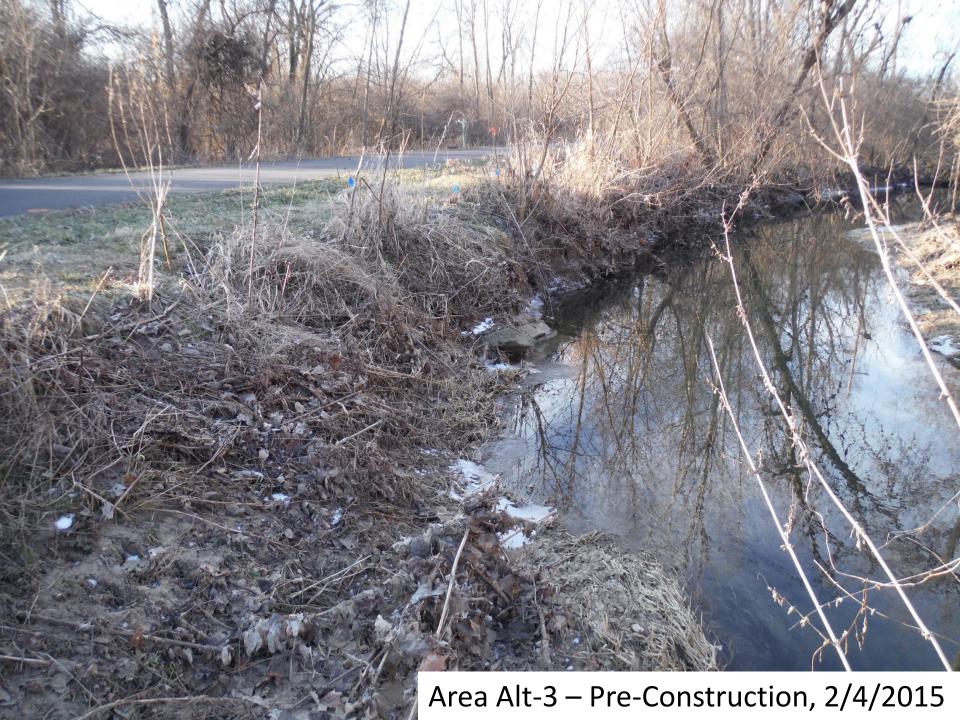
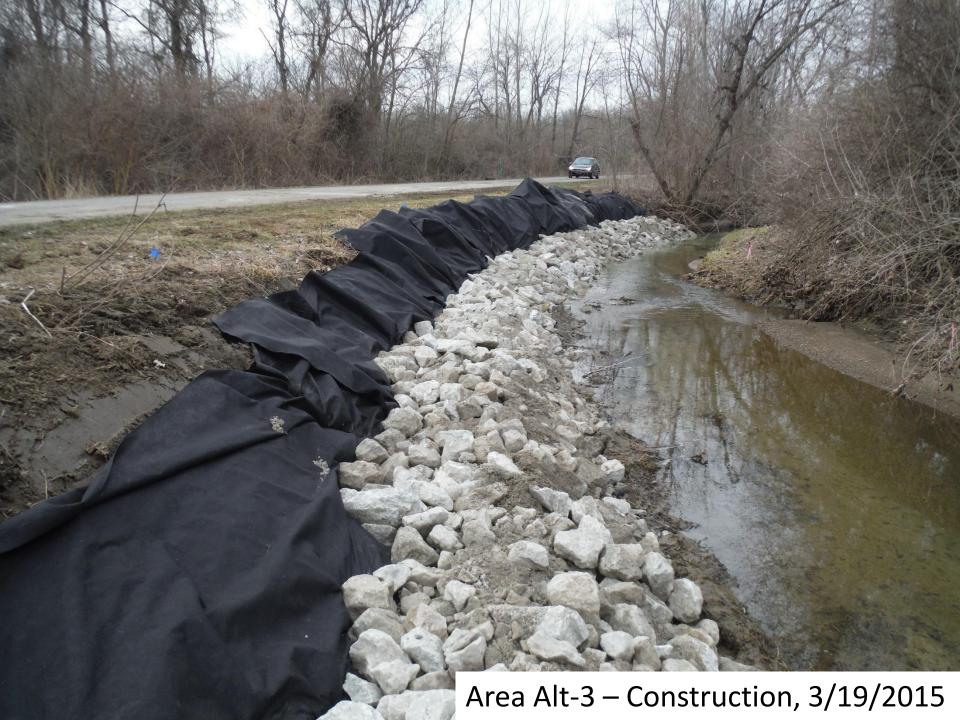
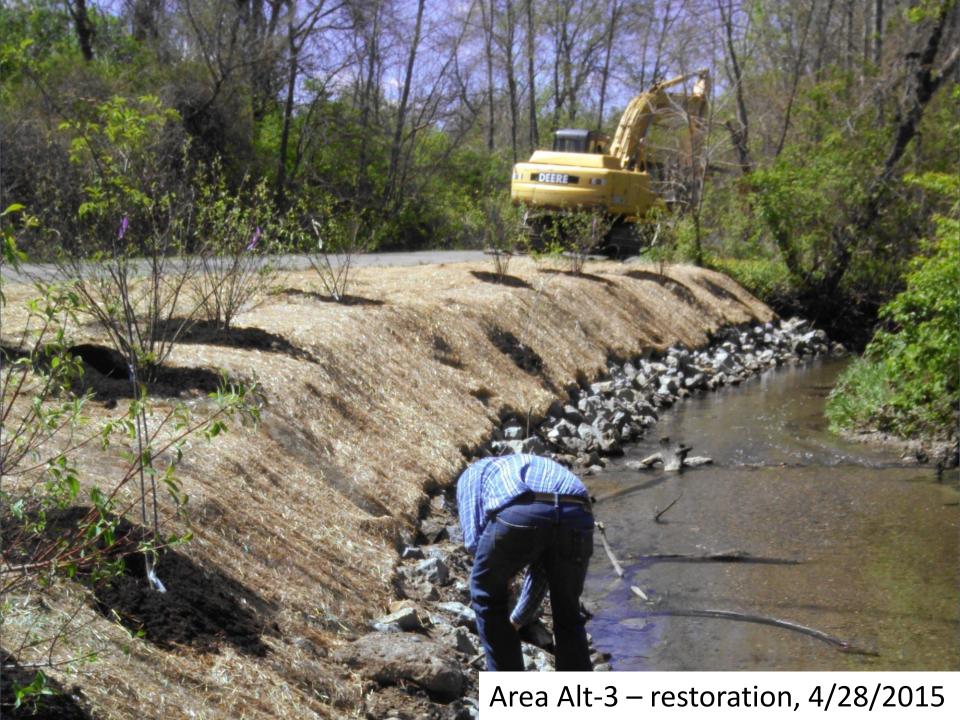
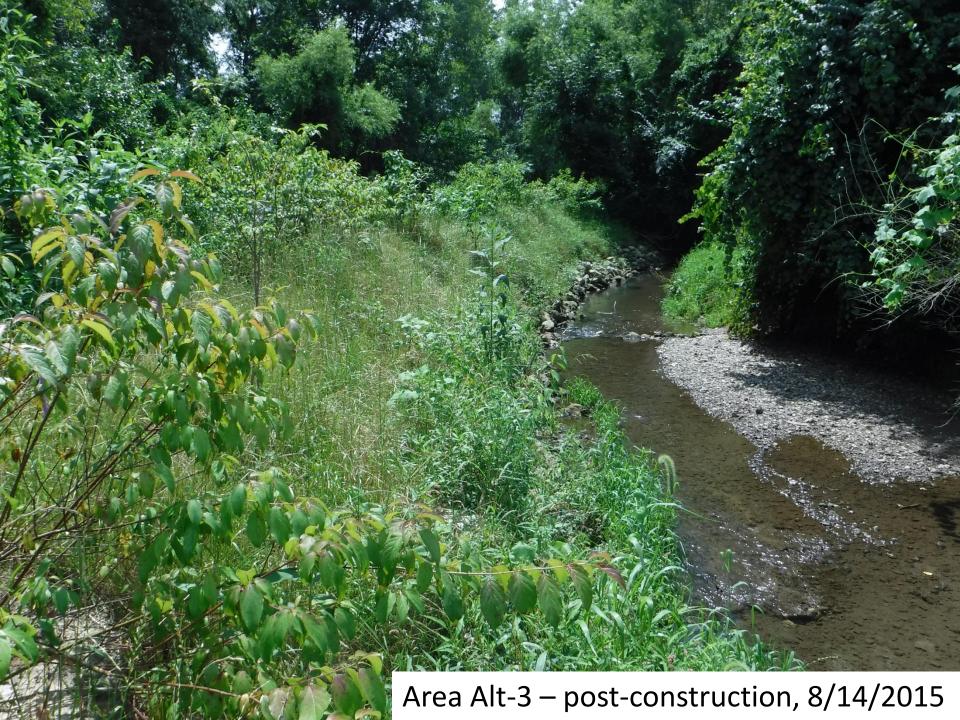
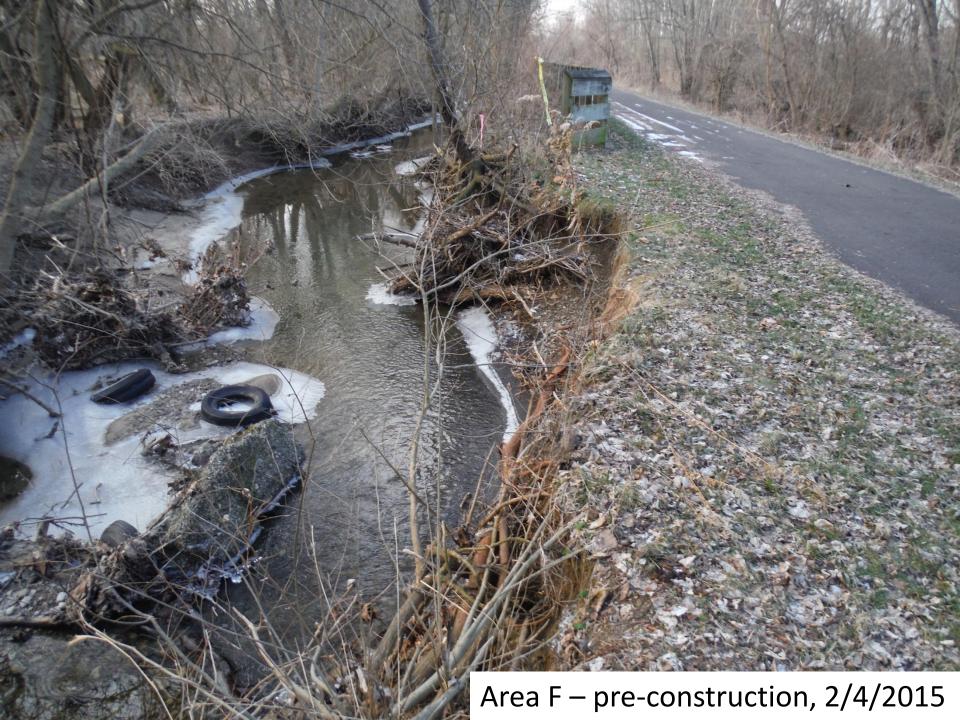
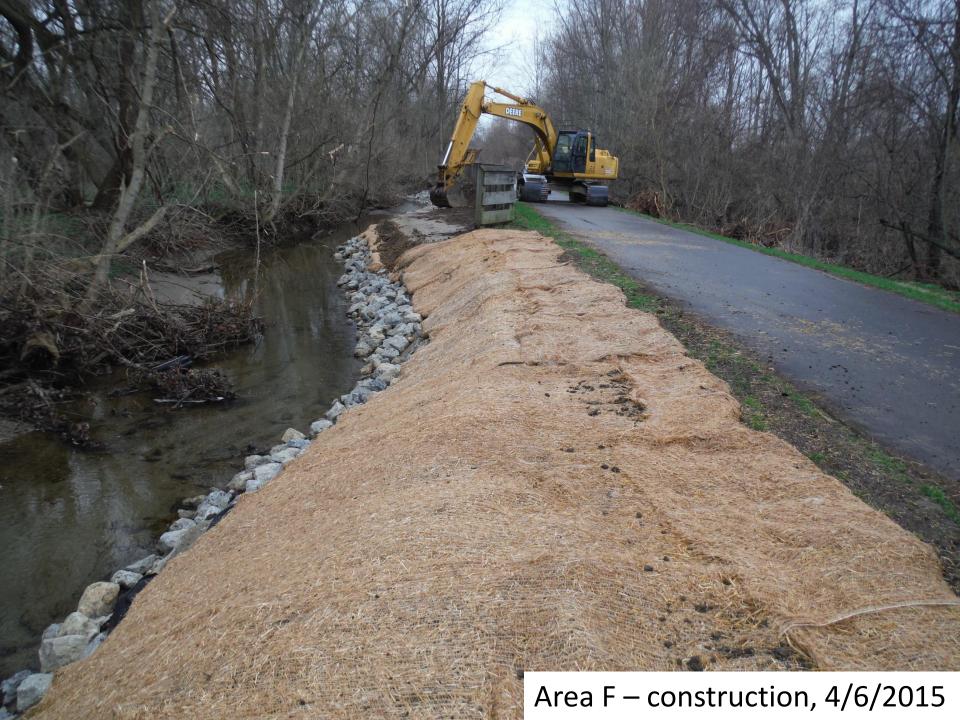
Case Study - Glady Run

- Project Owner: Greene County Parks and Trails
- Project Goal: Stabilize and restore rapidly eroding stream banks and protect a heavily used bike path
- Funding Source: Ohio EPA Section 319 Nonpoint Source Grant
- Stream Characteristics: cohesive soils, historically straightened channel, watershed area of 3.5 mi²
- Principal Design Elements:
 - o 600 cubic yards of toe rock
 - Native plantings (seed, shrubs, trees, live stakes)
 - Protection of adjacent bike path and timber fence
- Total Project Length: Approximately 2,900-ft
- Construction Cost: \$139,933 (Water Quality Systems, Inc.)
- Construction Schedule: February to June, 2015

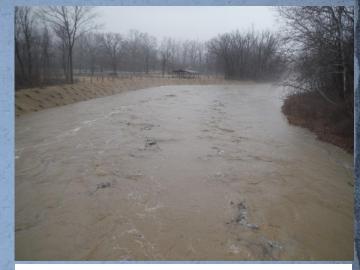
Dry Fork Creek, Site A - 1/3/2015 Flood

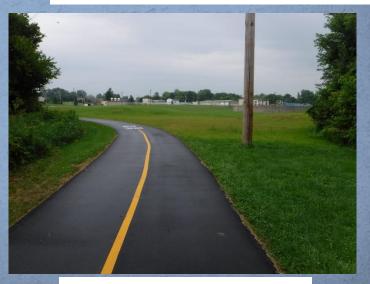
Glady Run, bike path overlay
