# Easterly WWTP

## Sinking Feeling – Finding and Fixing Leaking Plant Conduits and Air Piping

OWEA State Conference

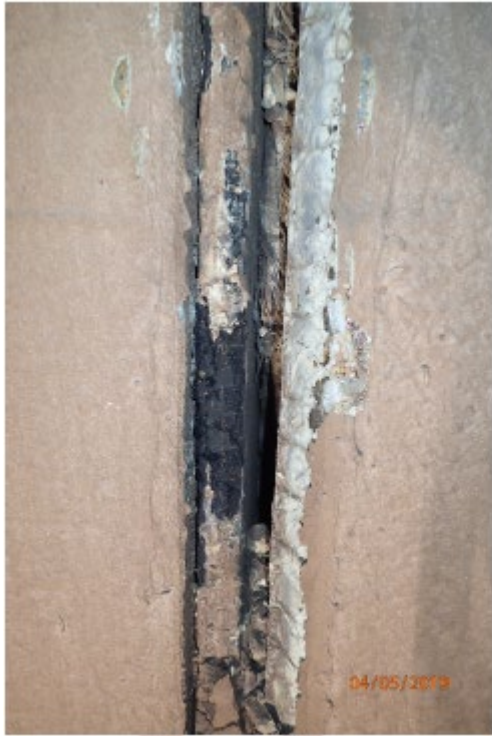
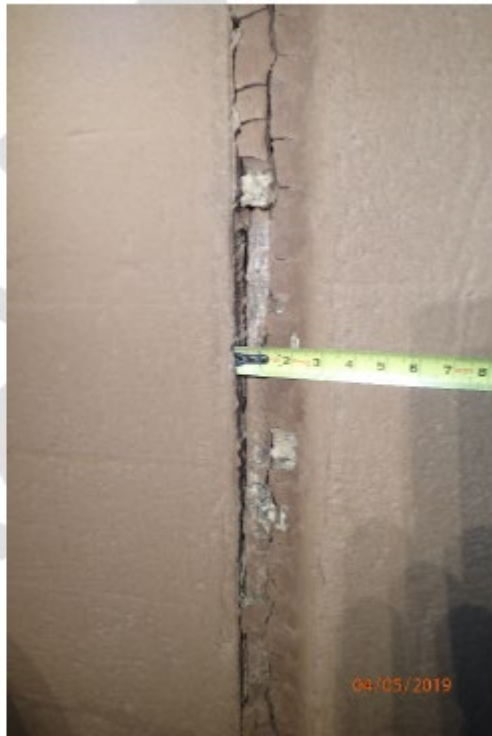
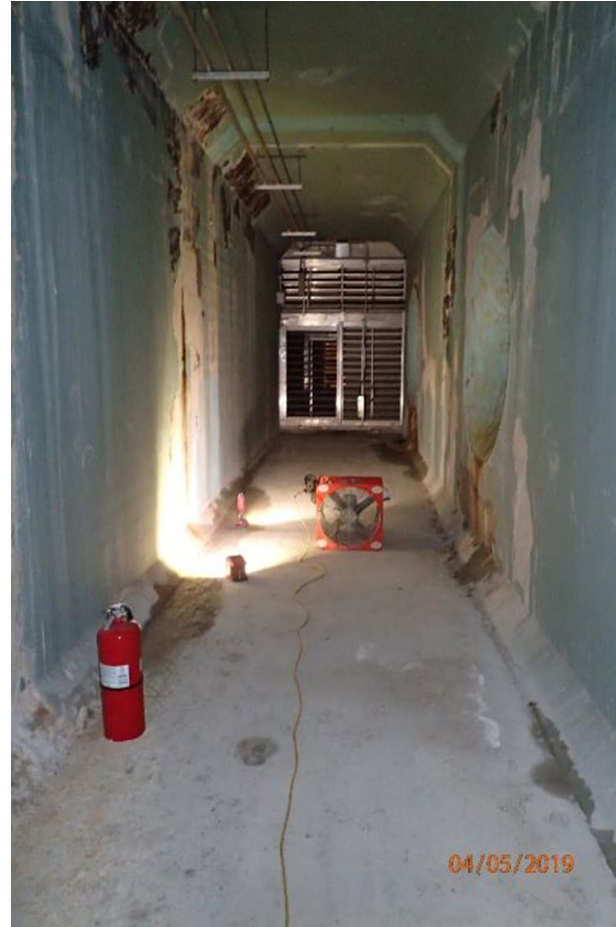
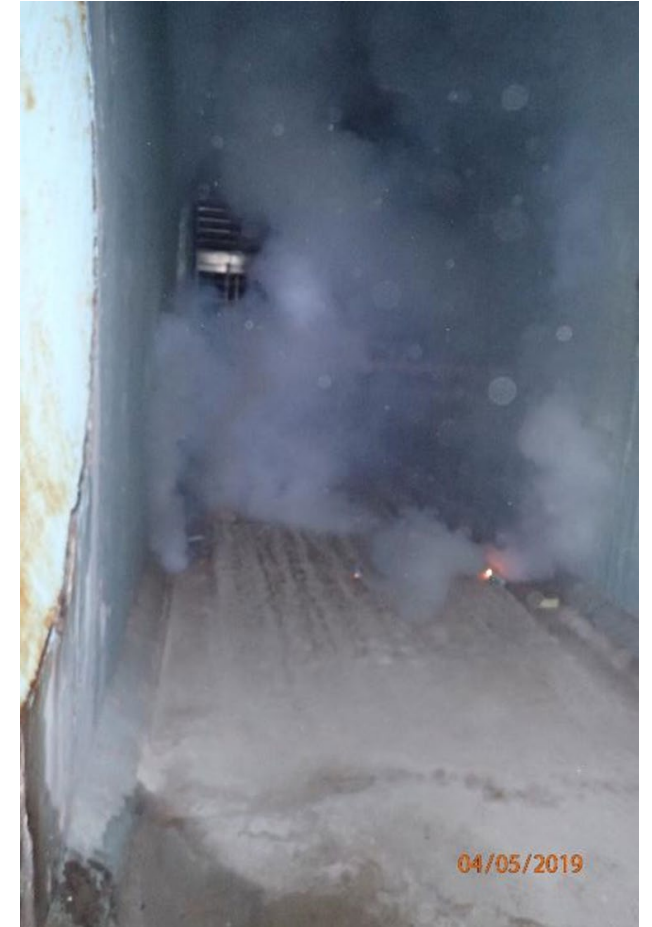
Expansion Joints Inside Discharge Conduit

Visual inspection was more beneficial than smoke test in determining the source of the leaks. System was shut down and the discharge conduit was accessed. Leaks were at the shared air discharge conduit concrete expansion joints and in the 60" pipe joints.

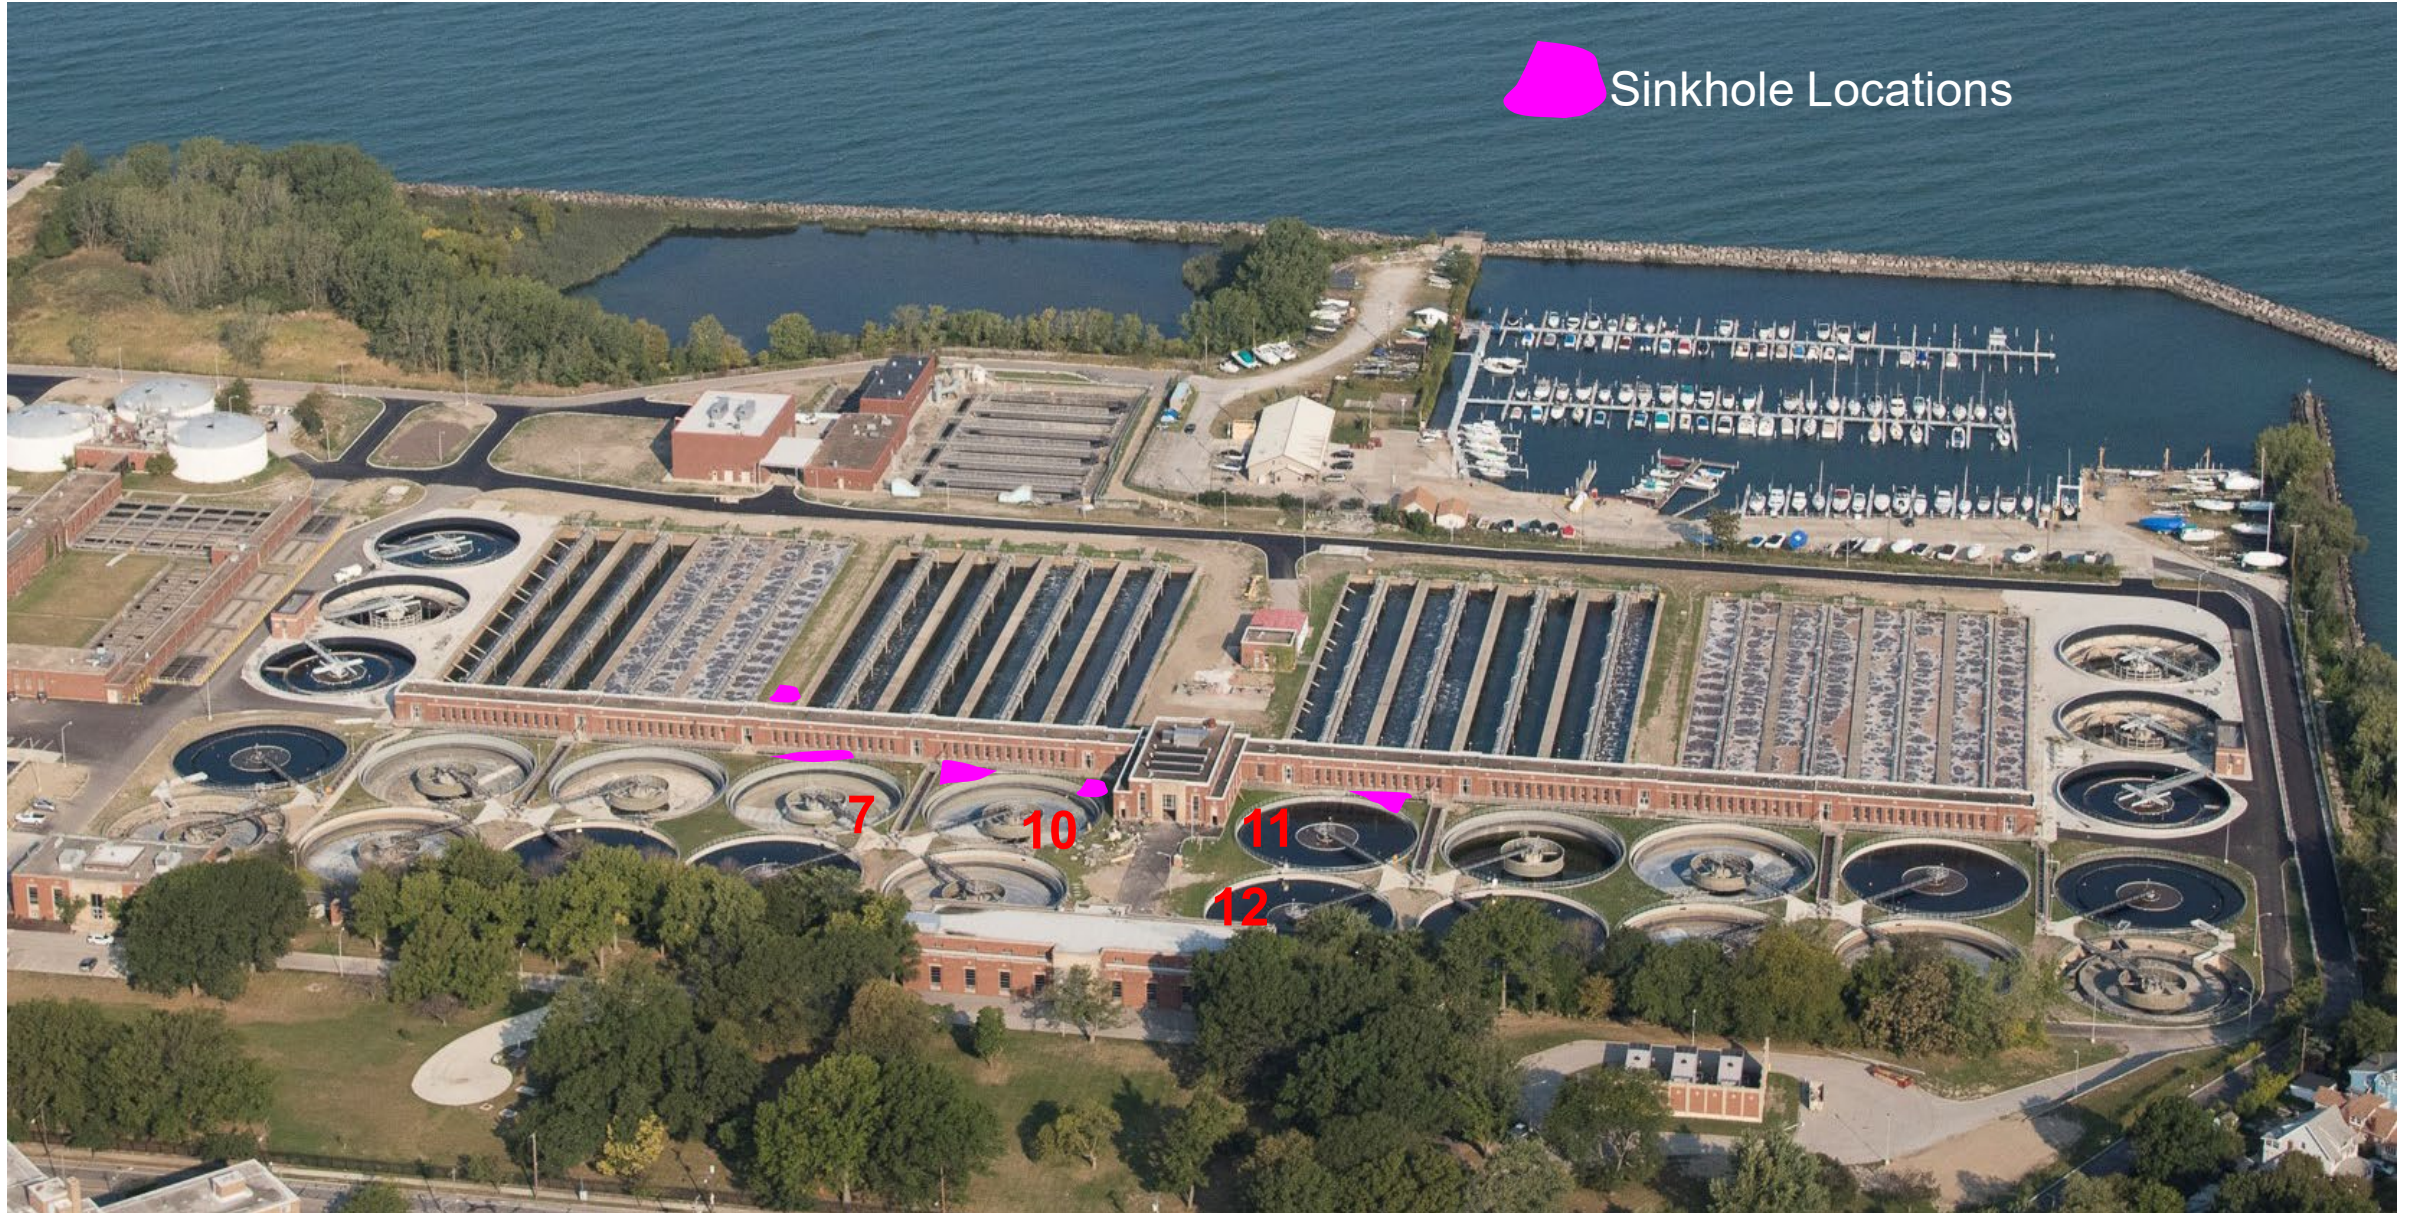
Sinkhole Locations

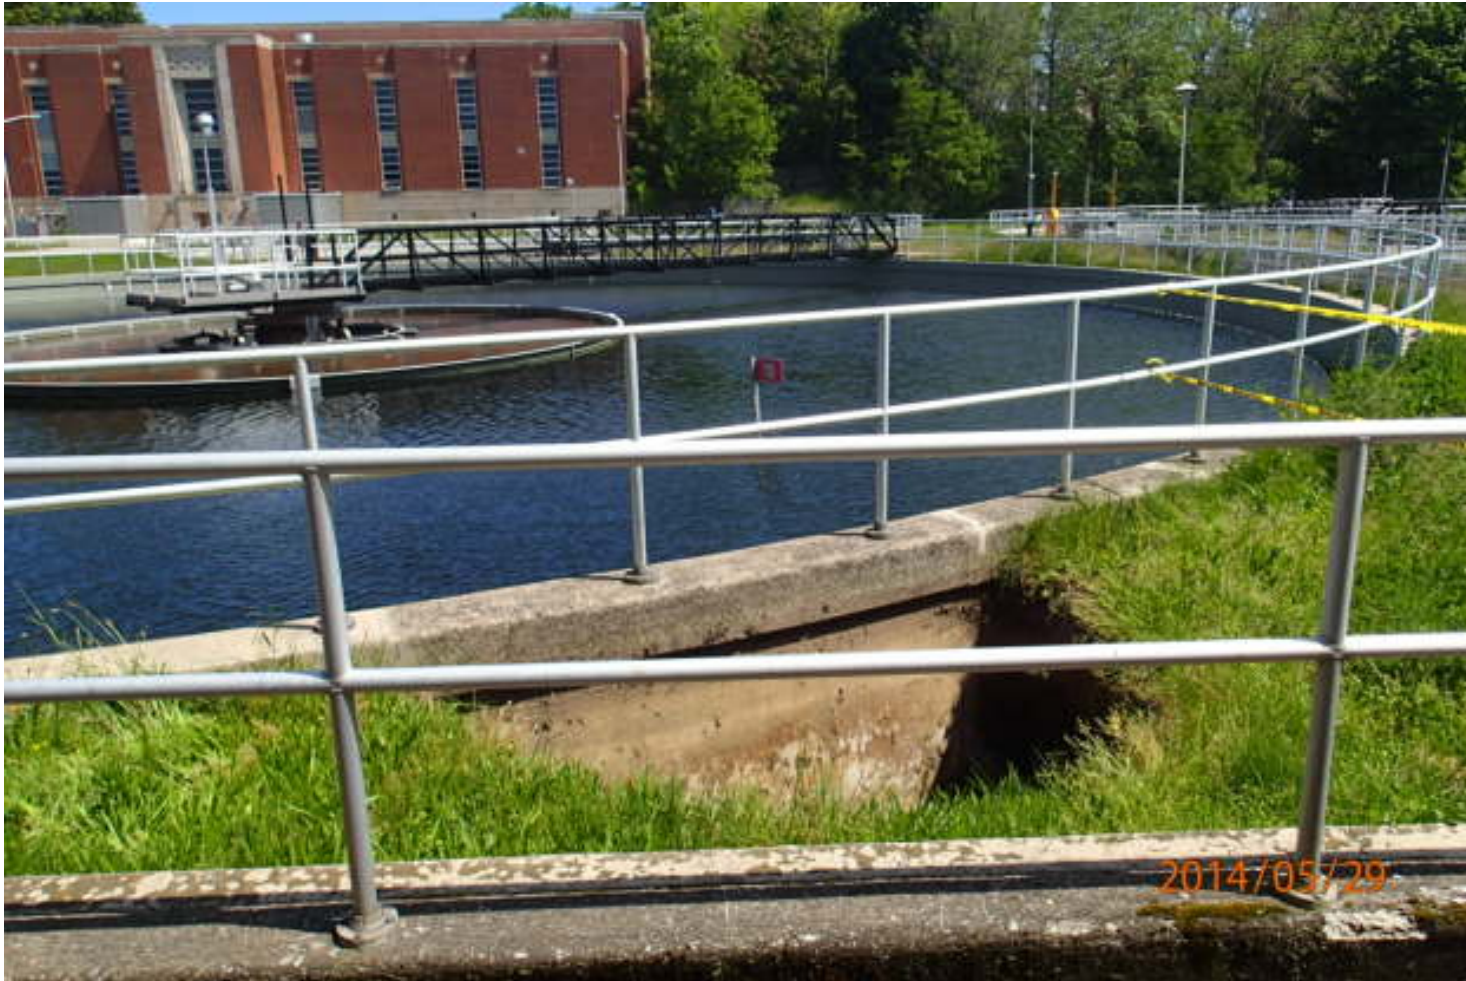
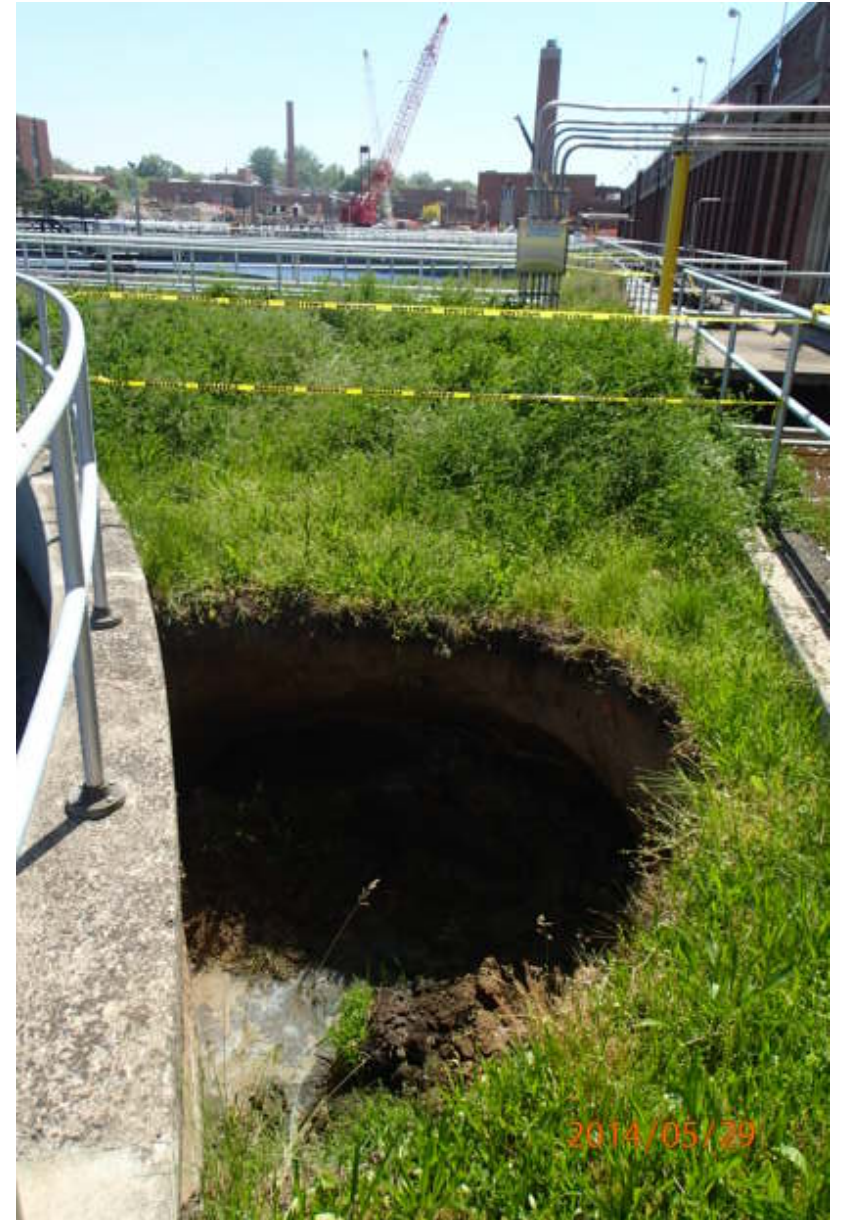
2014: Sinkhole Observed

March 2016: 16" RAS  
pipe video from Gallery  
side determined pipe  
displacement.

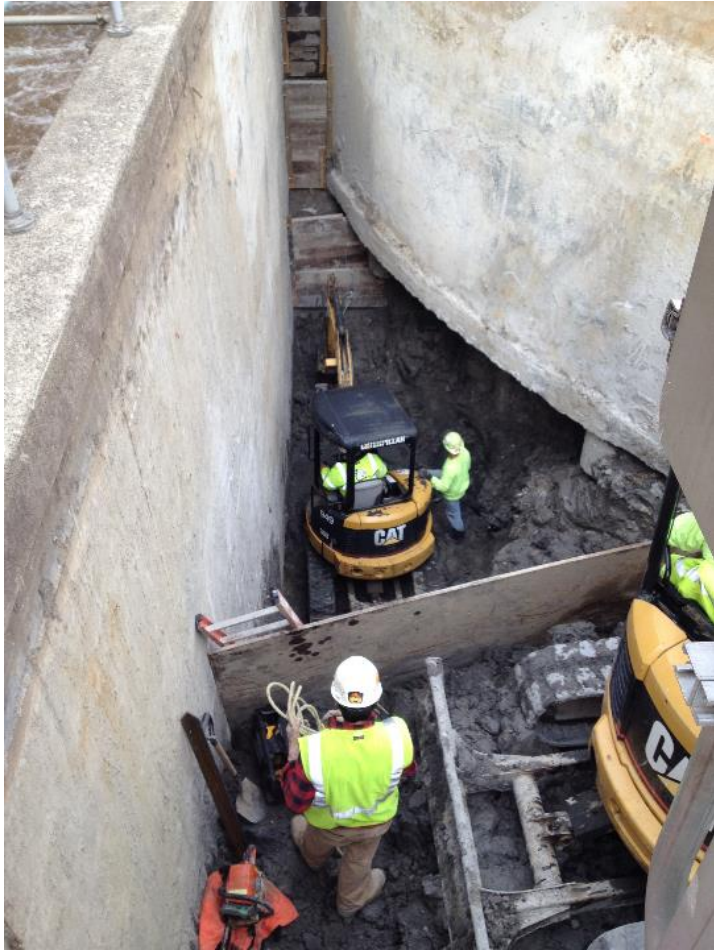
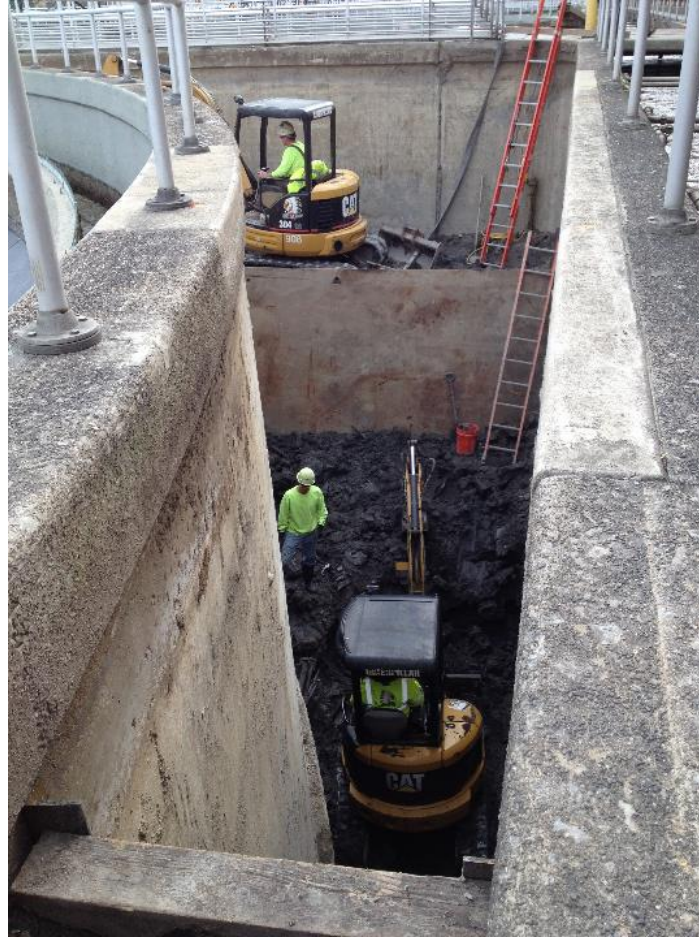
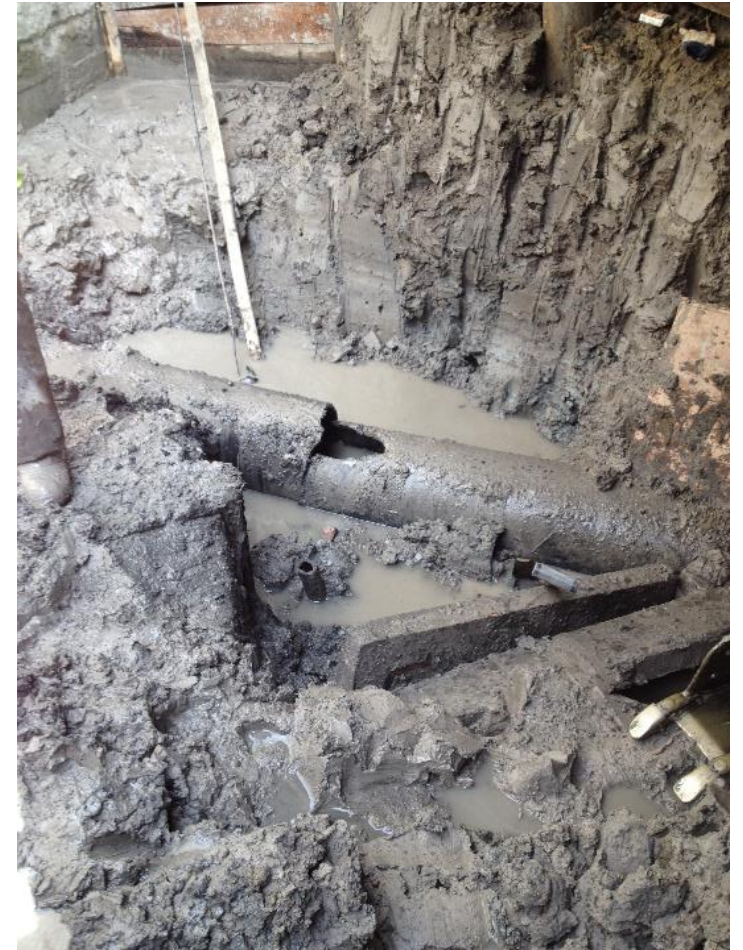
March 2016: 16" RAS pipe break repaired under ESS I Project Change Order. Open cut excavation and removal replacement of broken pipe and backfilled with sand.

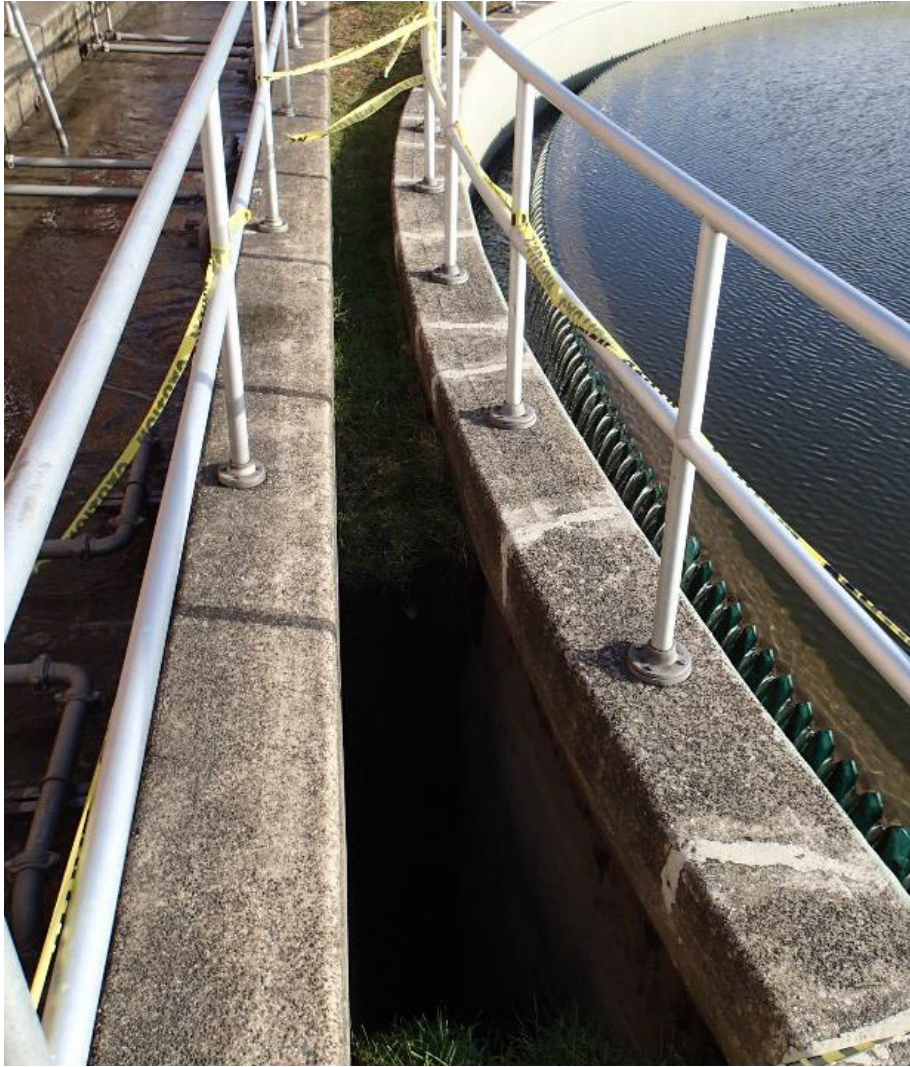
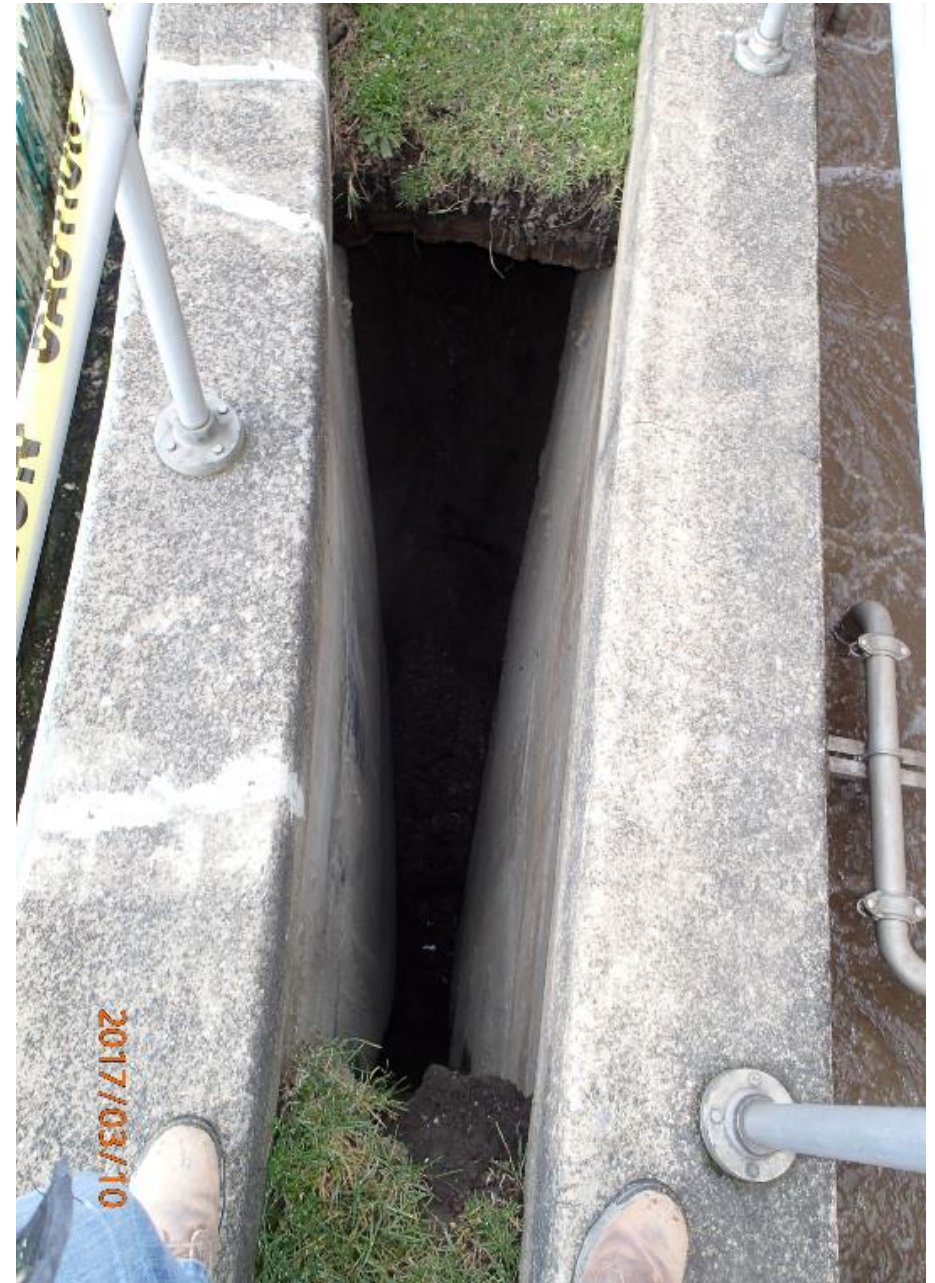
January 2017: Sinkhole Observed

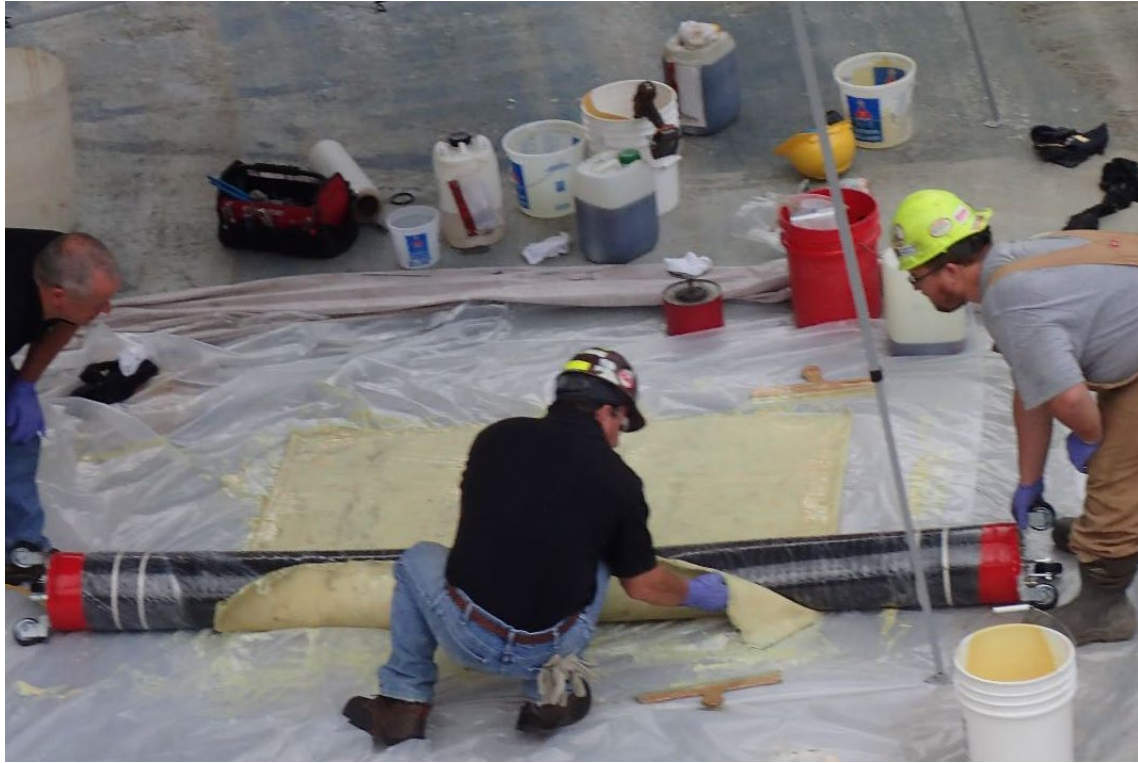
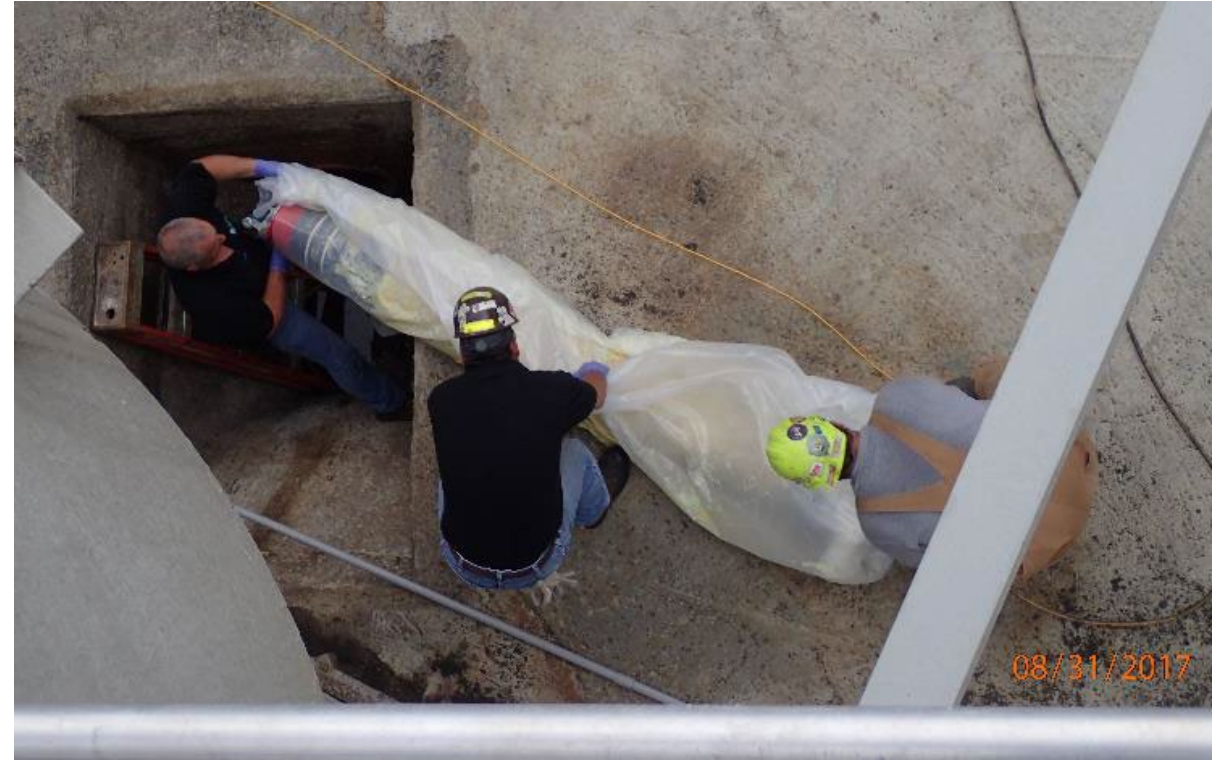
- 16" RAS Pipe video from tank side determined pipe displacement
- Pipe break repaired with internal fiberglass pipe repair
- Sinkhole backfilled with sand

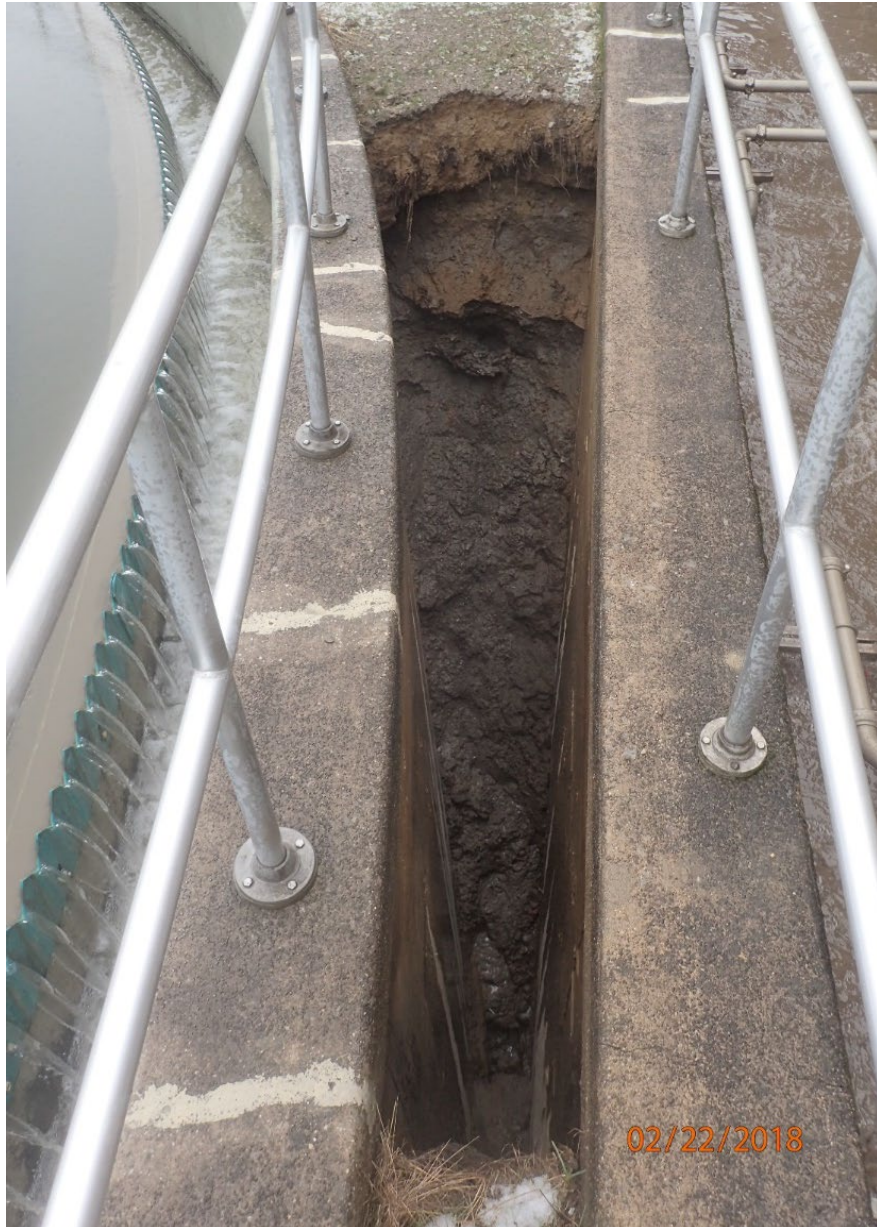
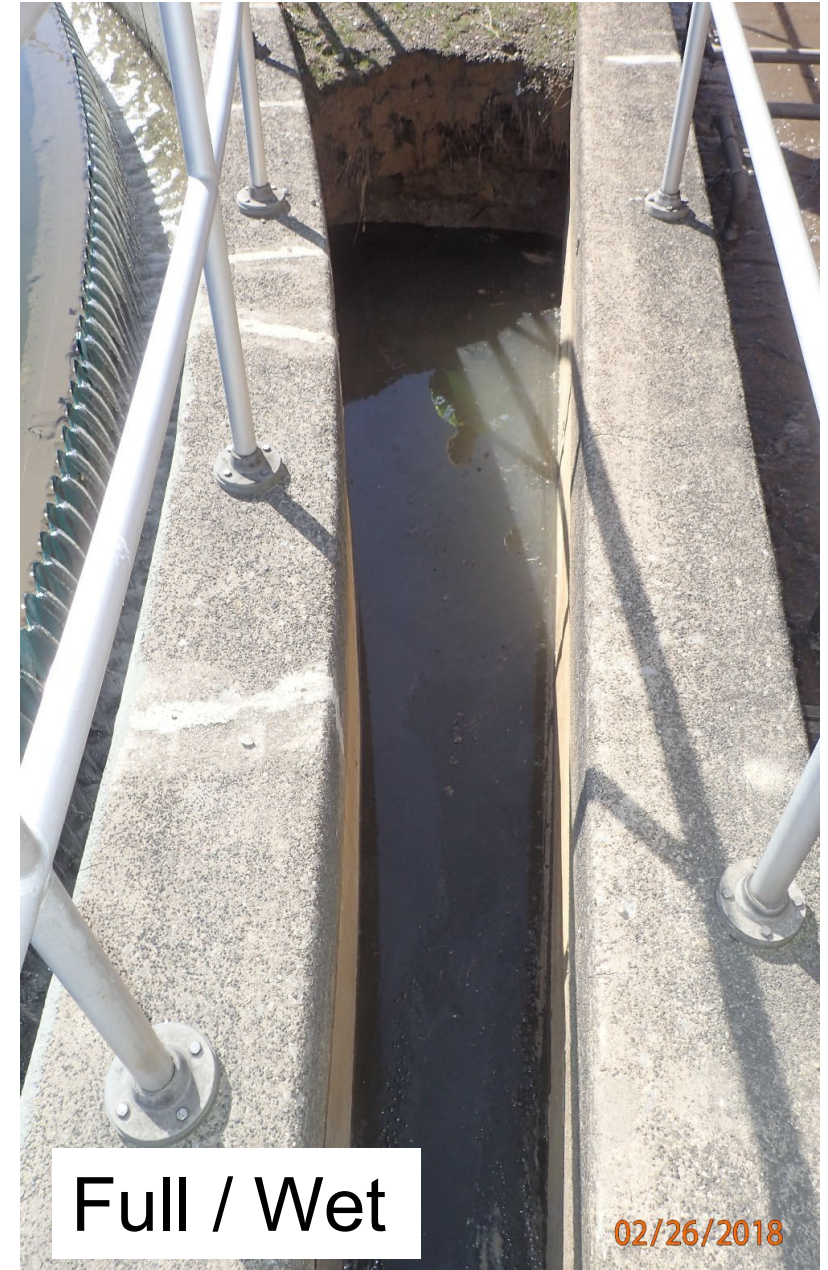
**Sinkhole Reappears  
in February 2018  
(6 months after  
backfilling with  
sand)**

Sinkholes are observed to fill and empty with the water level in the drainage conduit

This was the confirmation that the sinkholes were a result of the flow of water in and out of the drain conduit leak

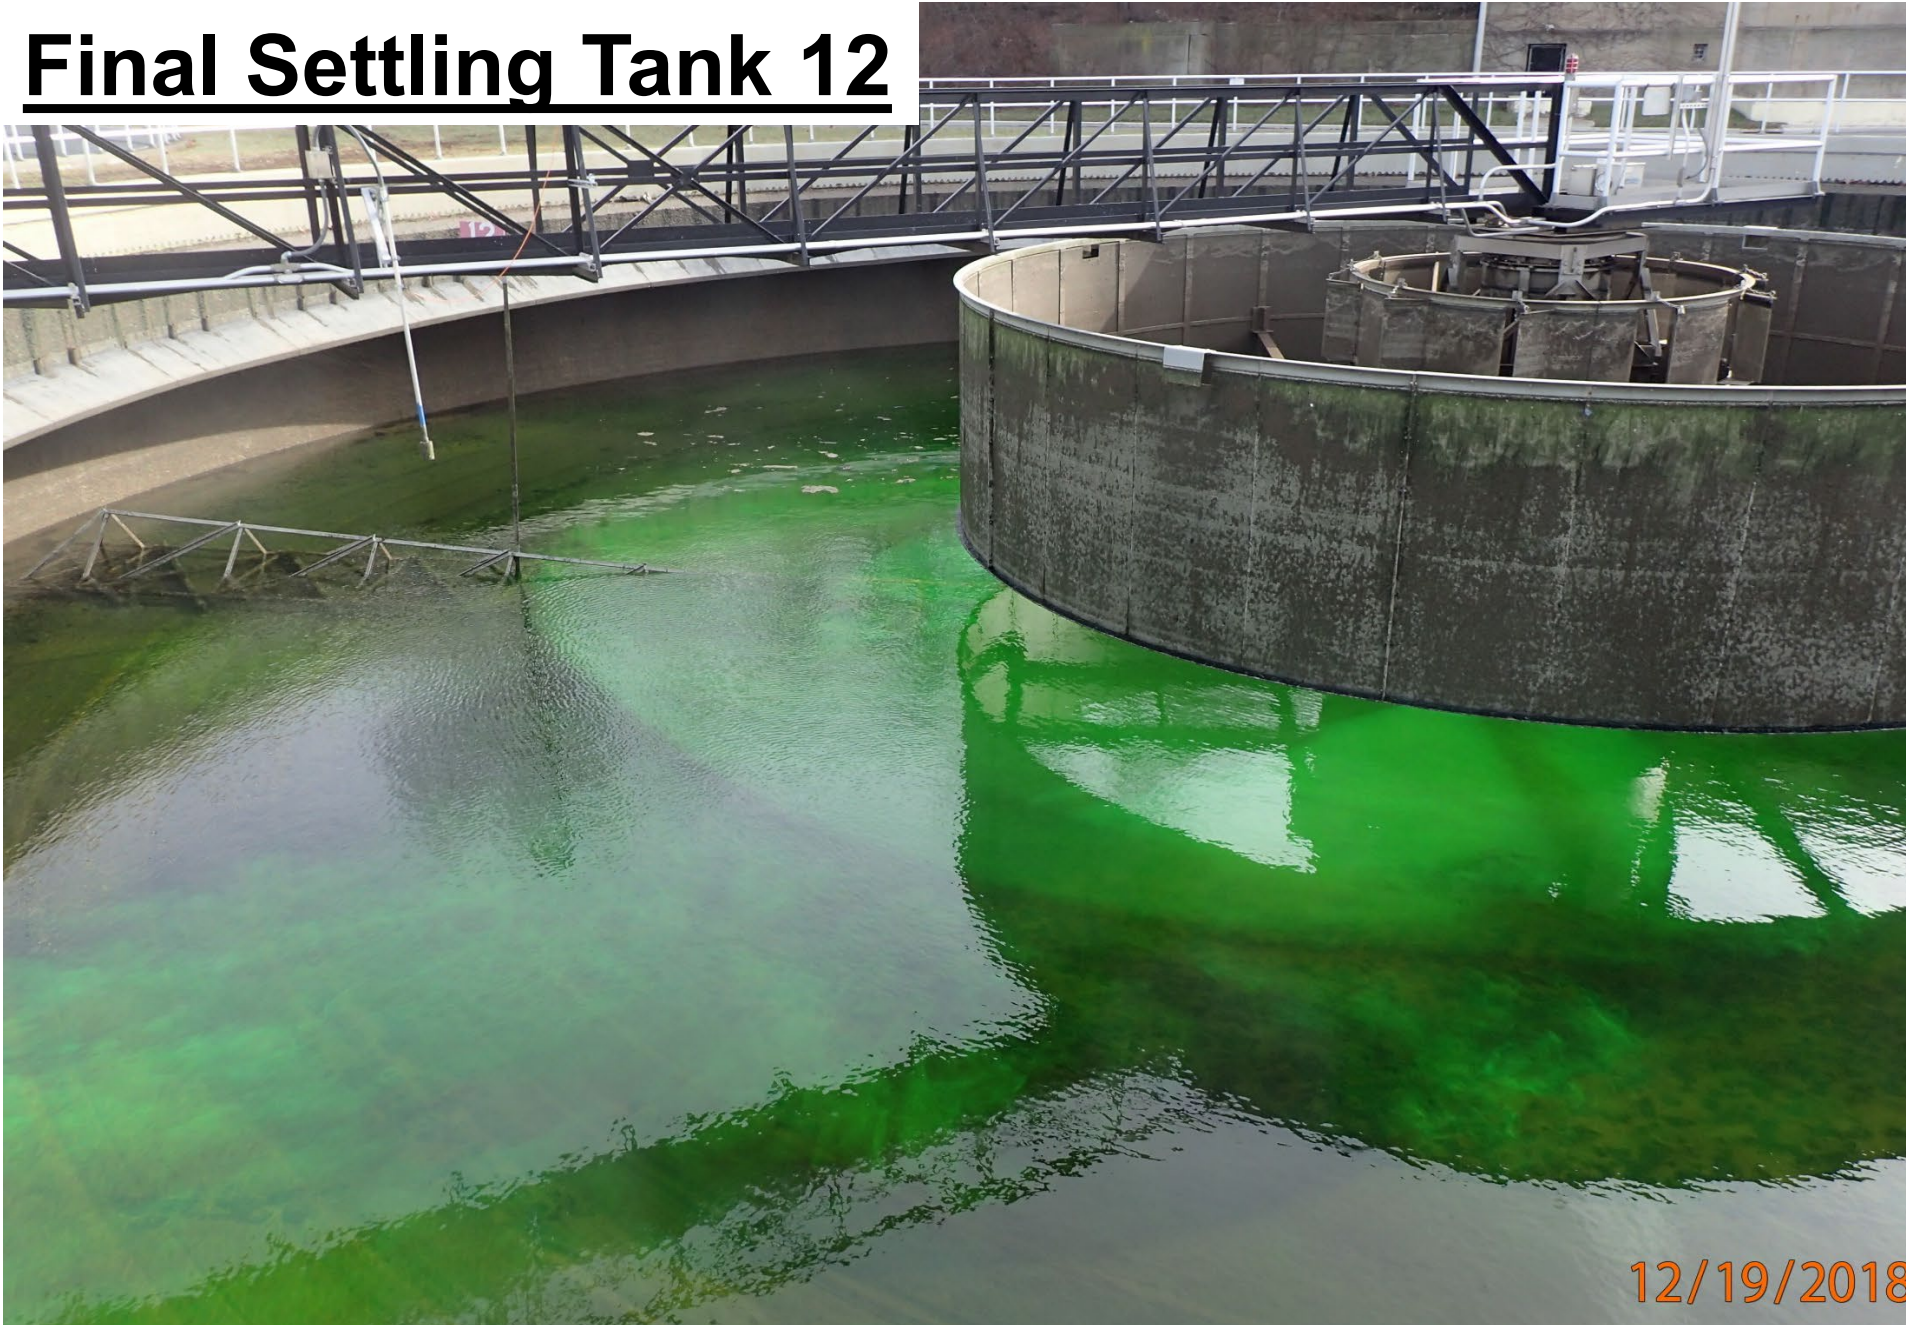
- Water level drop tests were conducted on all 20 FST Tanks looking for leaks. FST 11 & 12 were found to have leaks
- Dye Testing was conducted to determine the source of leak into Drain Conduit

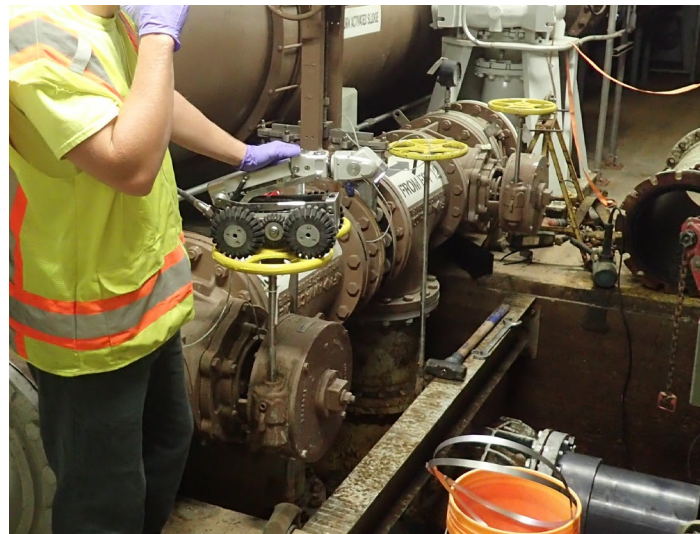
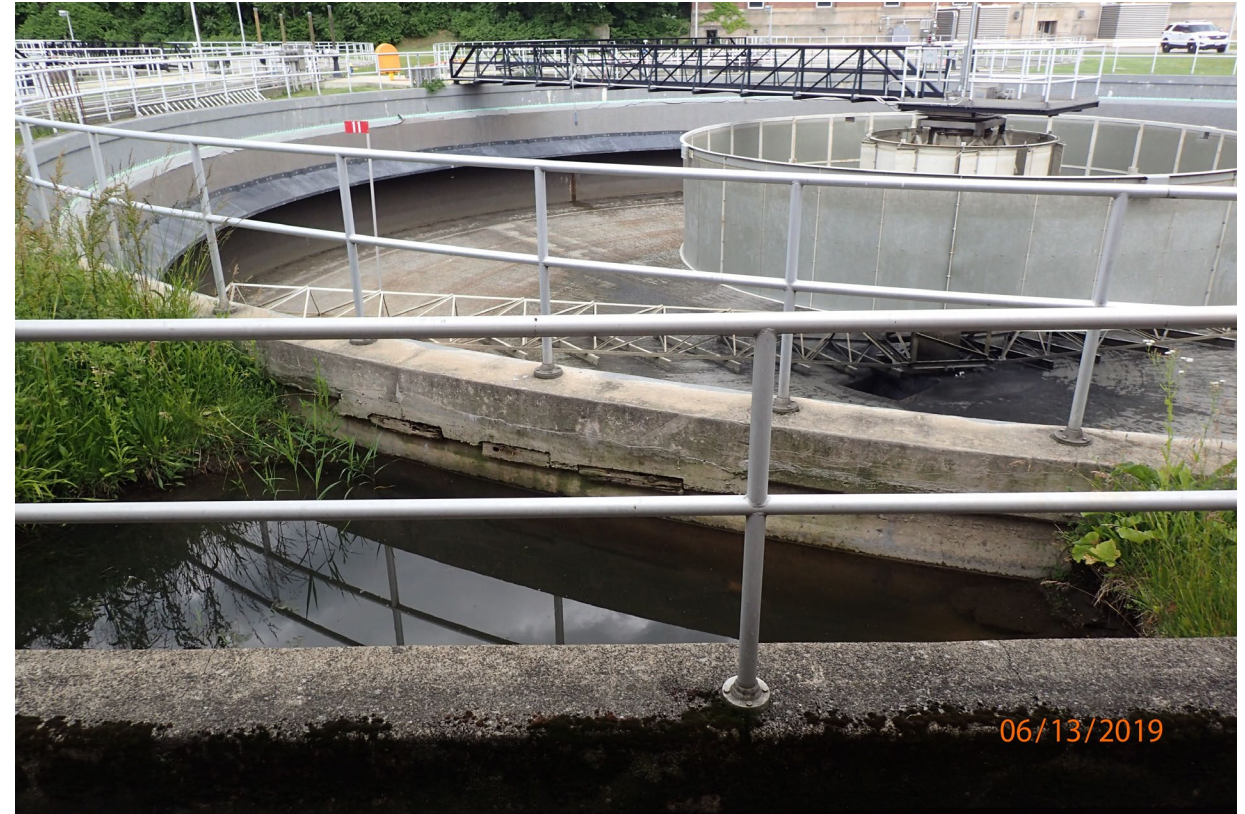
Pipe breaks were found directly below the sinkhole at FST 11

Pipe breaks were found in both 16" RAS pipes directly below the sinkhole at FST 11

- Final Settling Tanks 11 & 12 RAS Piping Breaks:  
Currently determining if pipes can be repaired by an internal repair method. This would be the most cost effective means to repair. If an internal repair cannot be performed then the area would need to be excavated and a portion of the pipe removed and replaced.
- Currently evaluating options to located suspected voids beneath the Drainage Conduit and Gallery bottom slab to determine the extend of voids created by the flow of water in and out of the large hole in the bottom of the Drainage Conduit in the West Gallery at repair location A.

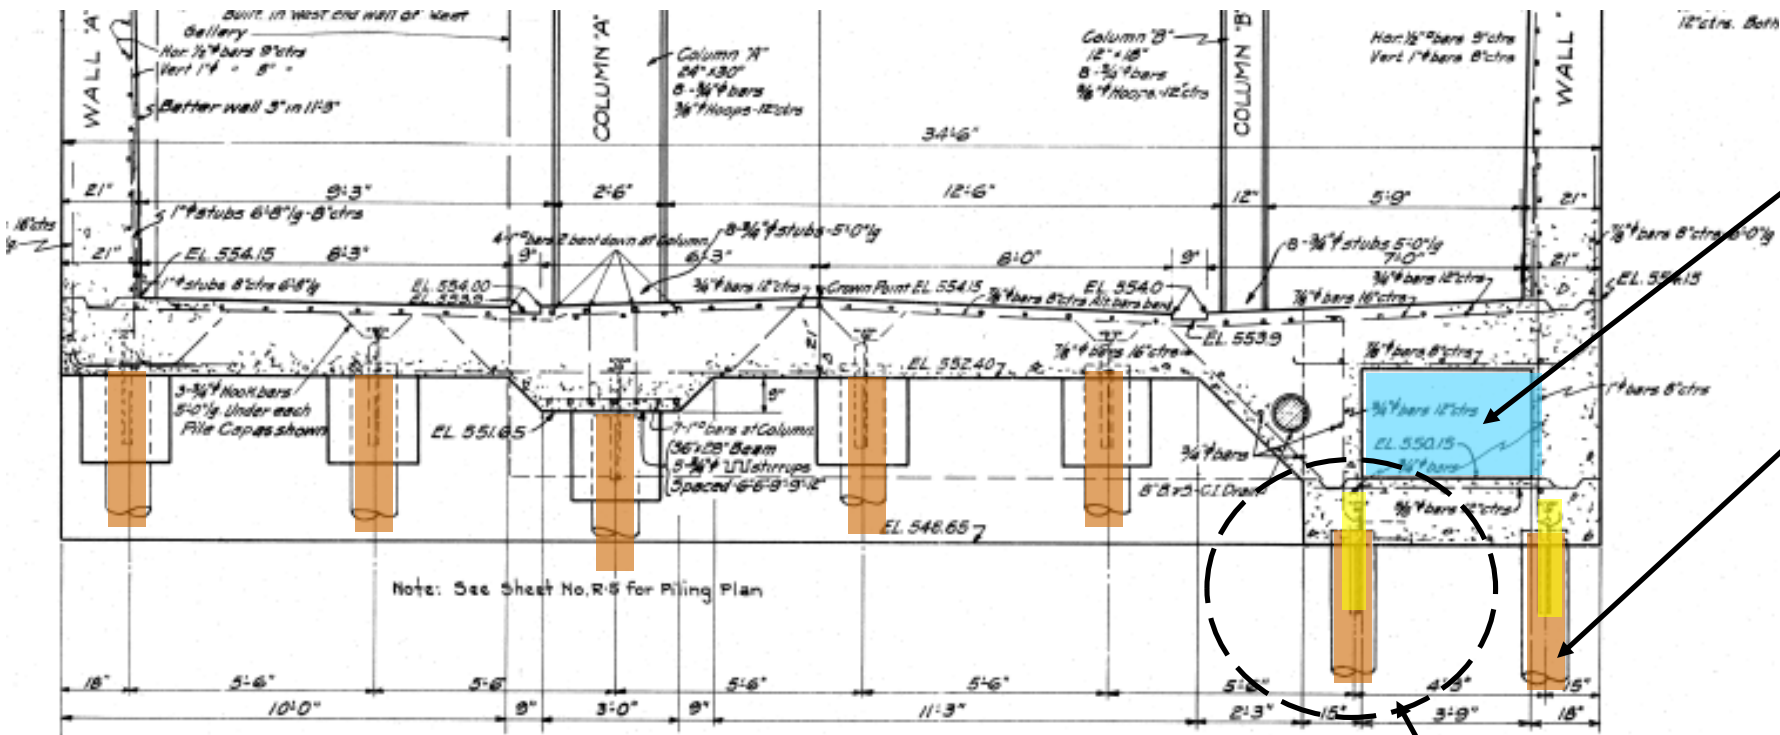
**Drain Conduit:**  
 2.5' high x 3.75' wide x  
 475' long each wing

12" Timber Pile

3" x 2 1/2" x 3/8" Angle Iron  
 Pile Anchor Straps

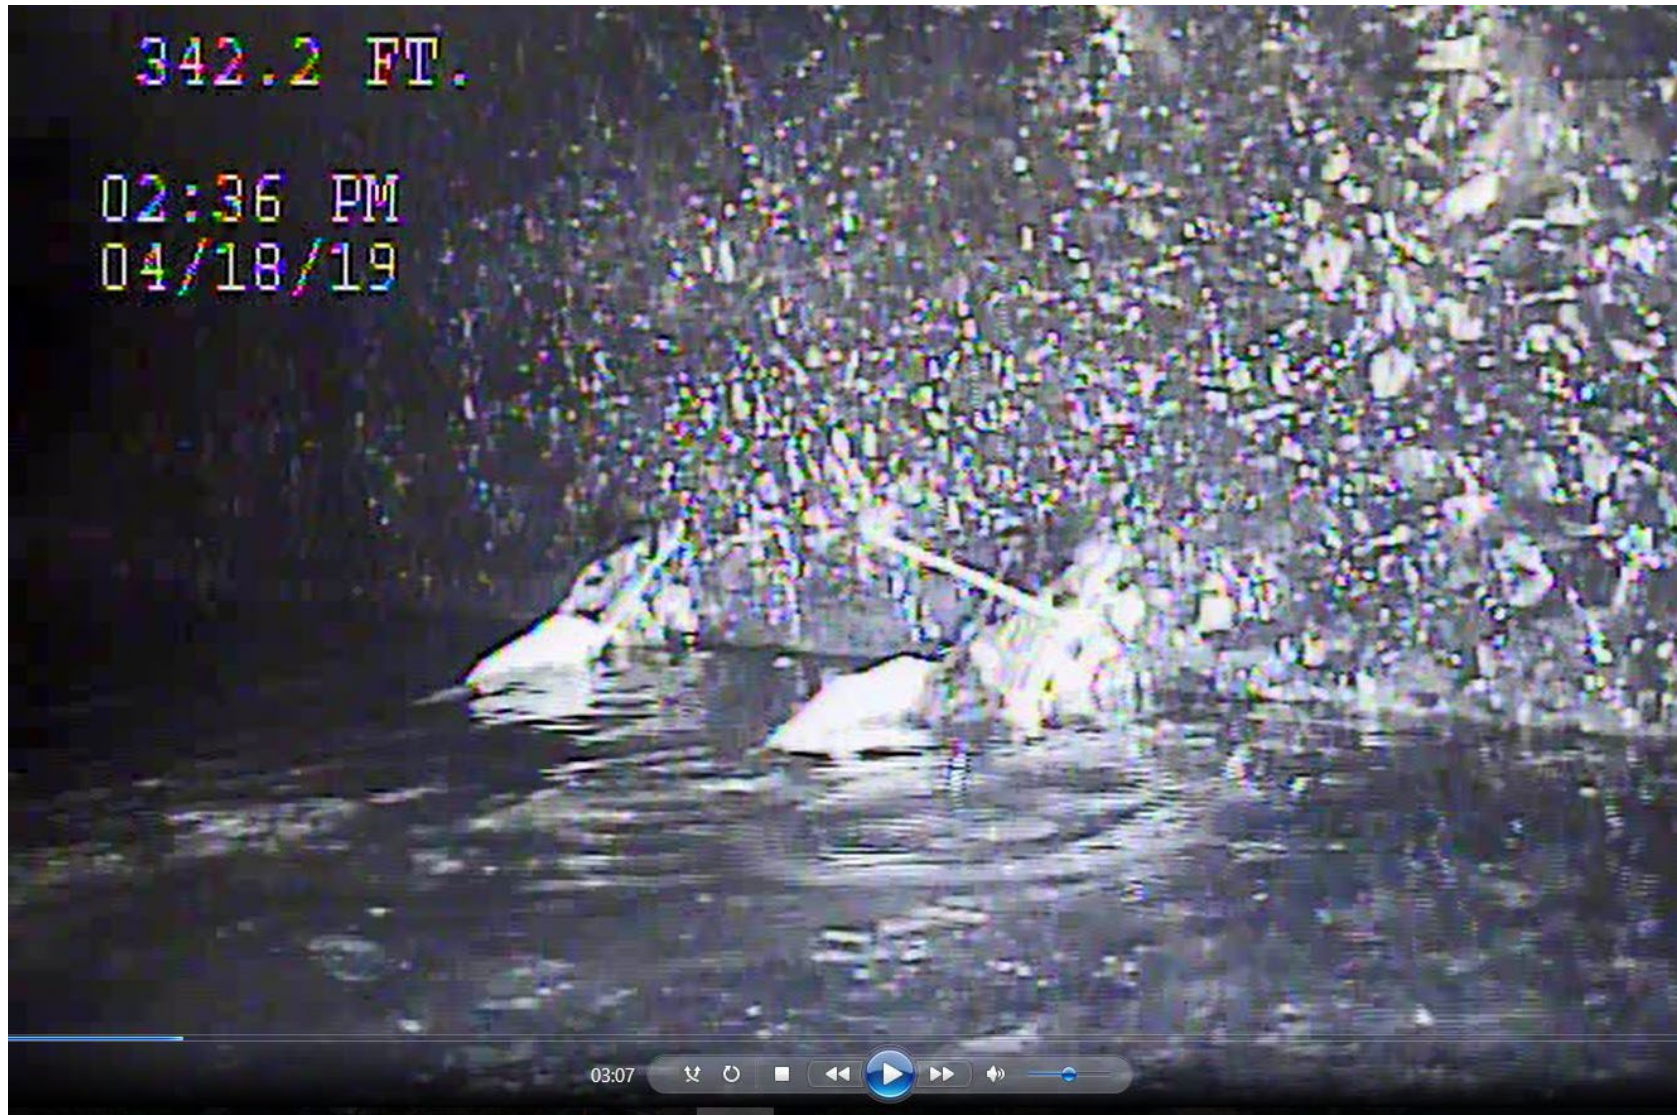
**East Conduit Object North Wall  
(Pile Anchor Straps?)**
