Prioritizing Sewer Cleaning in Cincinnati with Acoustic Inspection

Todd Trabert & Randy Schneider
Wastewater Collection Division of MSD

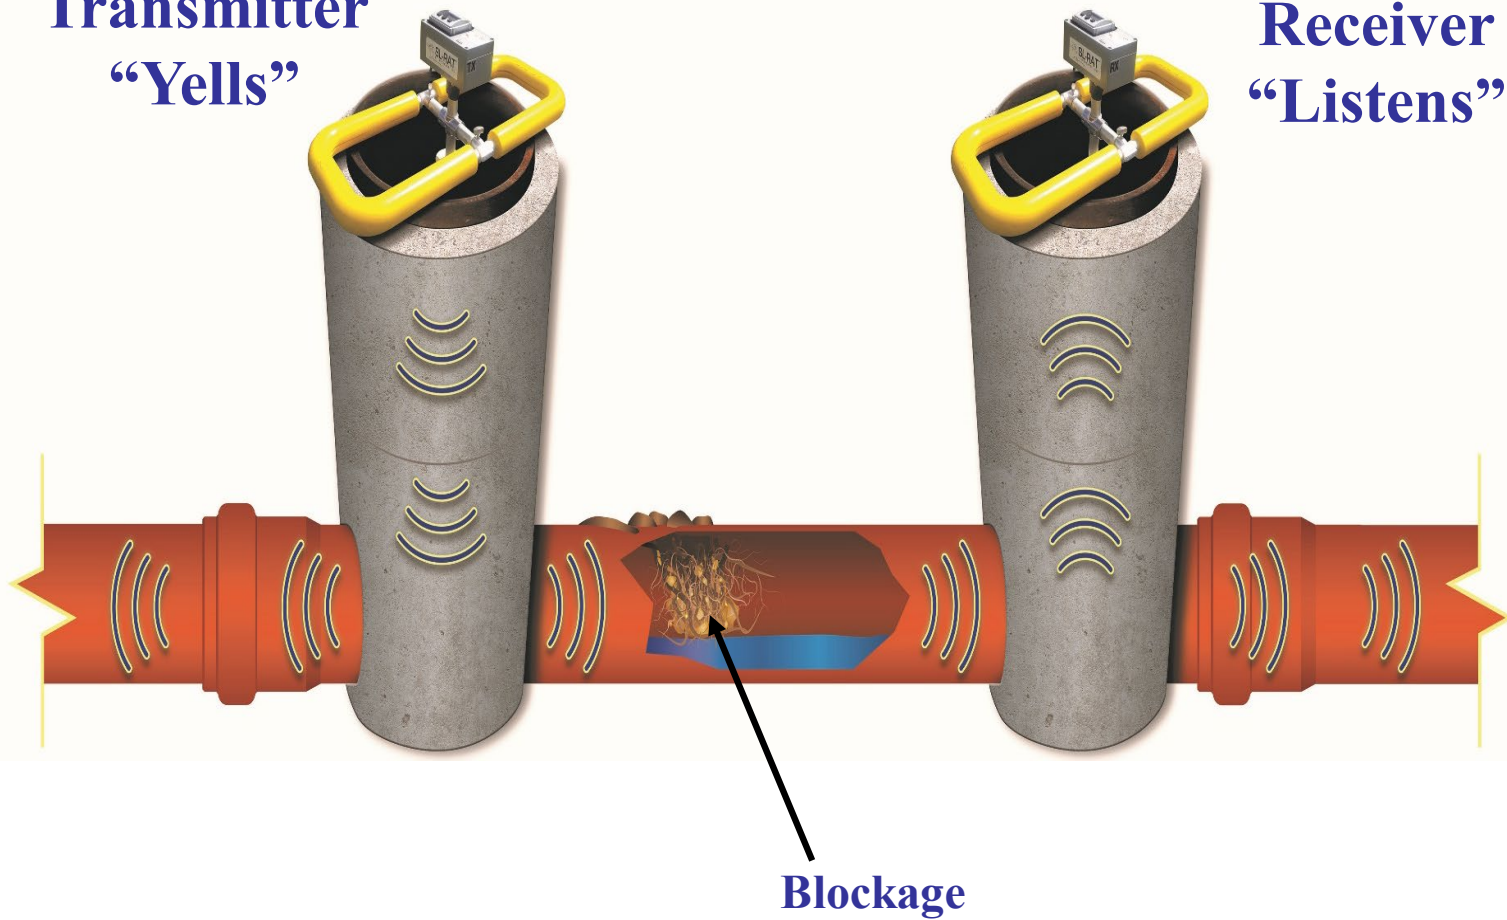
How Does Acoustic Inspection Work?

Transmitter
“Yells”

Receiver
“Listens”

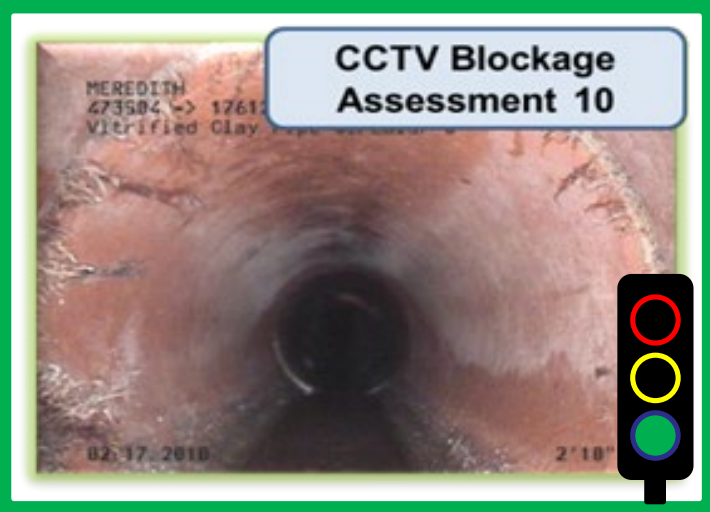
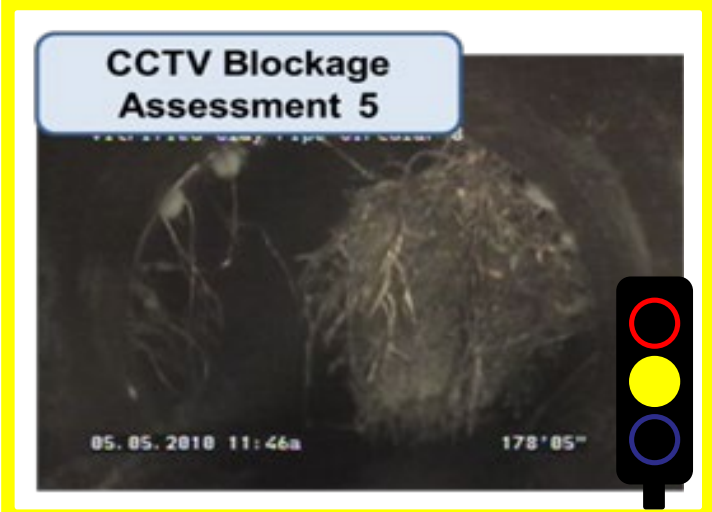
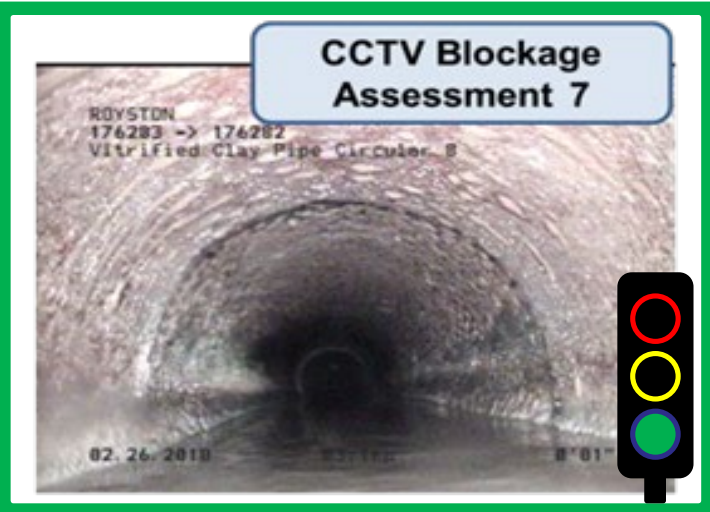
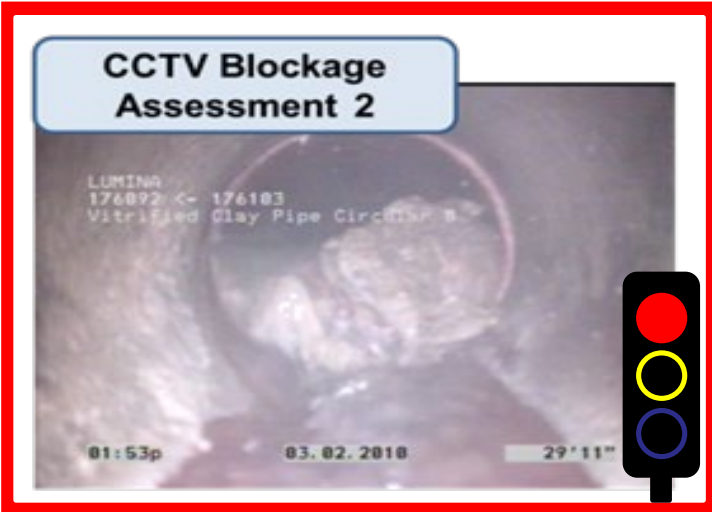
Sewer Segment: 643272

Type of Pipe: **Vitrified Clay Pipe**

Pipe Size: **12"**

Sewer Length: **274.2'**

RAT Score: 0

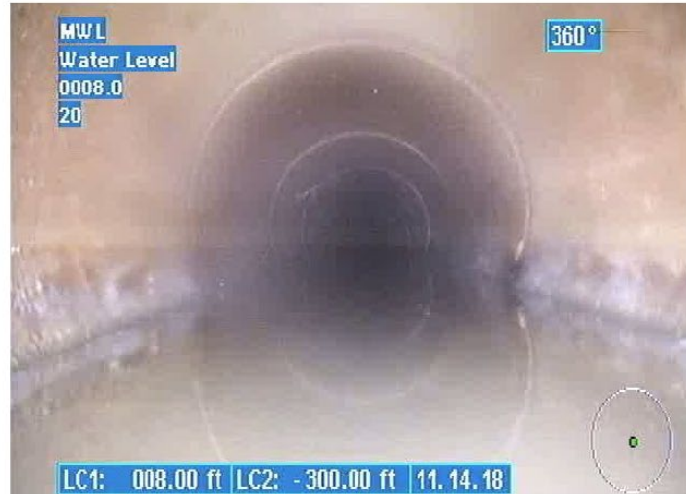
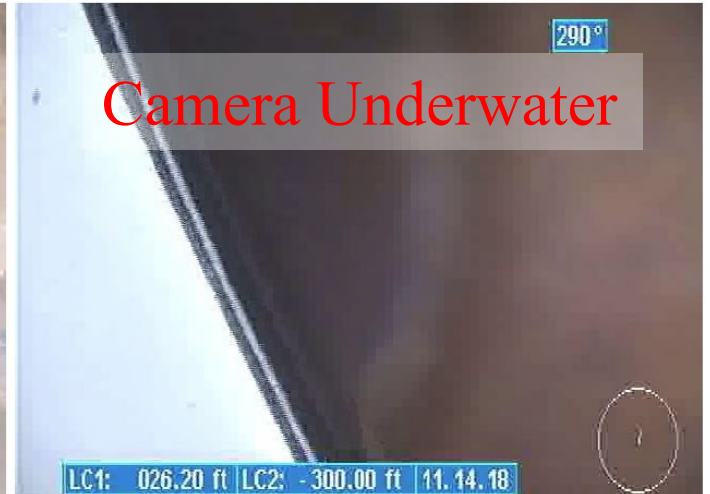
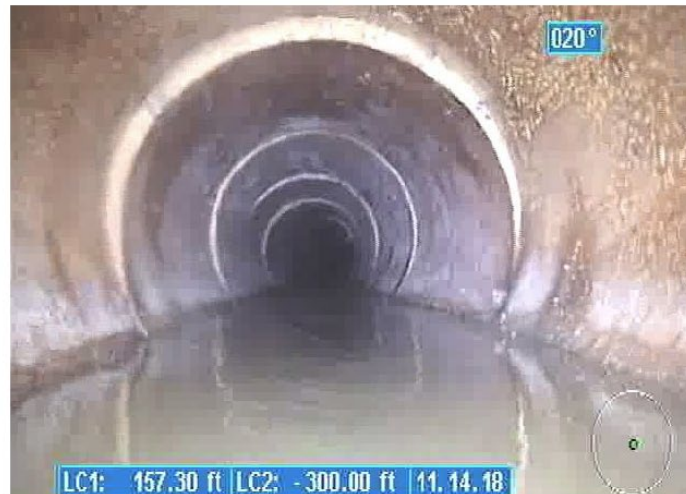
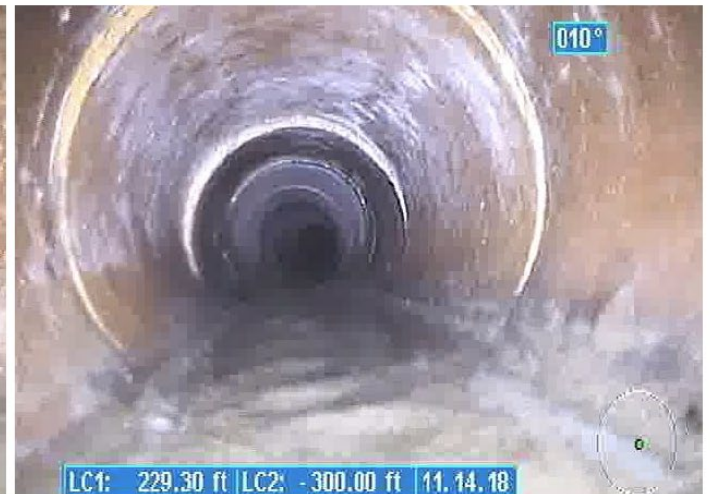
Sewer Segment: 594438

Type of Pipe: **Vitrified Clay Pipe**

Pipe Size: **8"**

Sewer Length: **279.8'**

RAT Score: 2

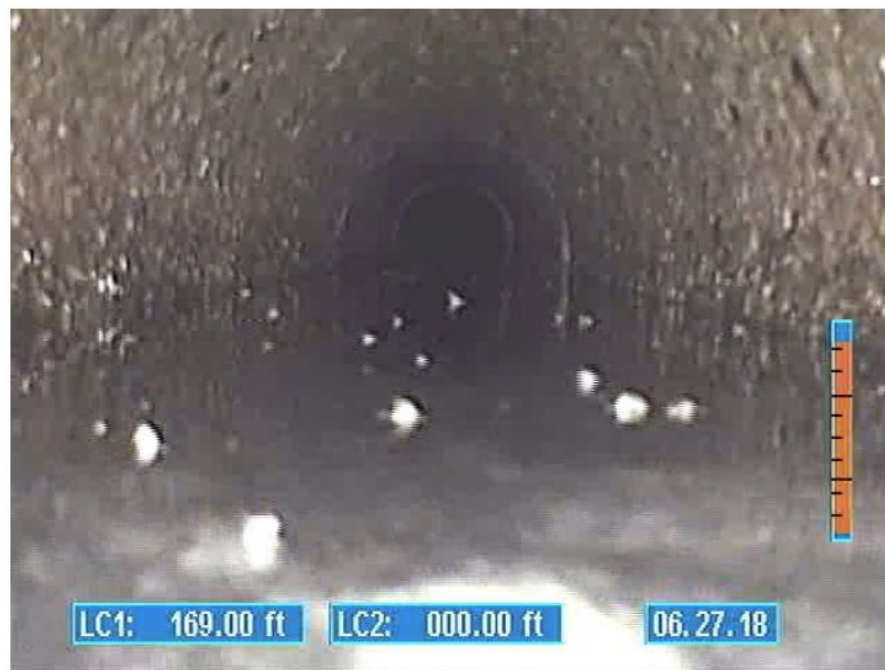
Sewer Segment: 574098

Type of Pipe: **Vitrified Clay Pipe**

Sewer Length: **255.9'**

RAT Score: 4

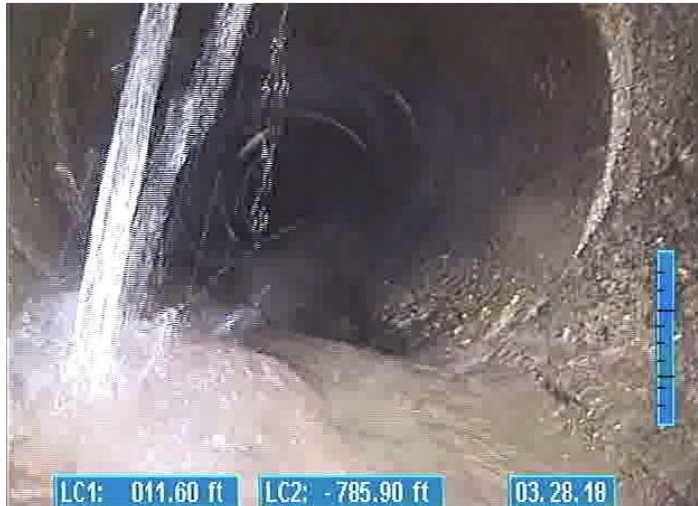
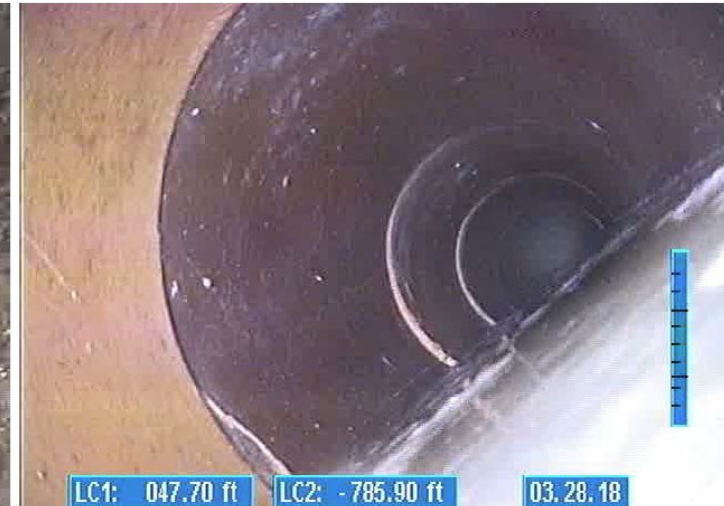
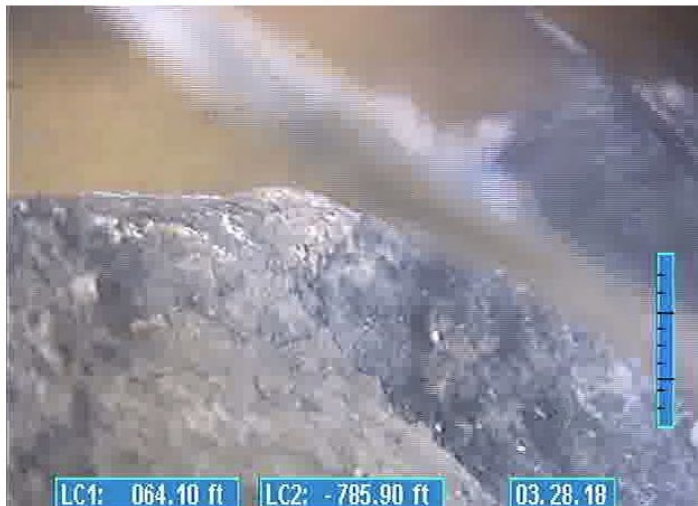
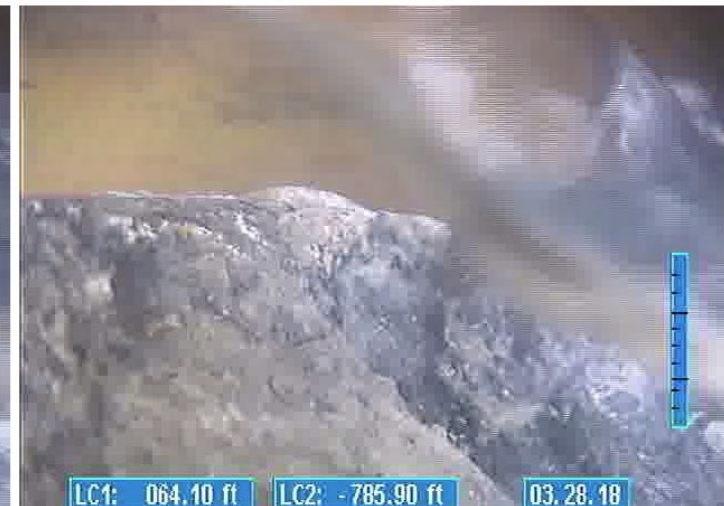
Sewer Segment: 633276

Type of Pipe: **Other**

Pipe Size: **12"**

Sewer Length: **296.2'**

RAT Score: 5

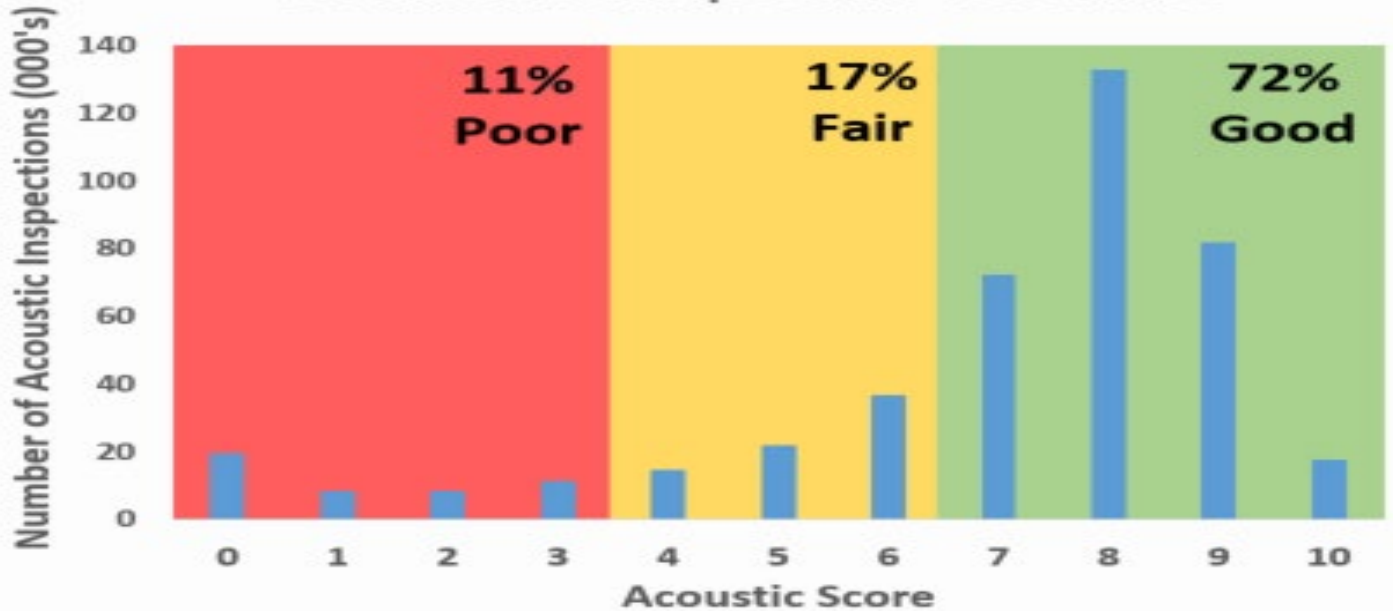
Acoustic Inspection Results

~120 Million Feet Inspected in ~280 Utilities
