Westlake Interceptor Repair Savings Prove Long-Term Success

CITY OF WESTLAKE

REHABILITATION PROJECT

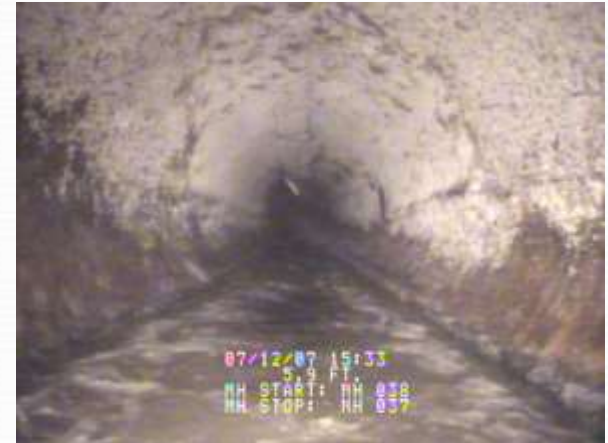
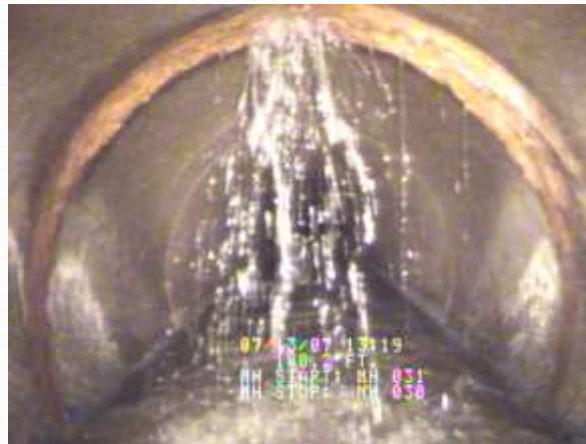
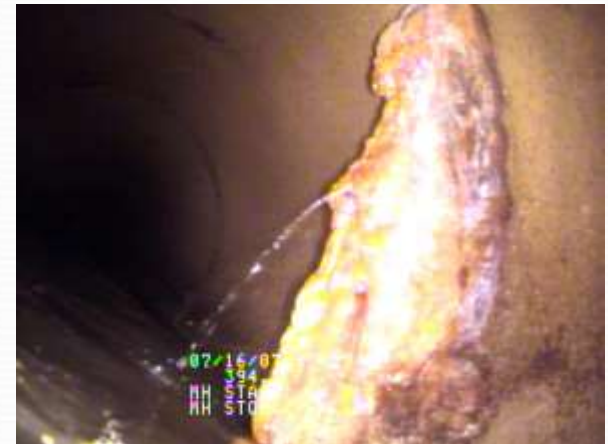
- OPERATIONAL AND MAINTENANCE ISSUES
 - LEAKING JOINTS (I/I)
 - CAPACITY REDUCING OBSTRUCTIONS
 - DEBRIS IN PIPE
- STRUCTURAL DEFECTS
 - CRACKS & FRACTURES
 - CORROSION (MIC)
 - OPEN JOINTS

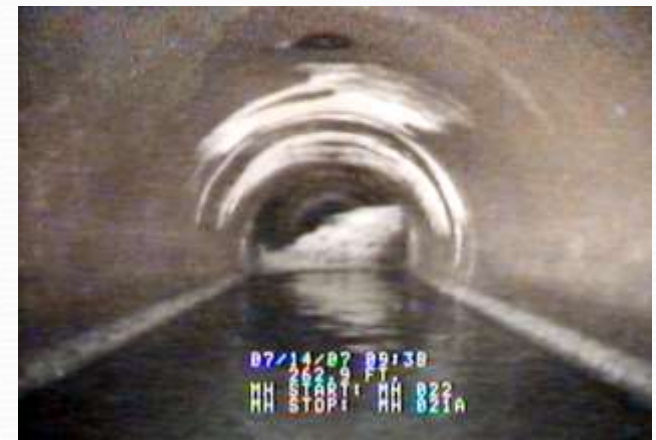
CLAGUE ROAD

- HYDROGEN SULFIDE CORROSION WAS SEEN AT ALL MAJOR TRUNK LINES (6) DUE TO DROP MANHOLES
 - 50' +/- MANHOLE
 - REMAINDER GOOD CONDITION

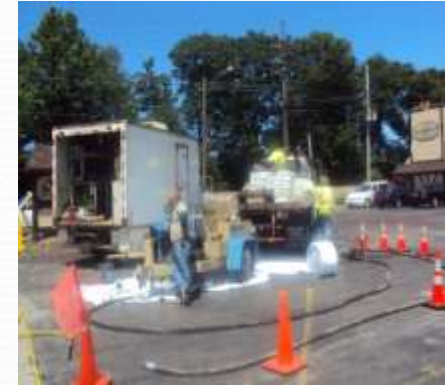
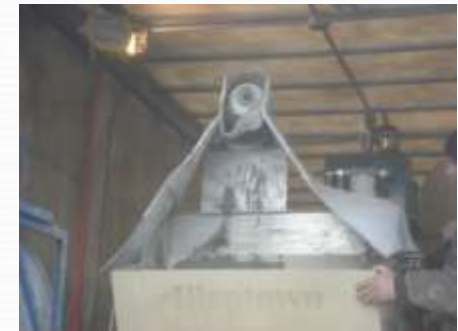
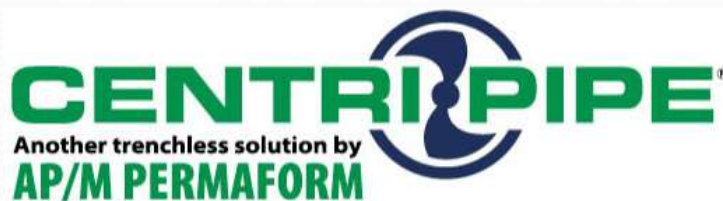
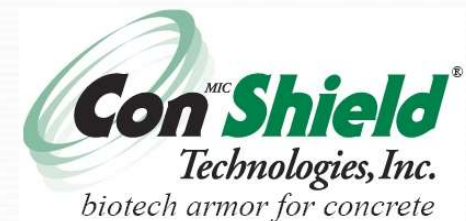
CCCP REHABILITATION

- TWO MOBILE BATCH PLANTS USED
- SPIN CAST MIX
 - PERMACAST PL-8000 – DRY MIX
 - CONSHIELD
 - WATER
 - AP/M PERMAFORM

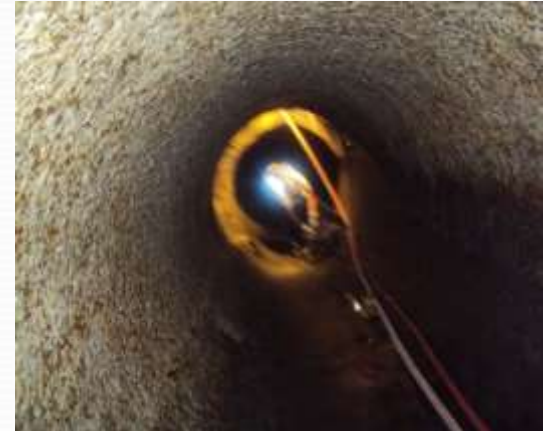
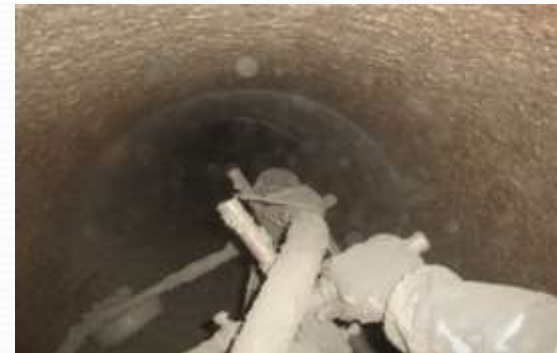
CCCP REHABILITATION

- SPIN CASTER
 - AIR LINE
 - PRODUCT LINE
- OPERATOR AT SPIN CASTER TO CONTROL APPLICATION RATE
- WINCH OPERATOR NEAR MANHOLE TO CONTROL RETRIVAL SPEED OF SPIN CASTER
- ID / CURING COAT APPLIED LATER

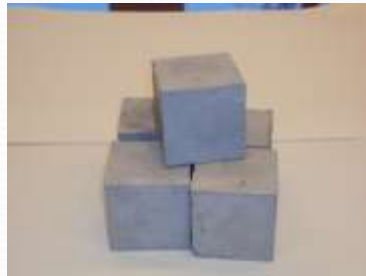
CCCCP TEST RESULTS

- COMPRESSIVE STRENGTH TESTING
- ASTM C 109
- FLOW WAS RESUMED UNDER 24 HOURS WITH A MINIMUM 2,300 PSI BREAK

1 DAY	2 DAY	3 DAY	28 DAY
AVG. BREAK (PSI)	3,160	4,865	6,246	8,037
