**Concrete Restoration at the Columbus
Southerly WWTP**

June 16, 2010

**Bill Johngrass, P.E. – Project Manager
URS Corporation**

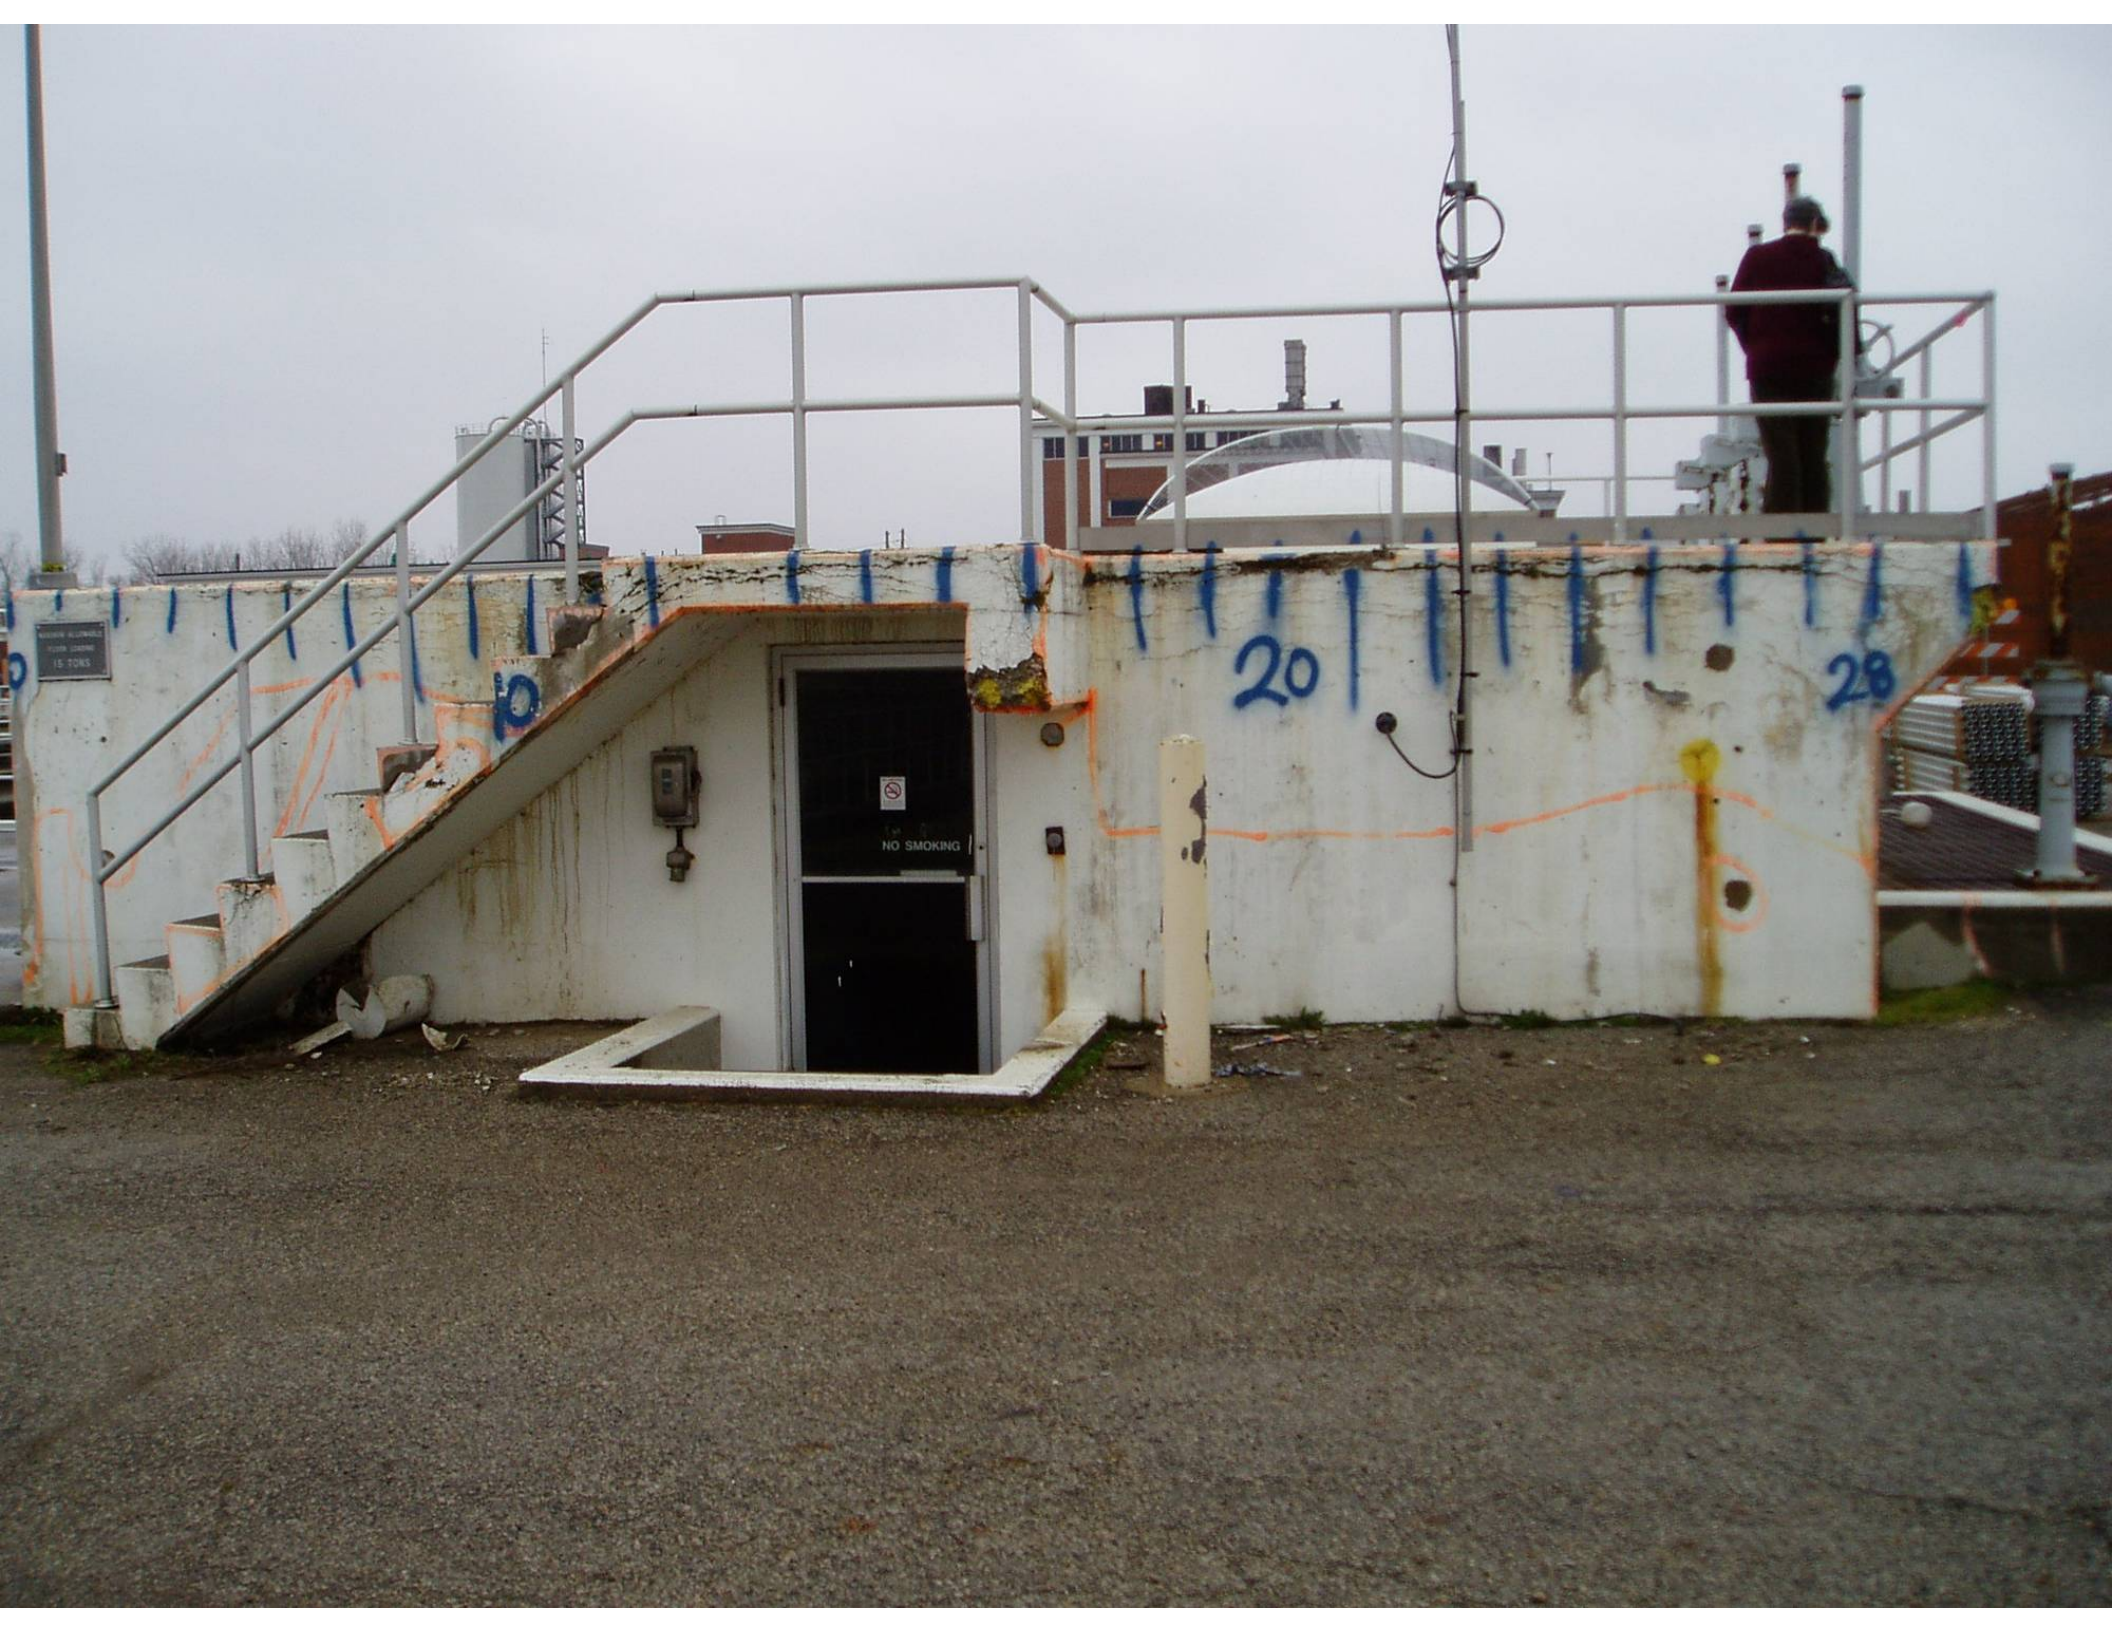
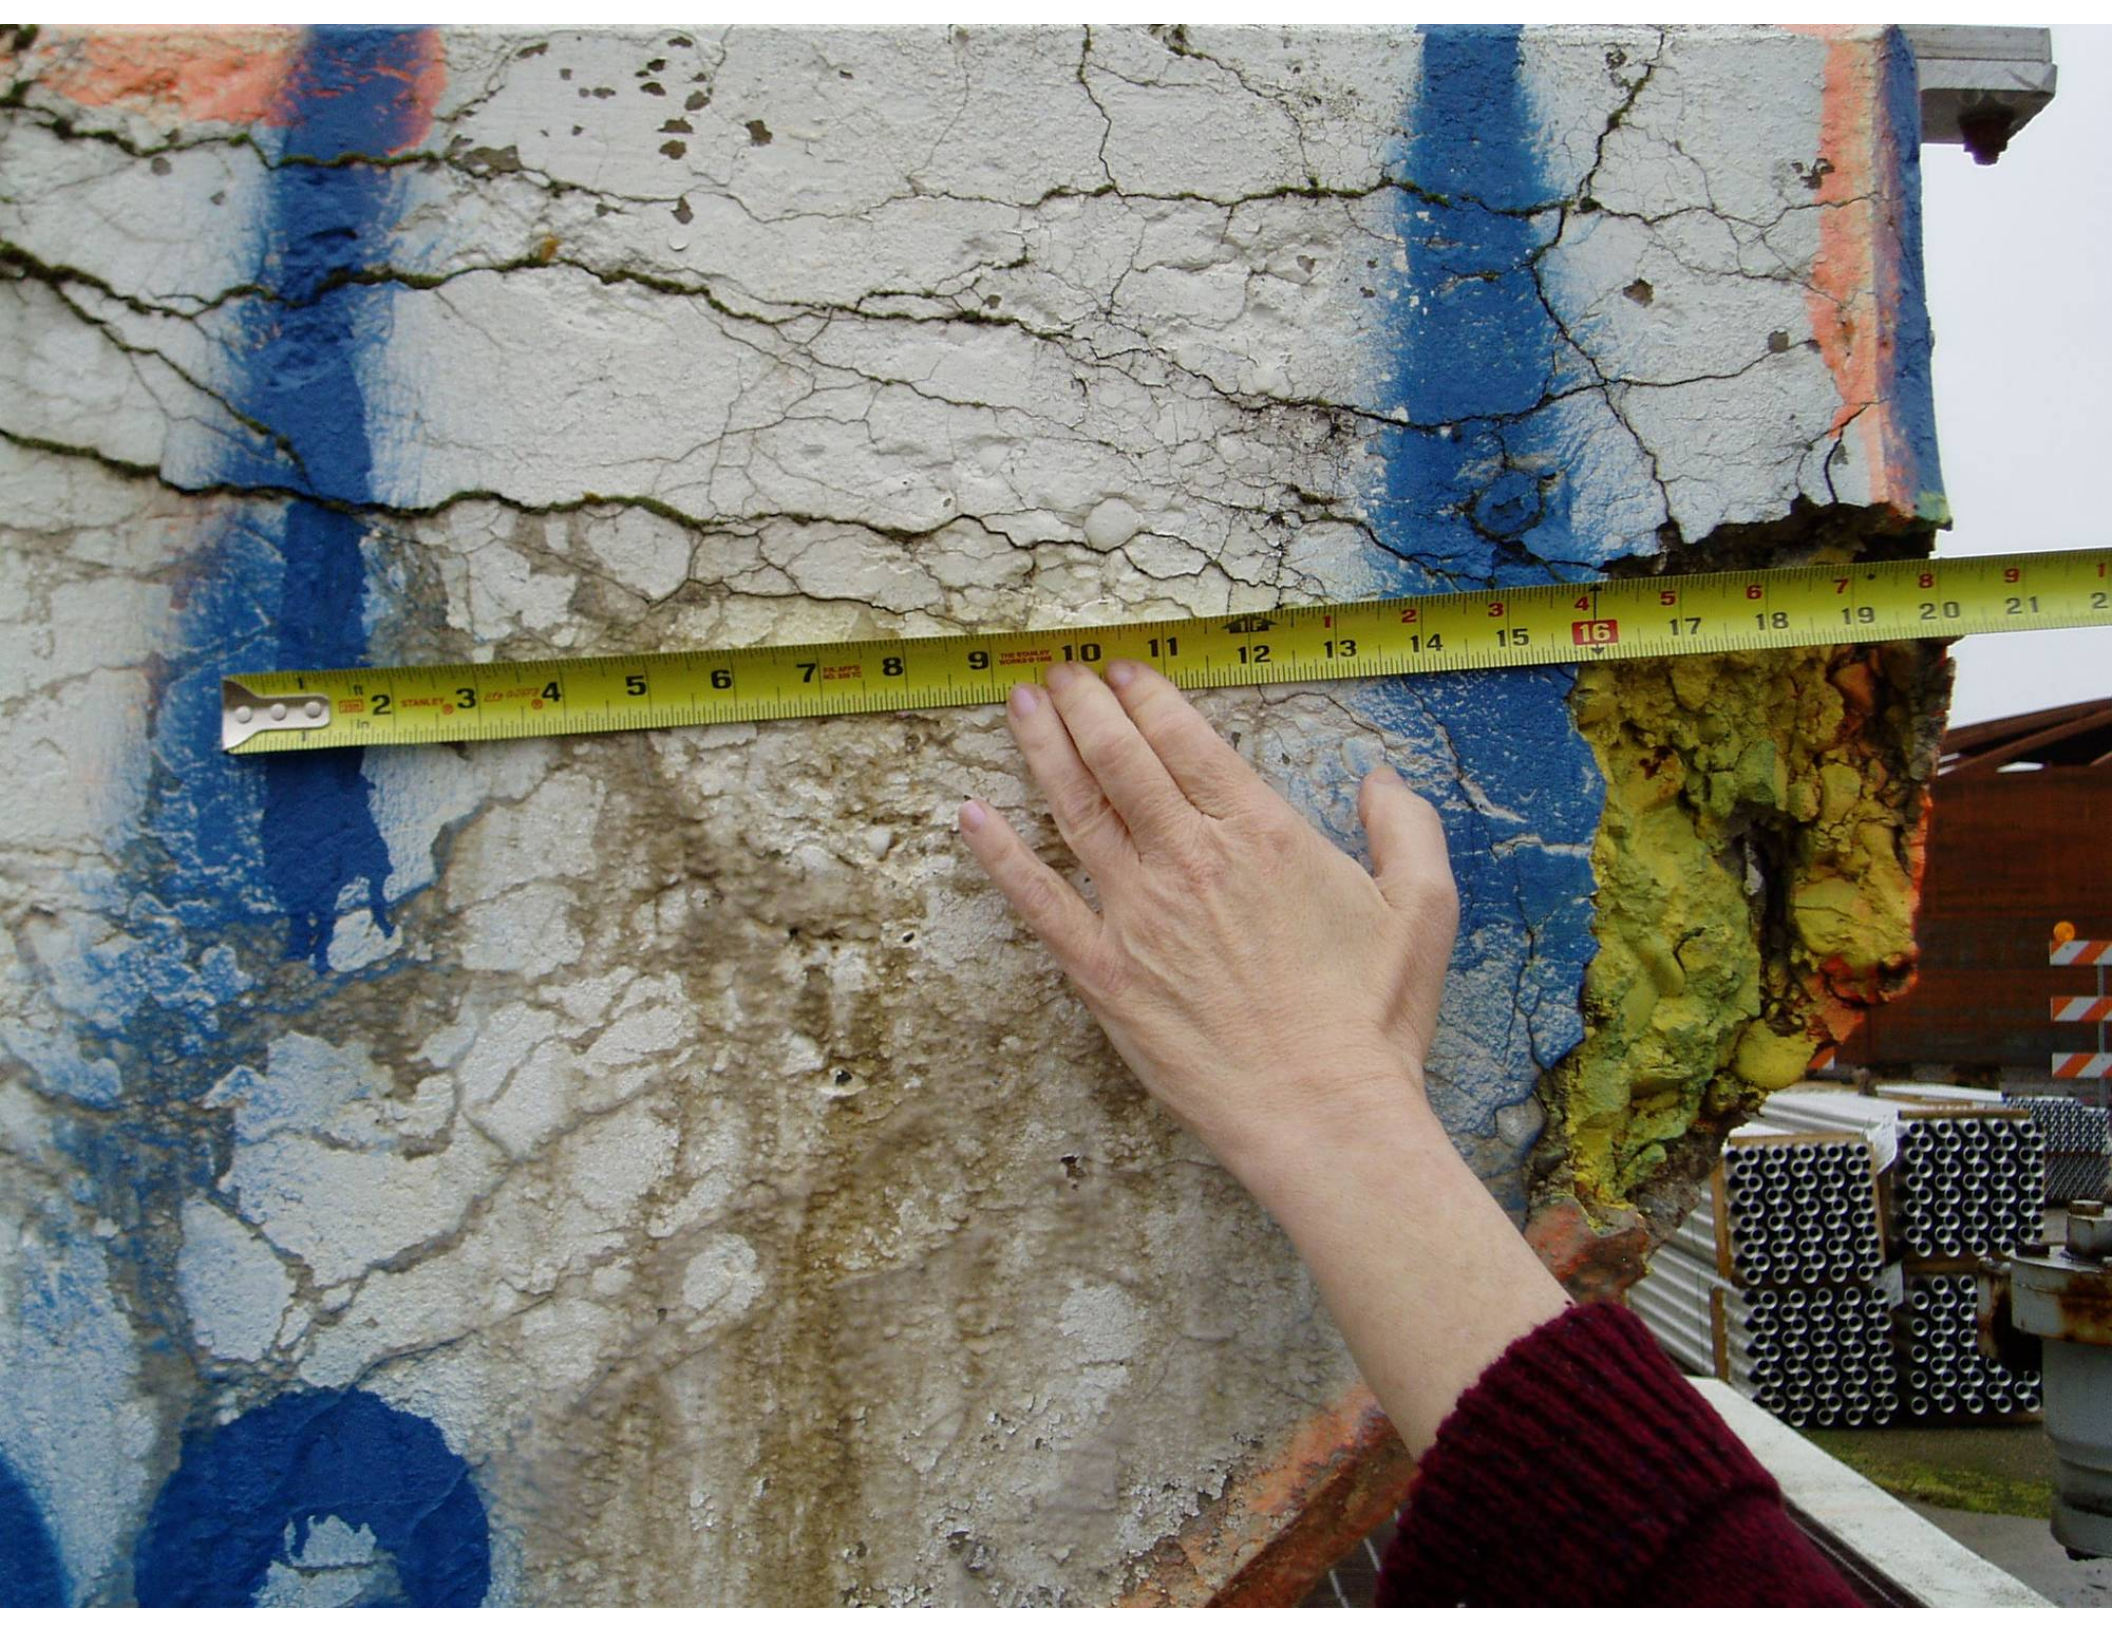
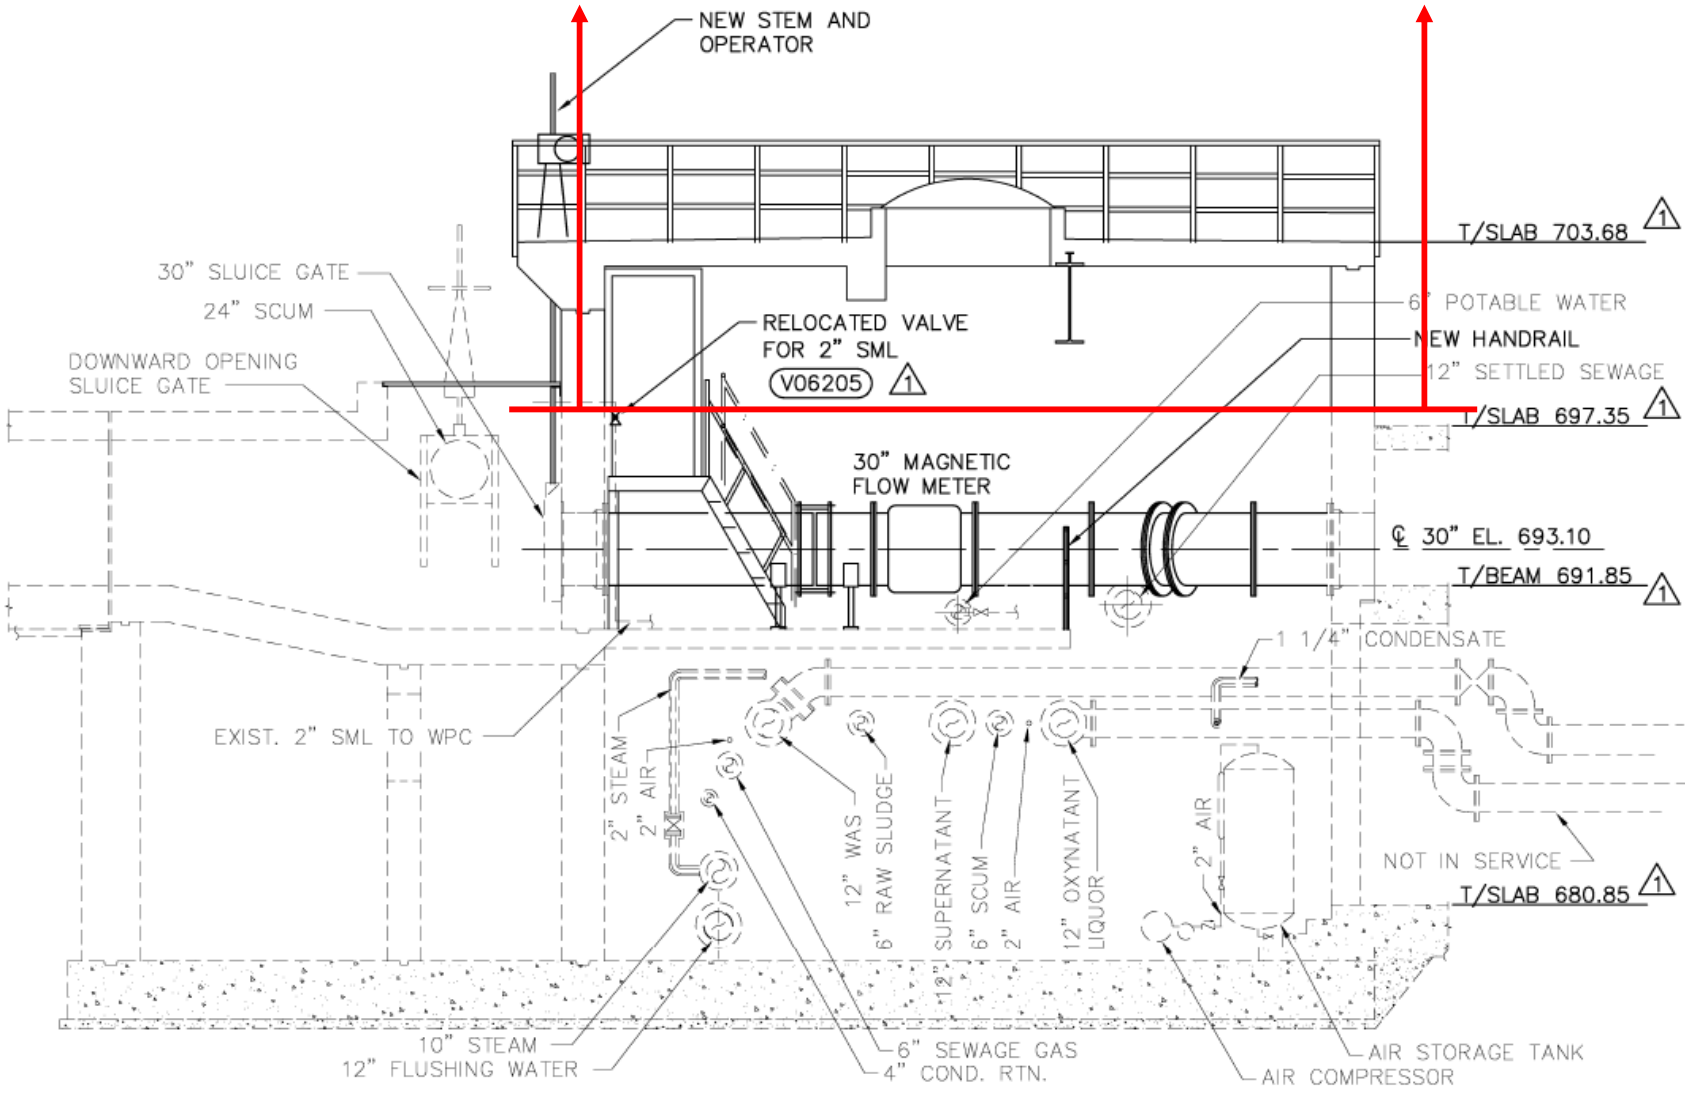
West Primary Metering Chamber Condition

- Concrete Walls and Roof in Poor Condition
- Below Grade Walls (Part of Tunnel System) in Good Condition
- Recommendation to Rebuild Structure
- Due to Construction Sequencing, the Piping (Supported from the Ceiling) Had to Remain in Service During the Structure Replacement

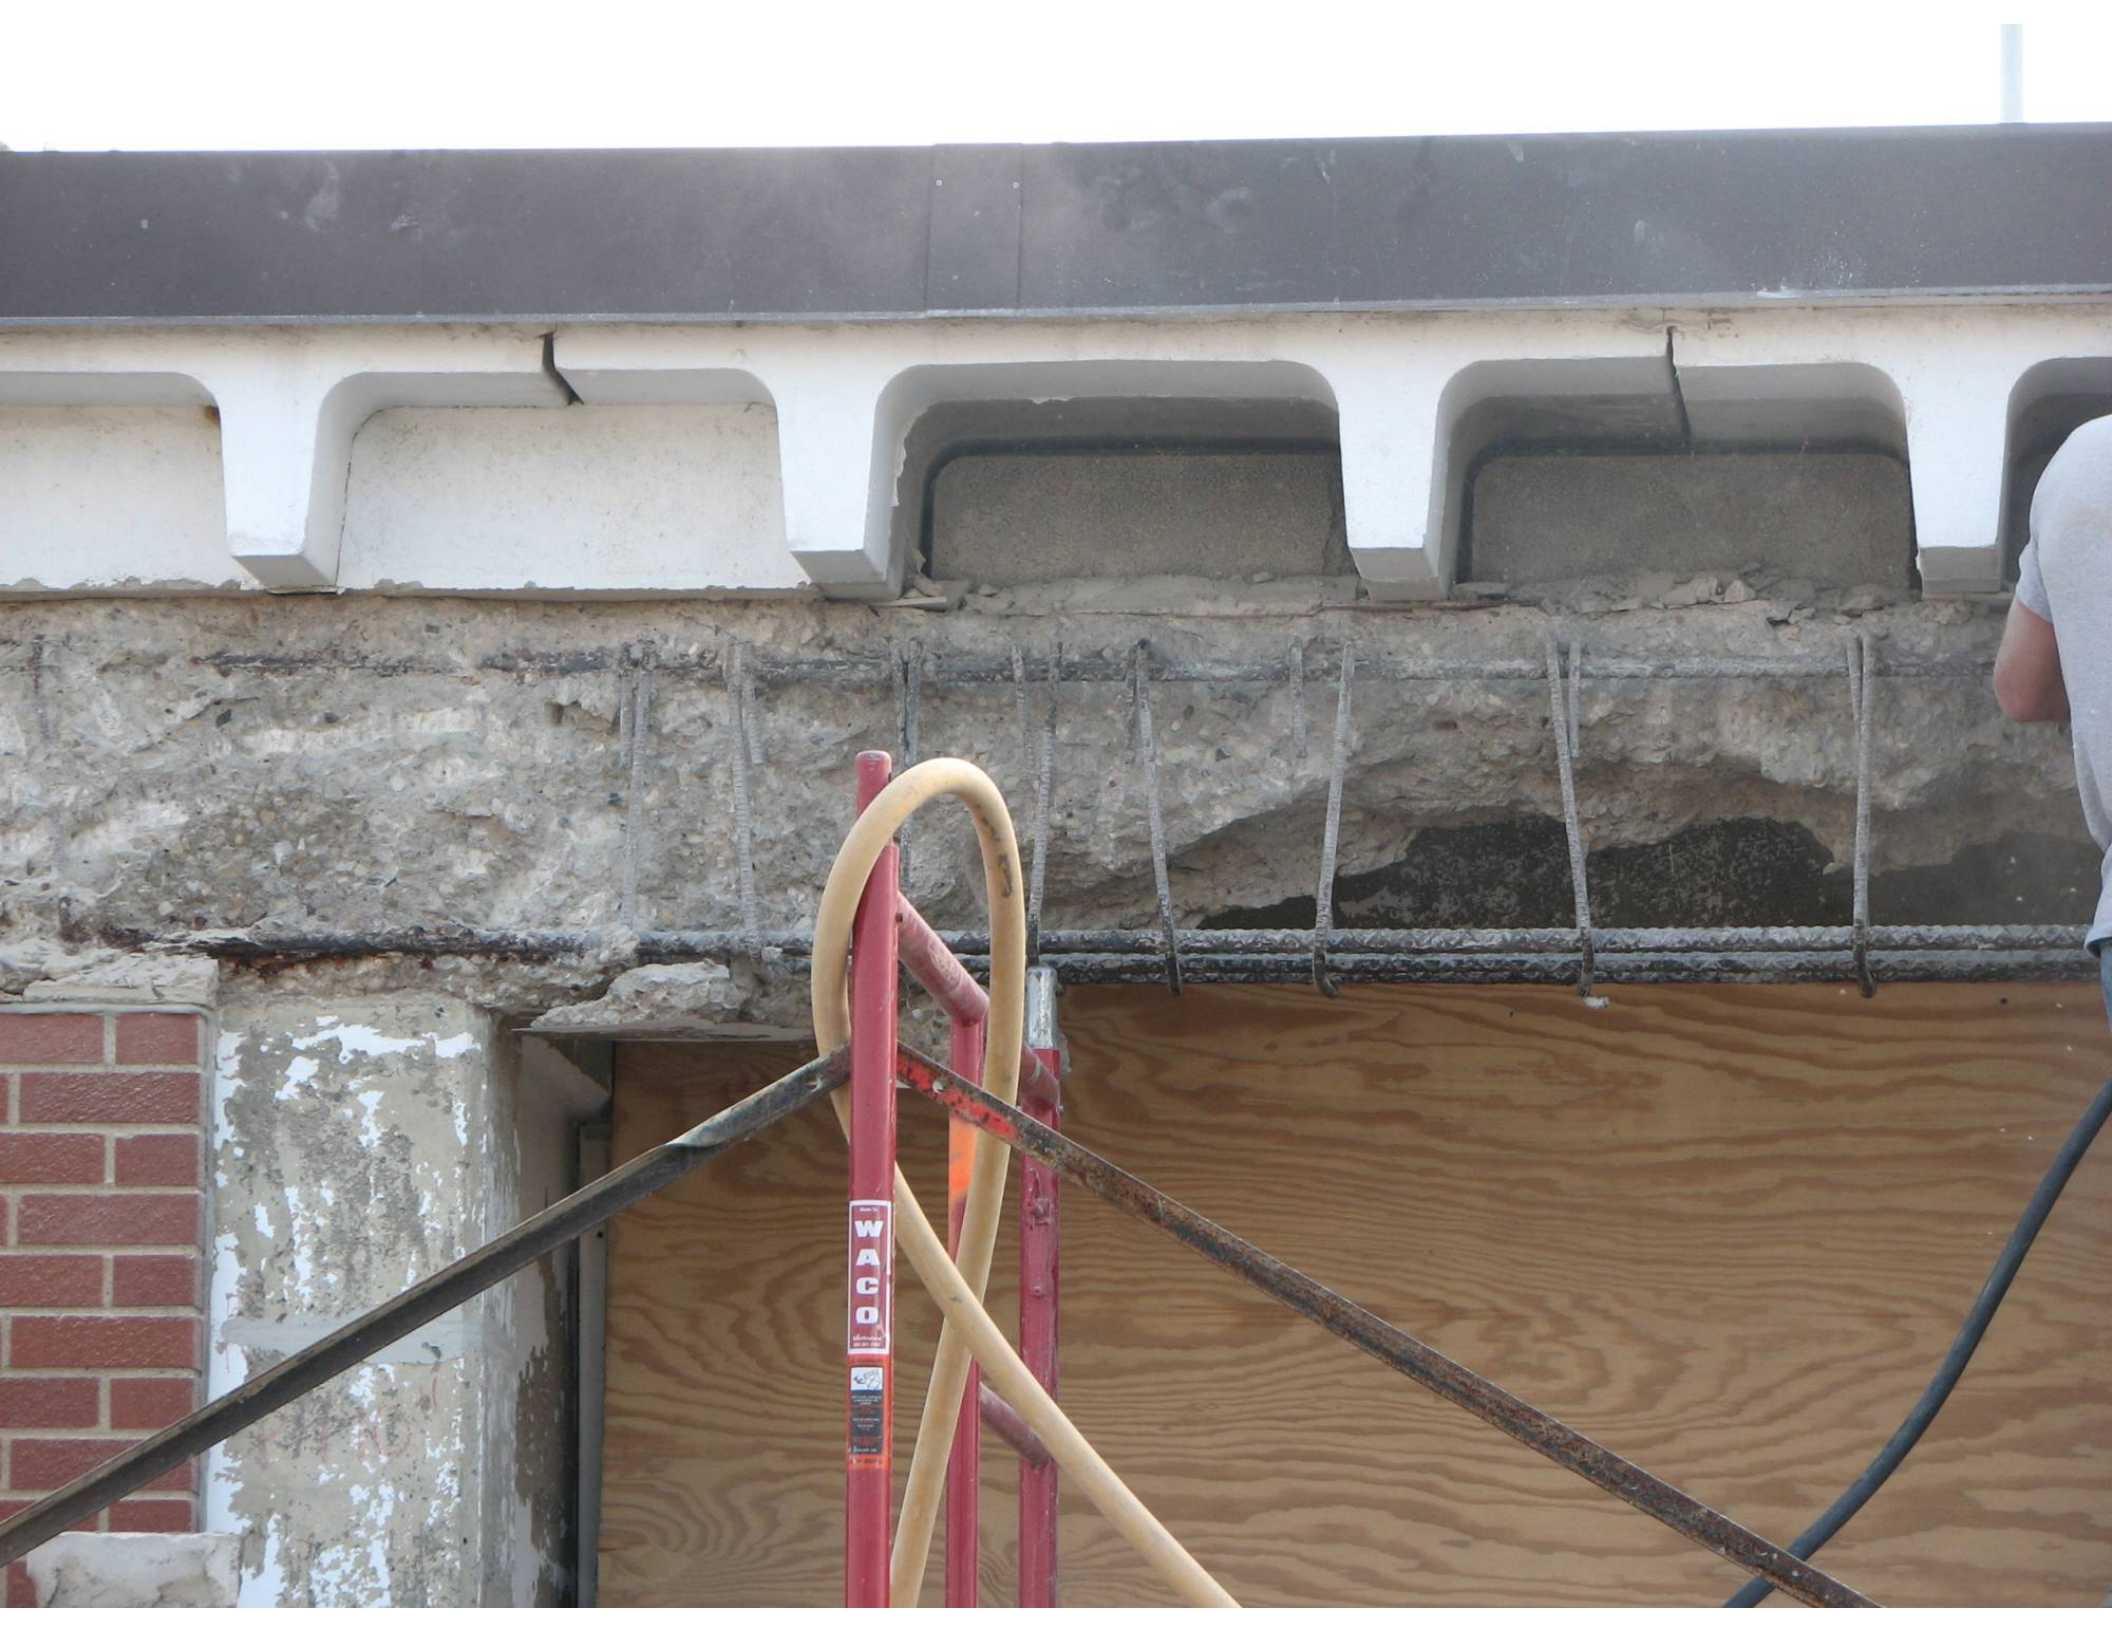
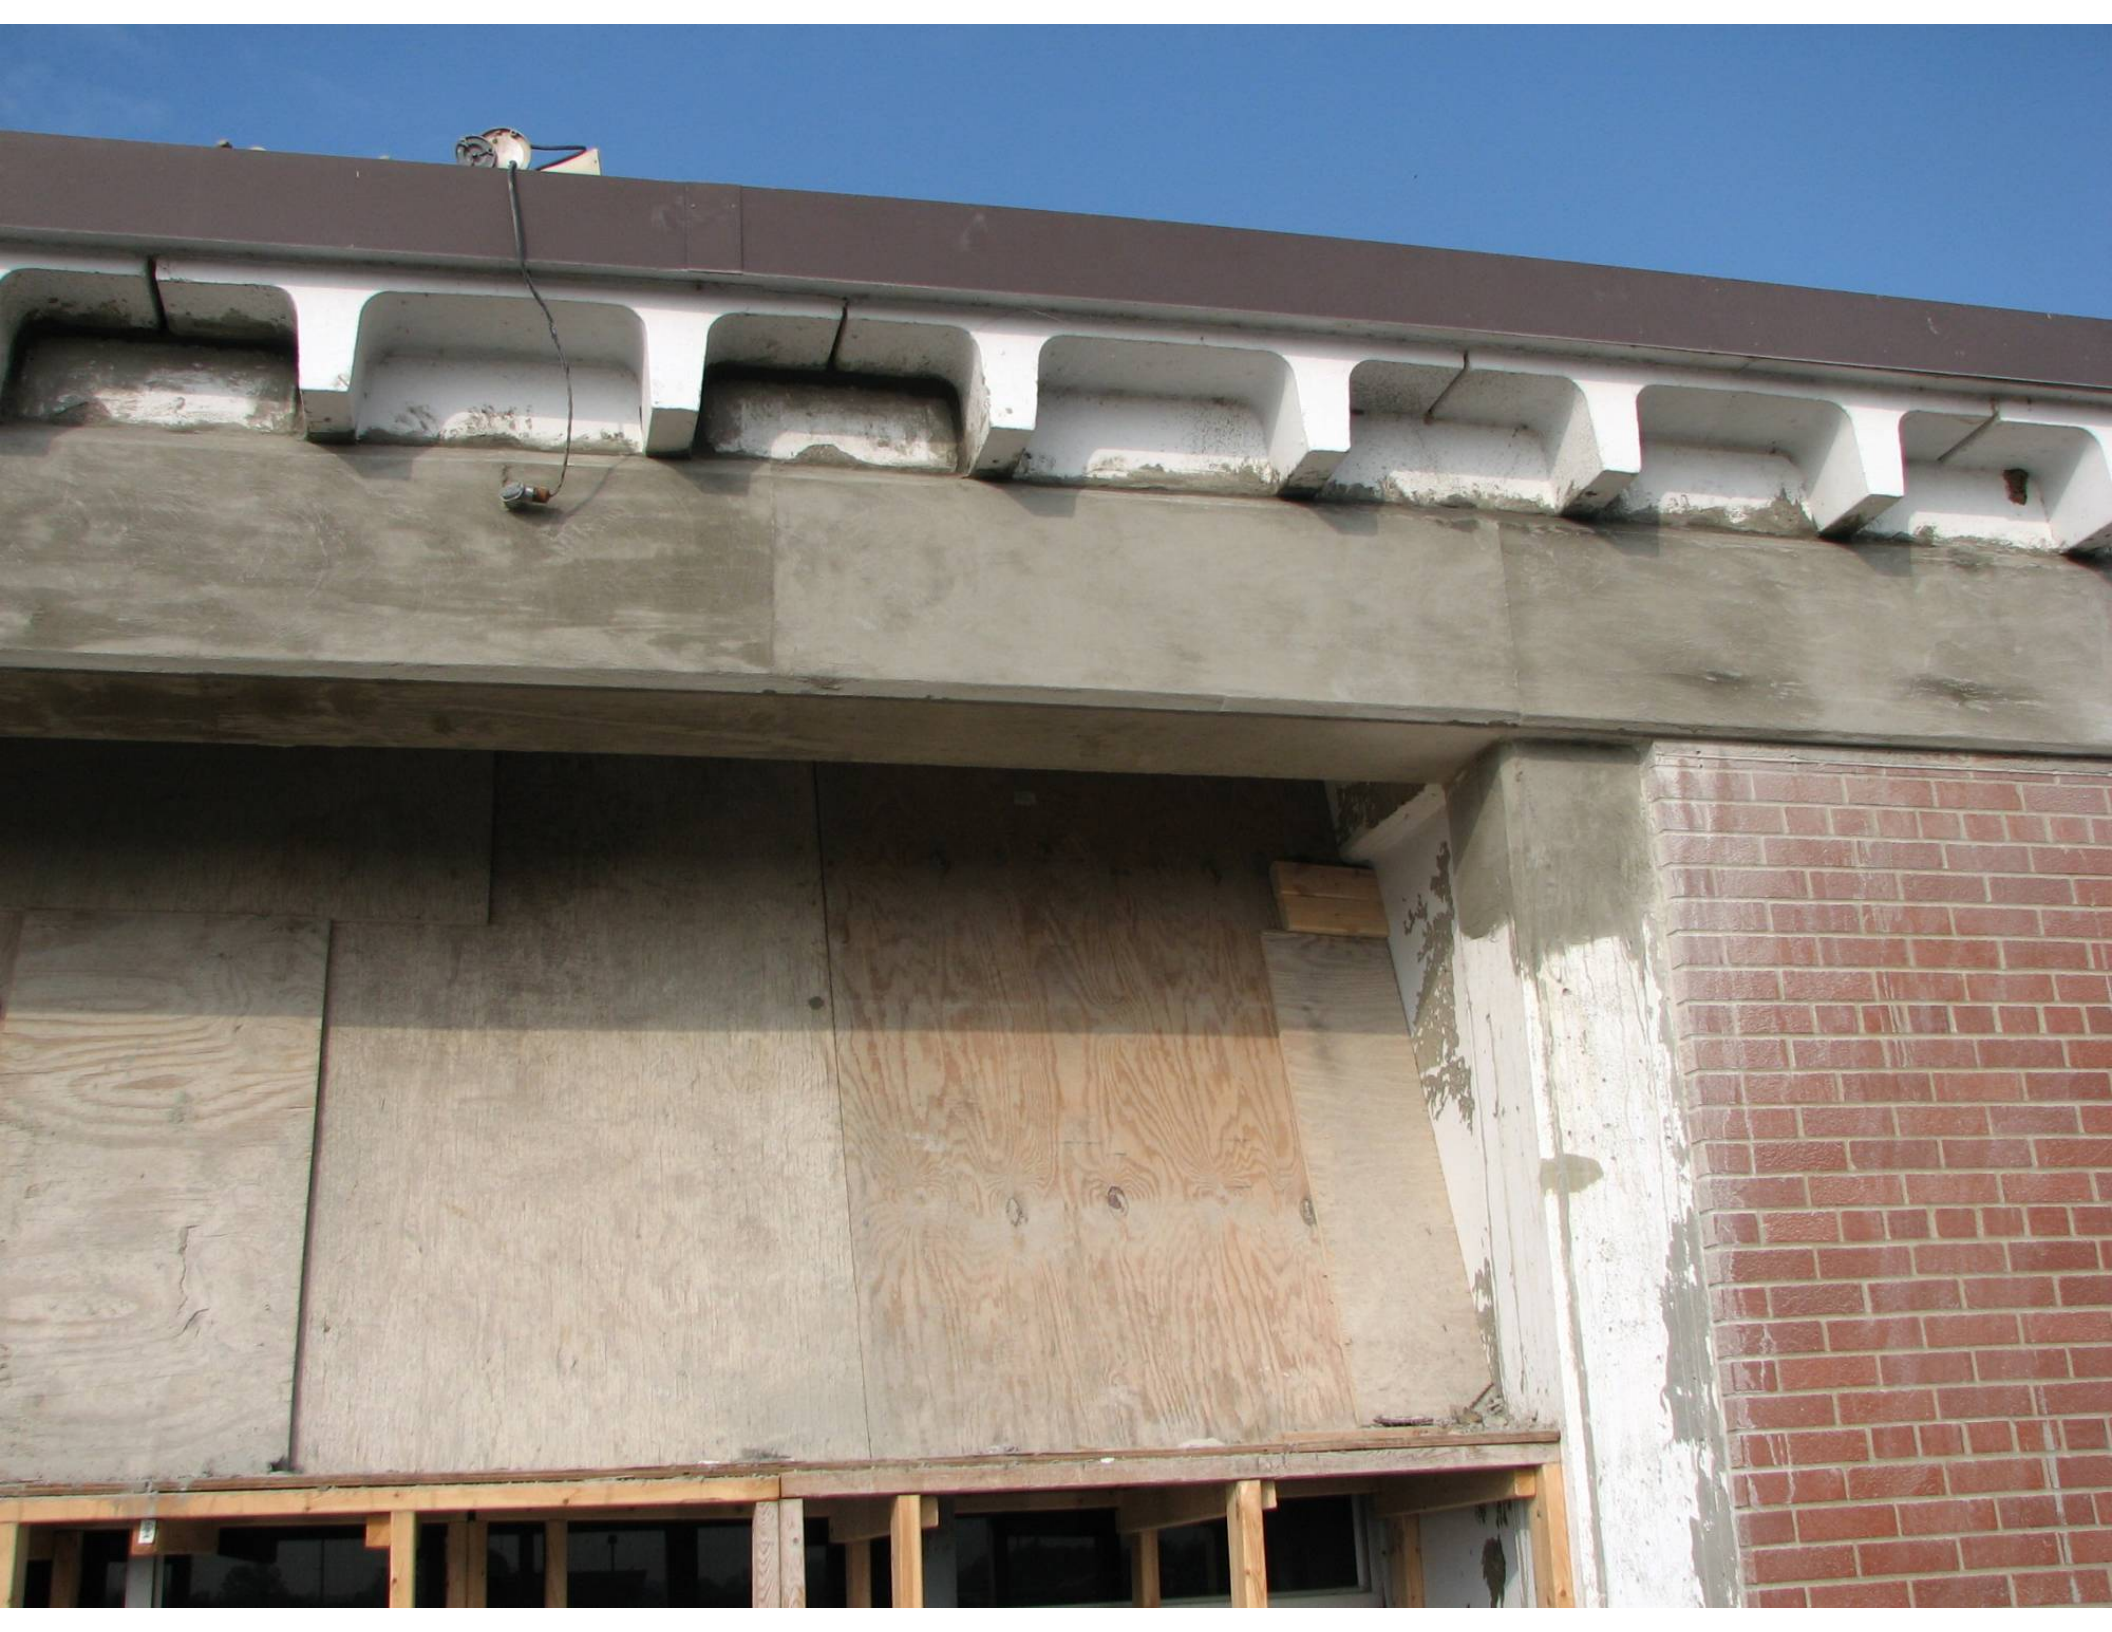
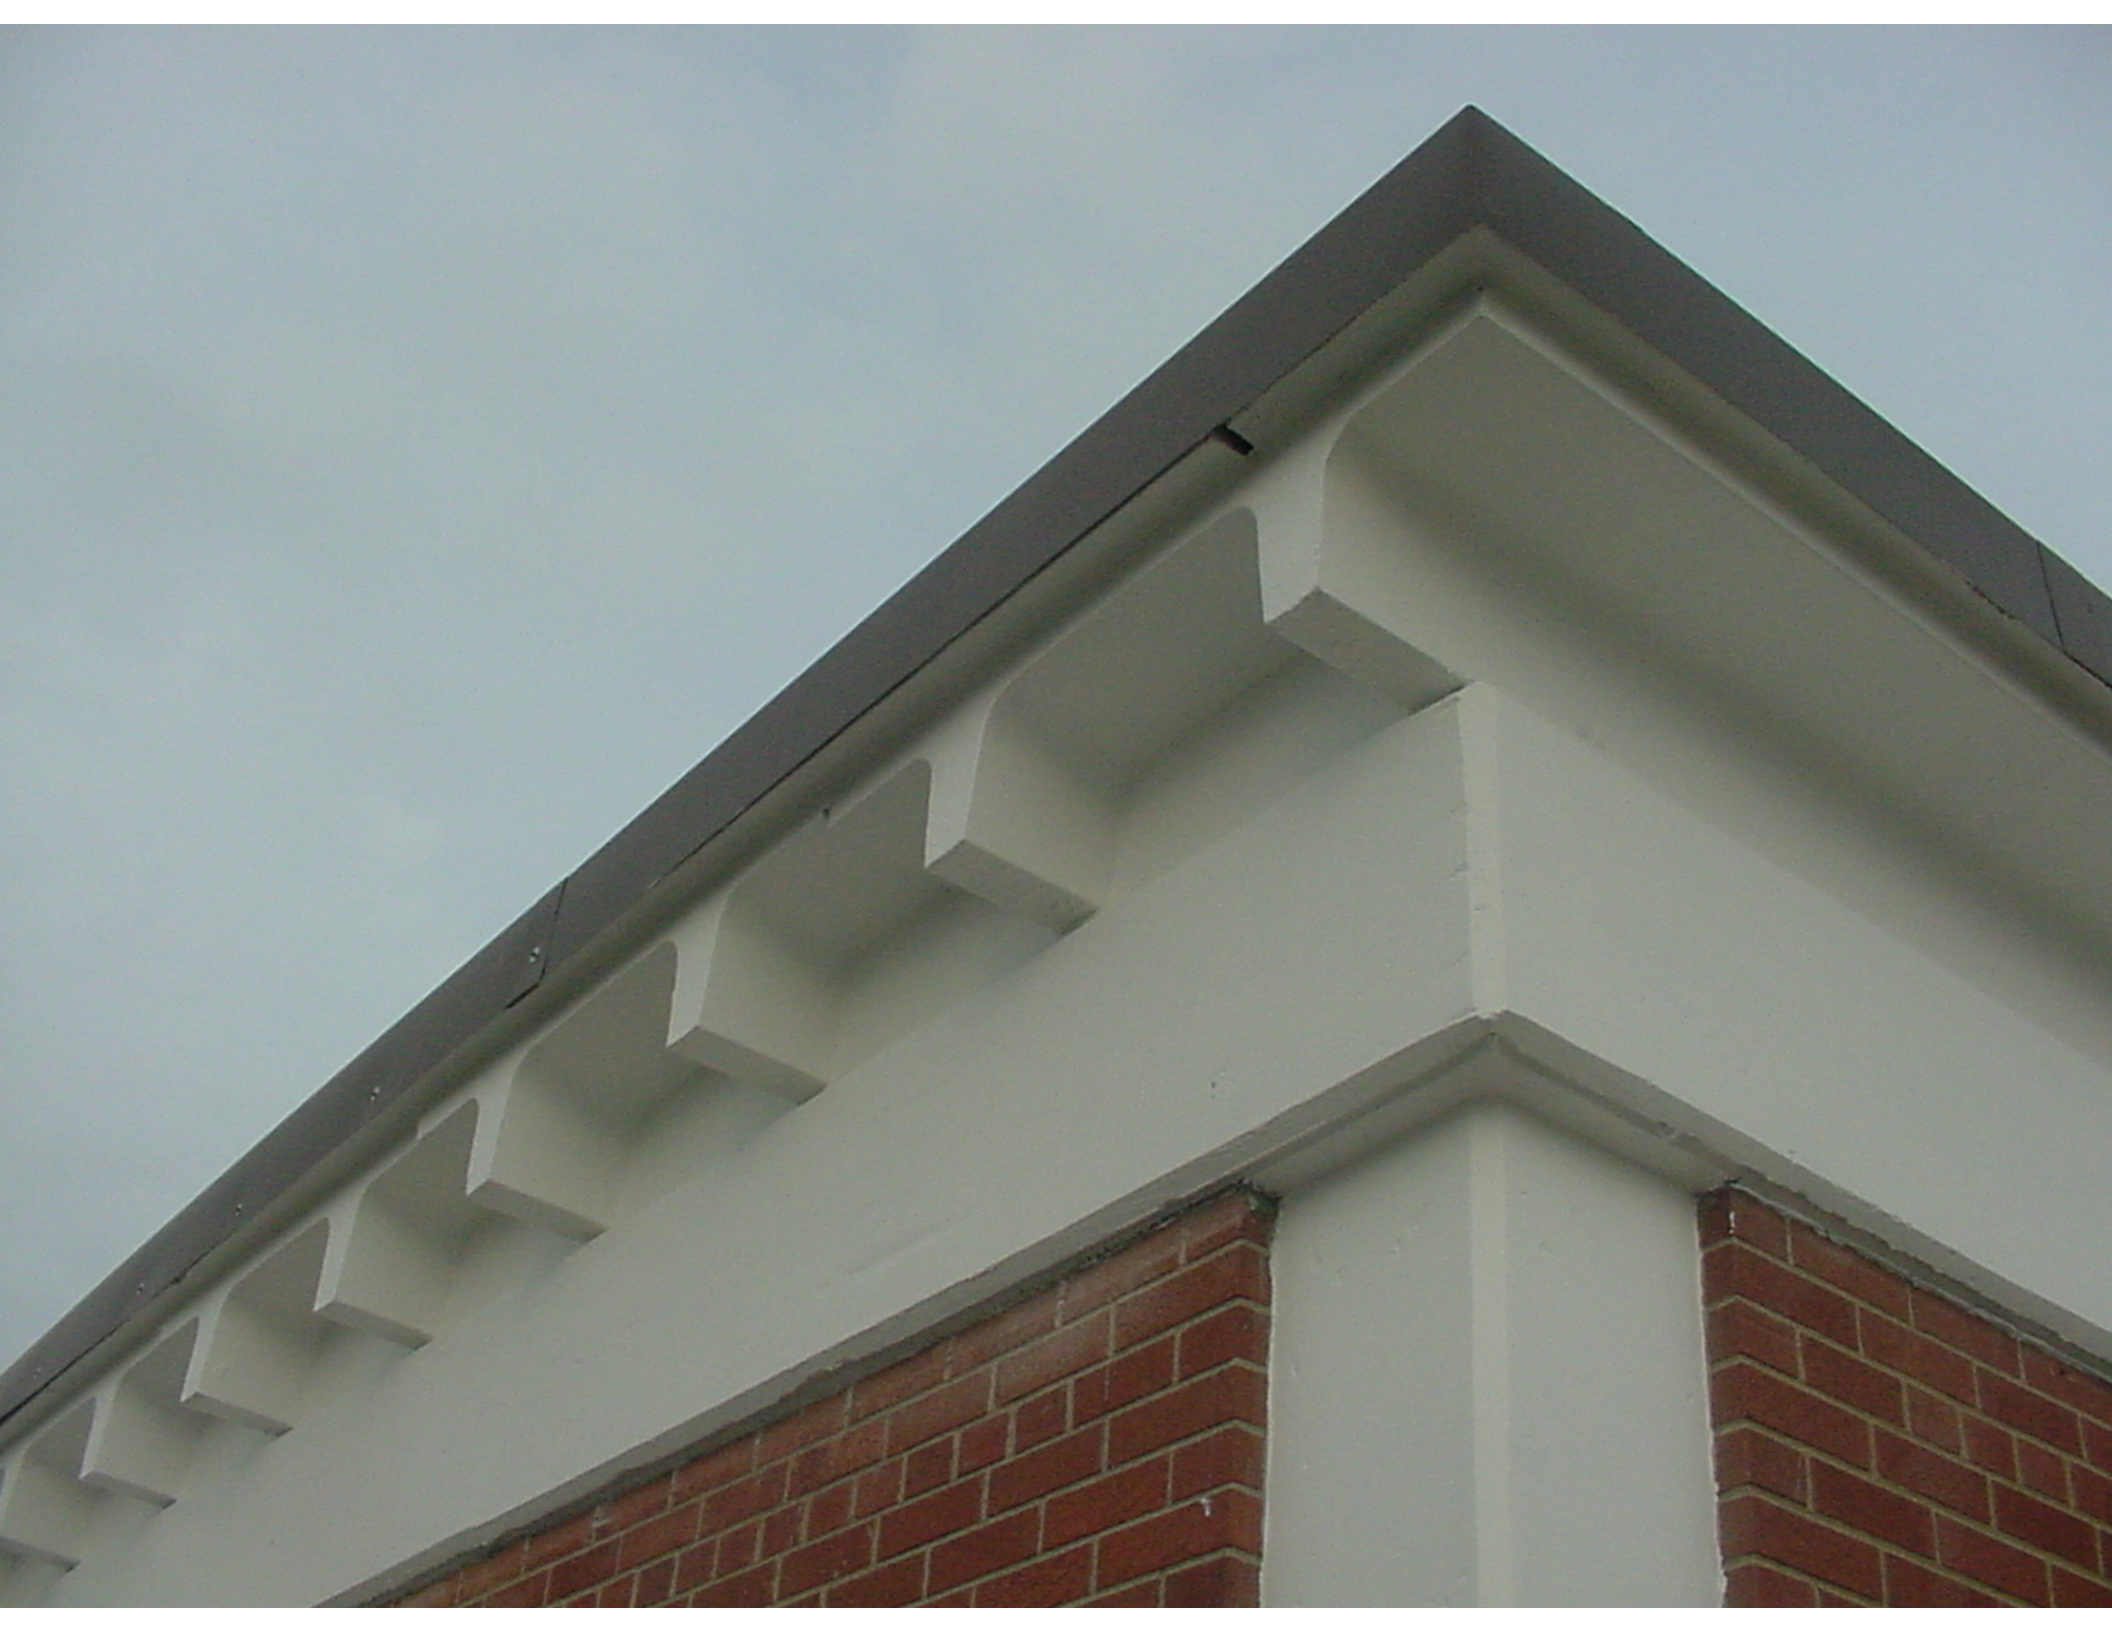
West Primary Control Building

- Significant Concrete Deterioration on the Exterior Beams and Columns
