**Concrete Restoration at the Columbus
Southerly WWTP**

June 16, 2010

**Bill Johngrass, P.E. – Project Manager
URS Corporation**

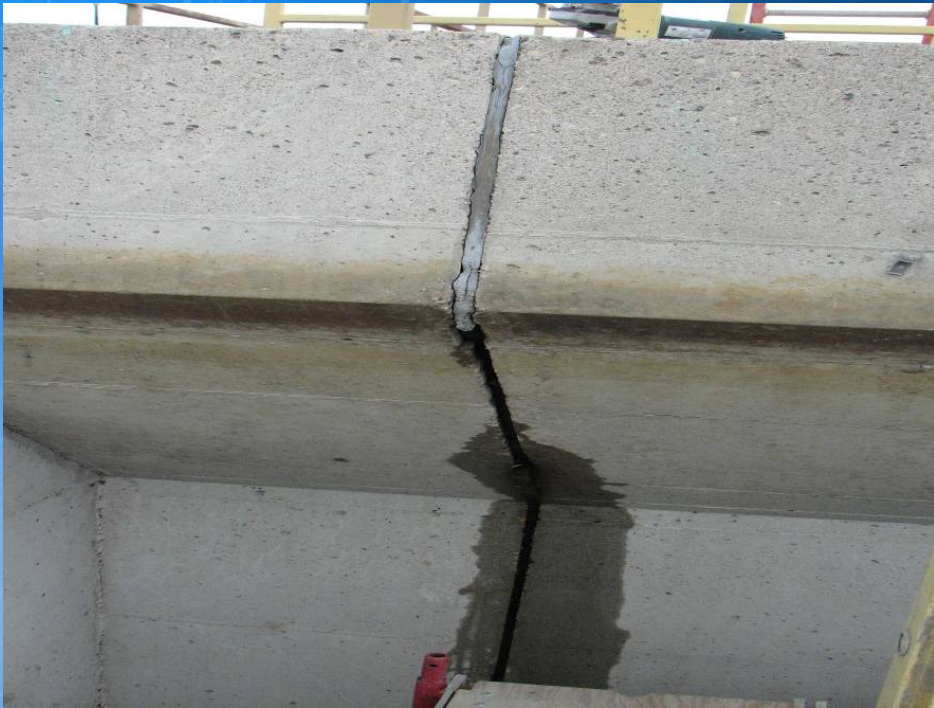
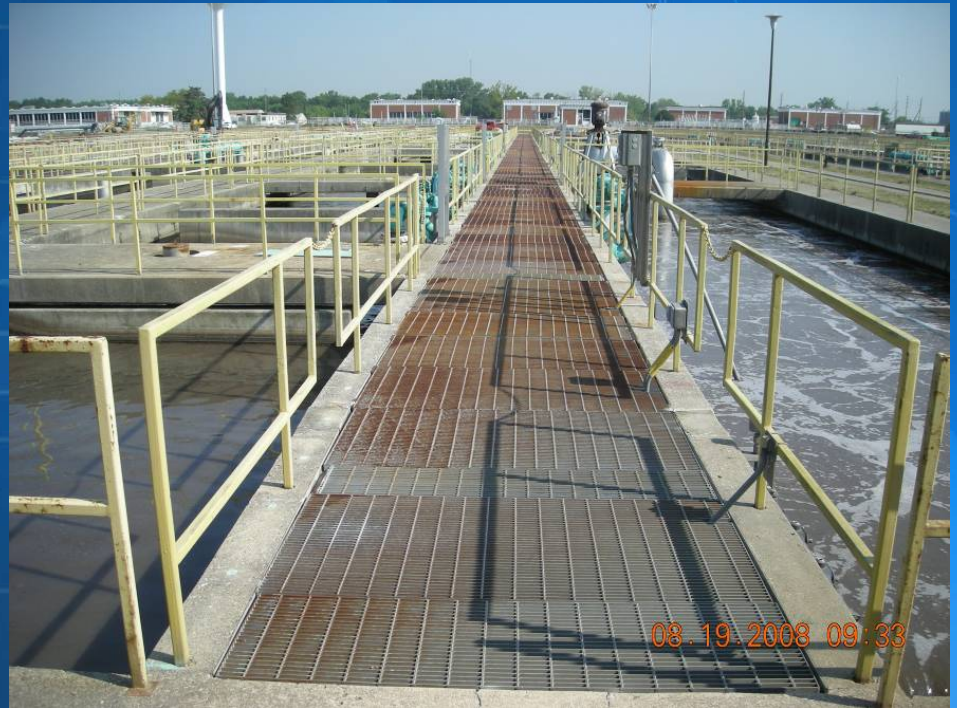
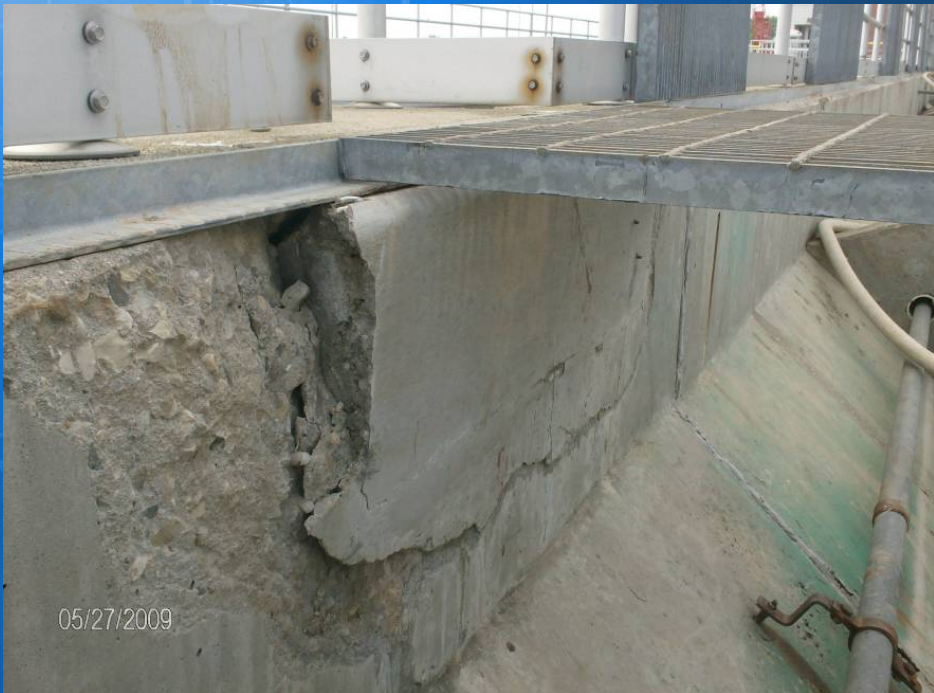
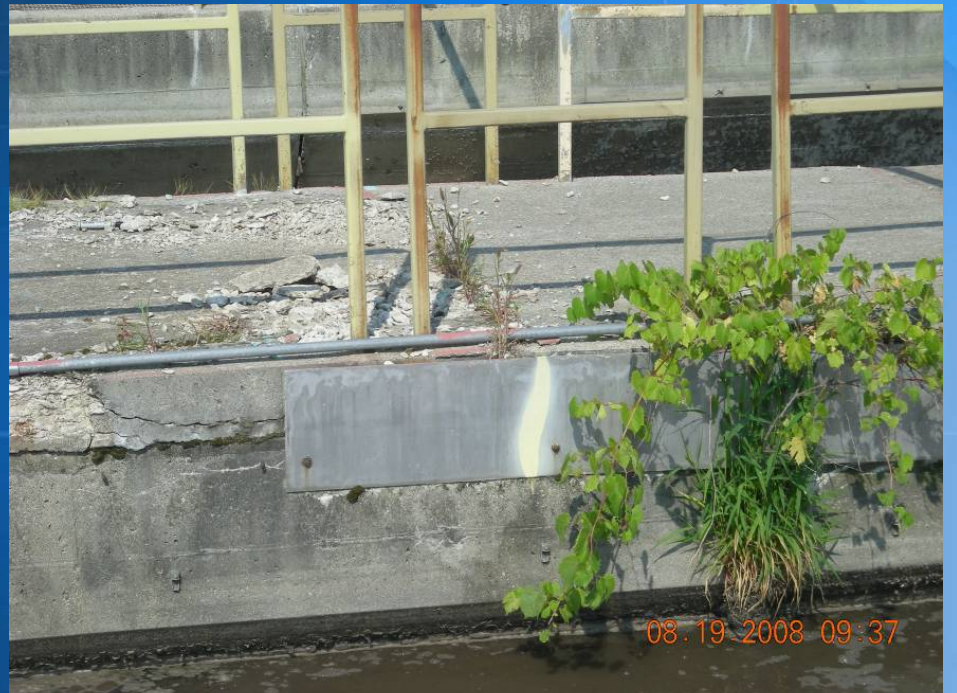
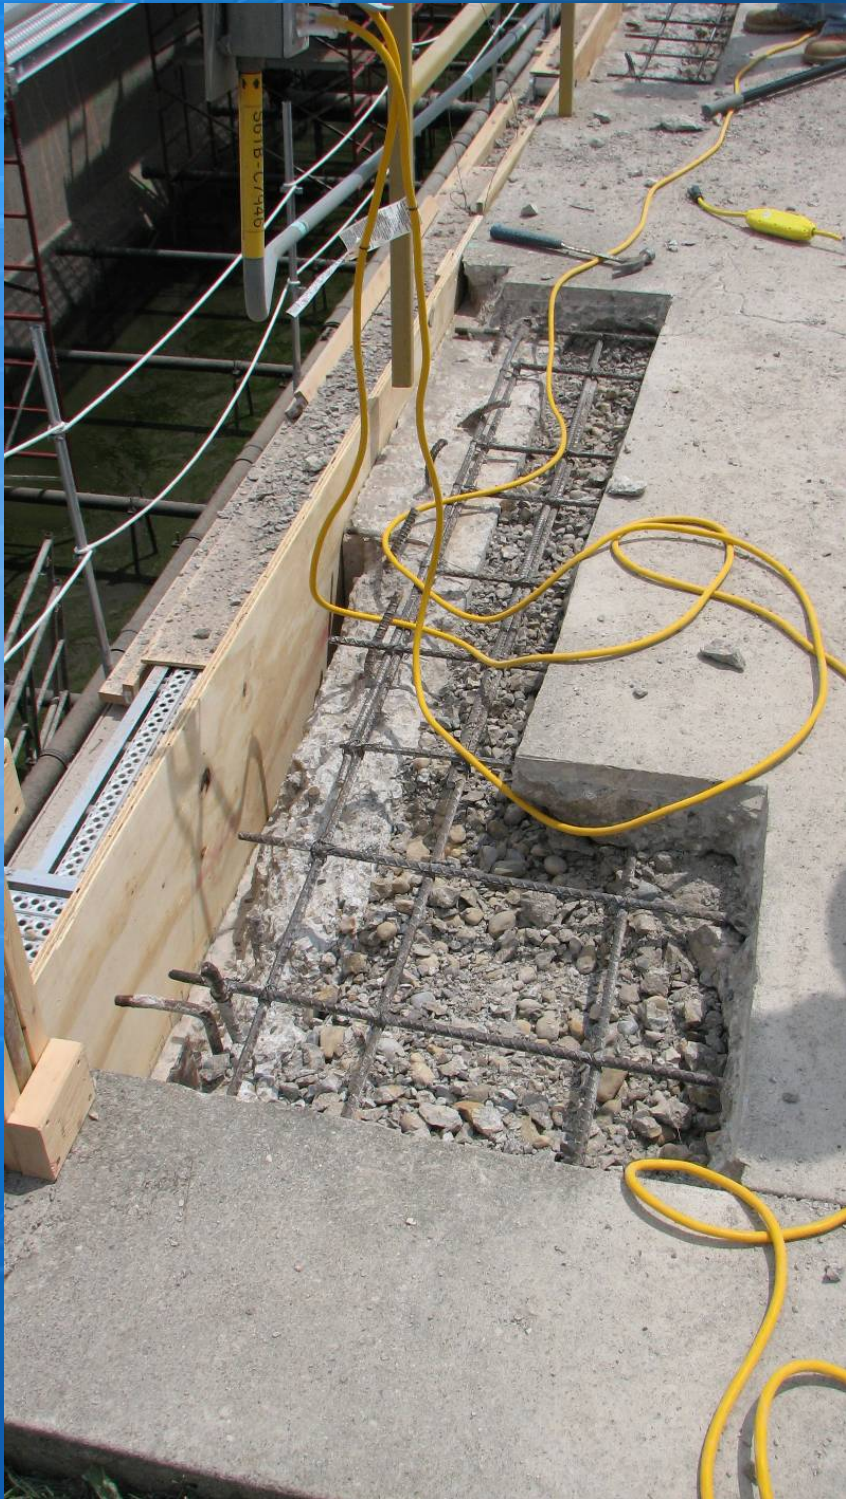
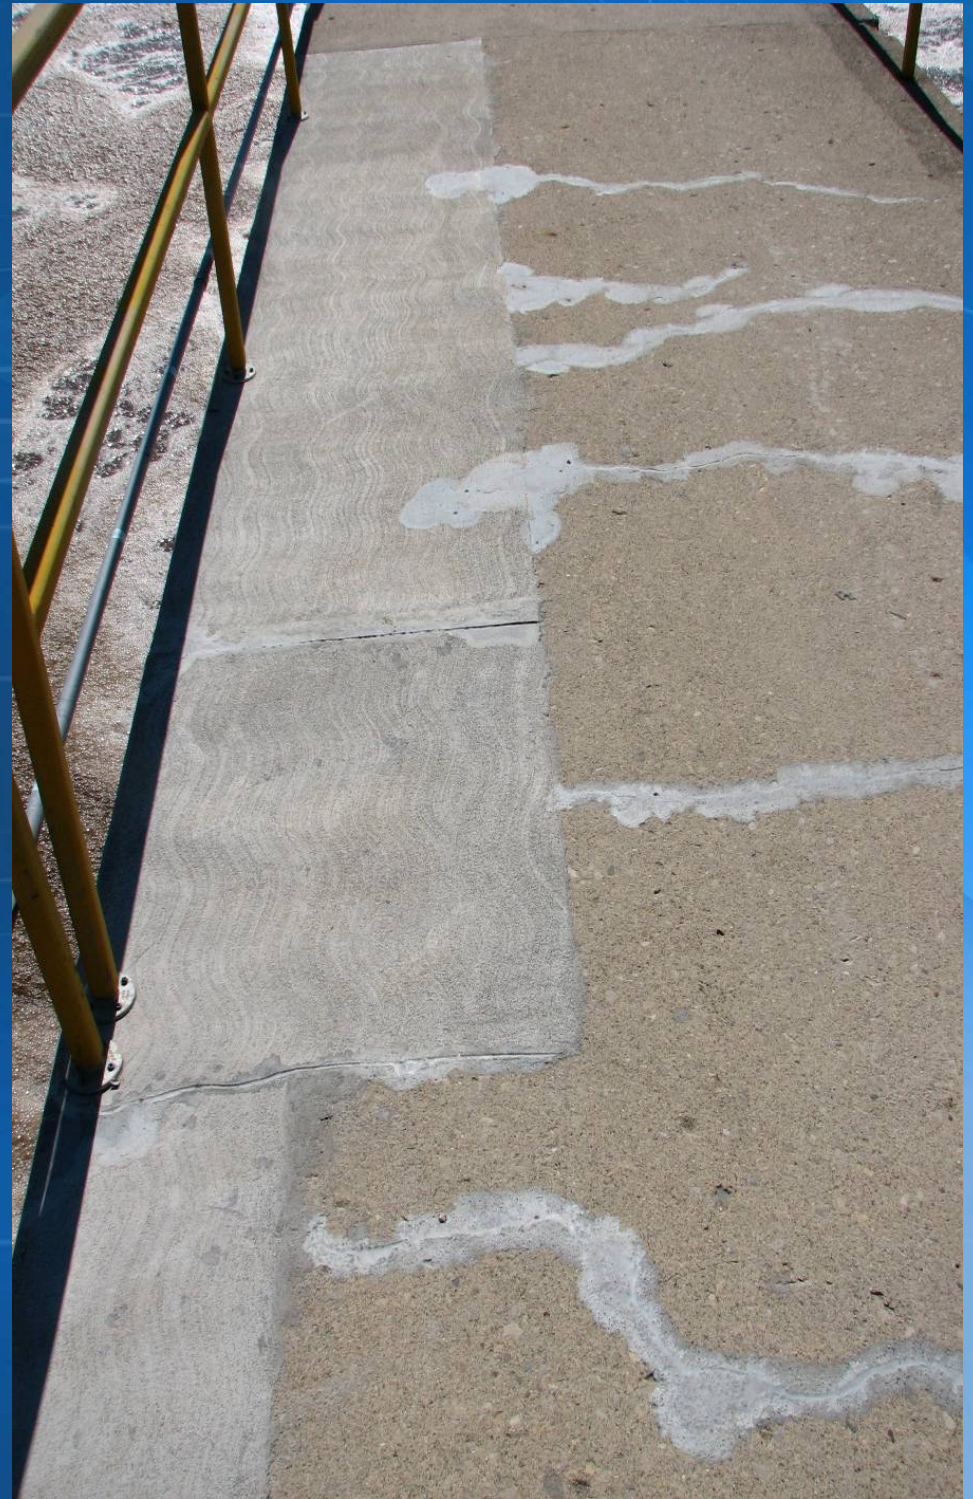
- Aeration Tank Rehabilitation
 - Center Train (Circa 1968) Had Significant Freeze-Thaw Damage Above the Water Line
 - Repairs Included the Following:
 - Replacement of Steel Handrail with Aluminum
 - Replacement of Galvanized Grating
 - Repair Expansion Joints
 - Crack/Spall Repairs and Slab Replacement
