## Managing the Useful Life of Your Segmented Block Combined Sewer

Dianne M. Sumego, PE  
June 28, 2017

**Sewer Condition Assessment for Lima, OH**  
**S Metcalf St & Lake St**  
 Inspection Area 9  
 105015

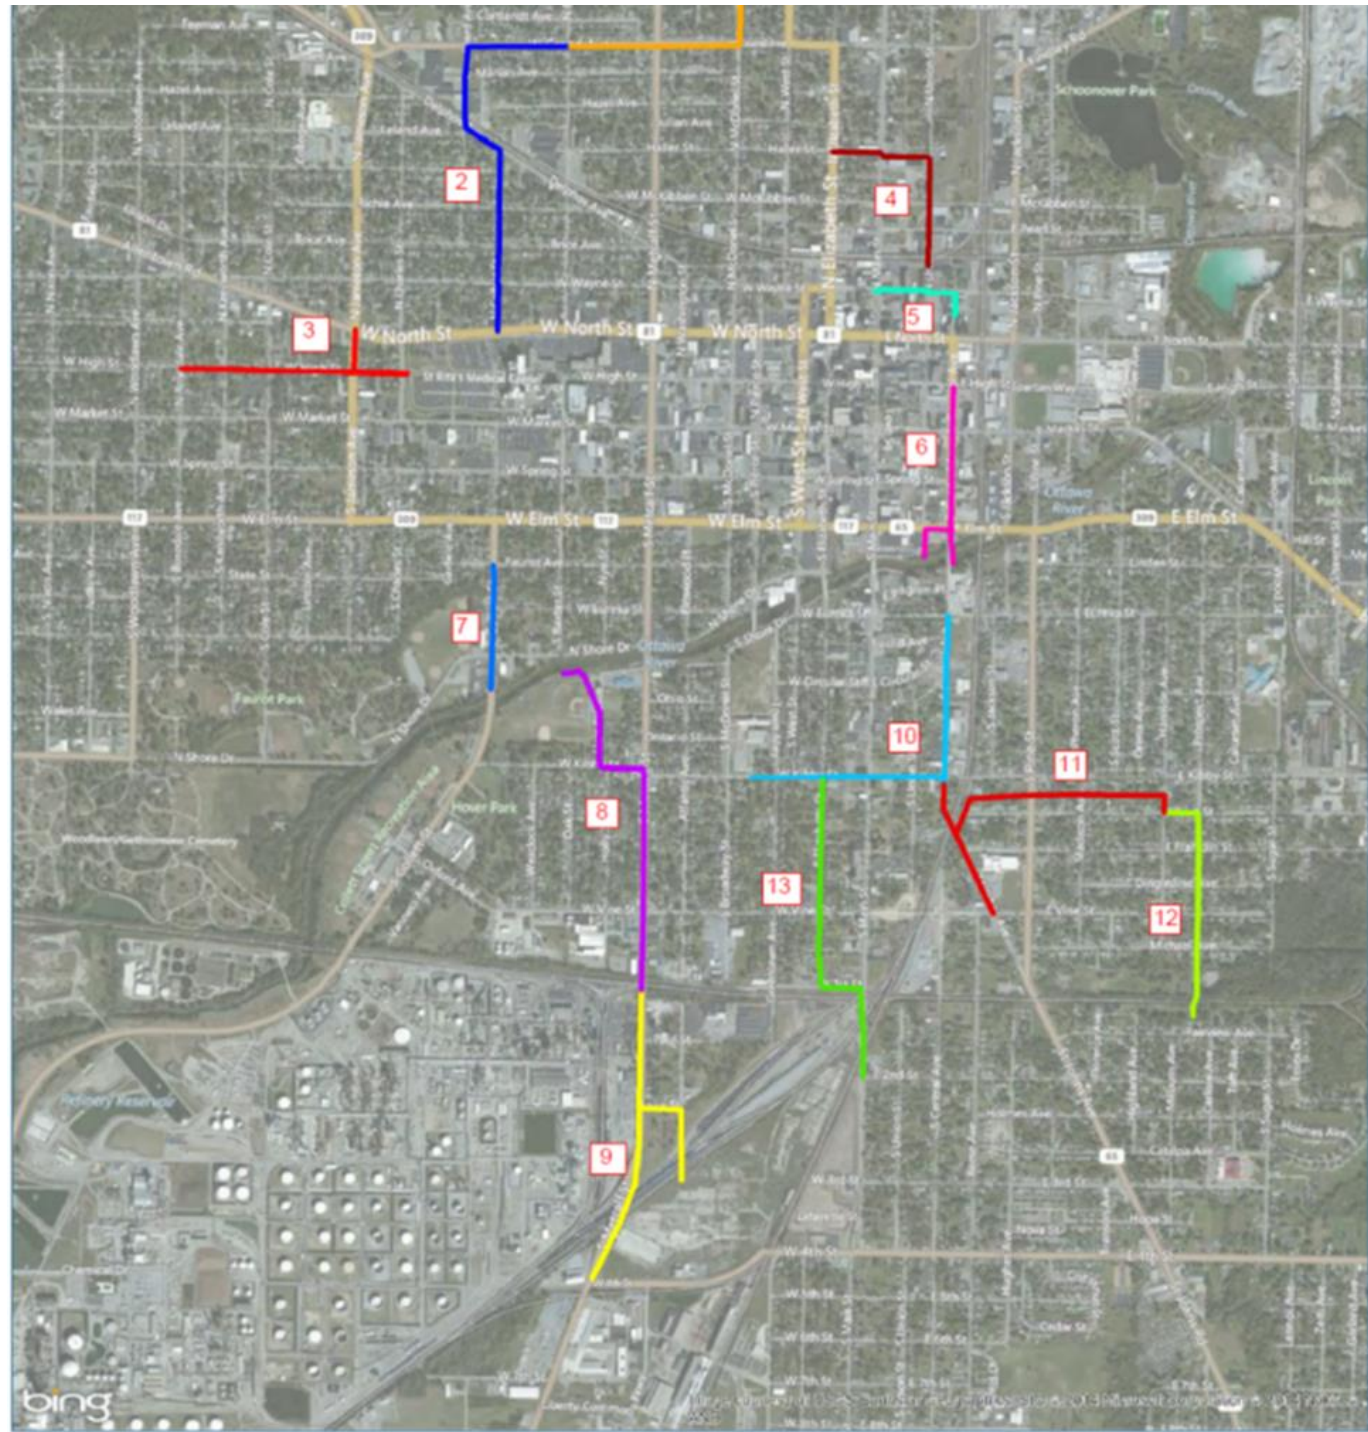
# Inspection Divided into 13 Sub Areas

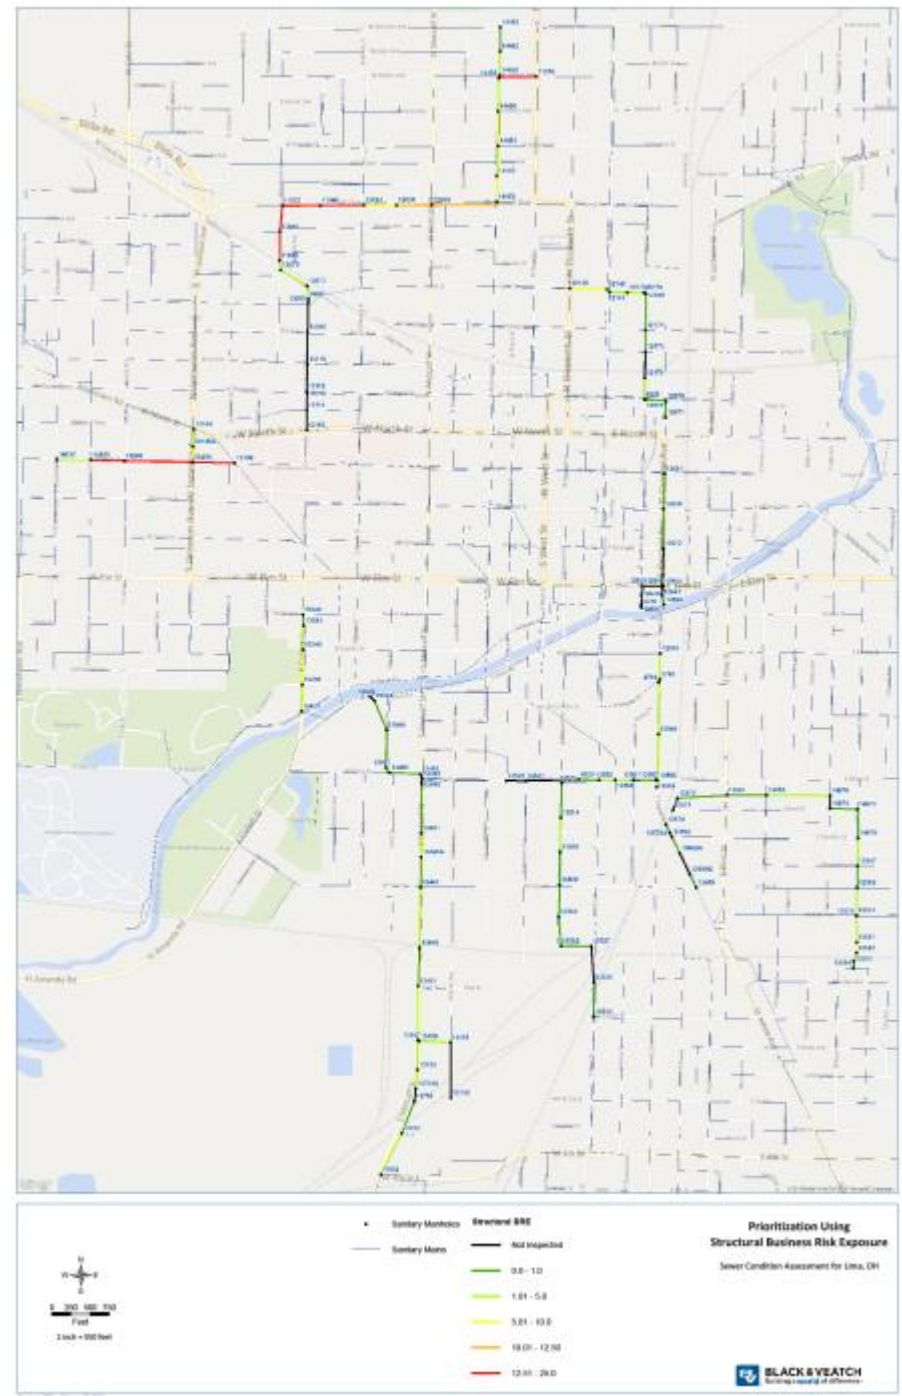
# Prioritization Using Structural Business Risk Exposure

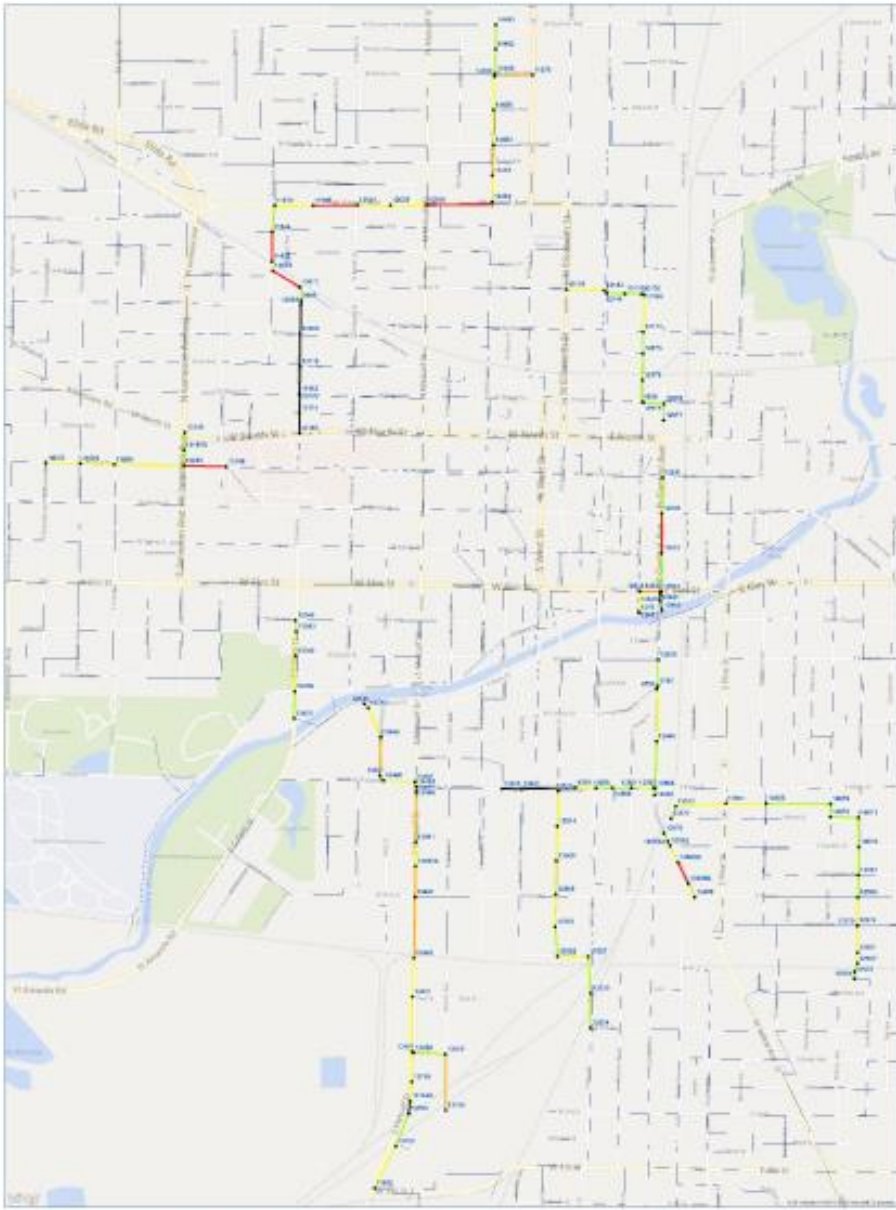
# Prioritization Using O & M Business Risk Exposure

**Prioritization Using O&M Business Risk Exposure**  
Source: Condition Assessment for Lines, OH

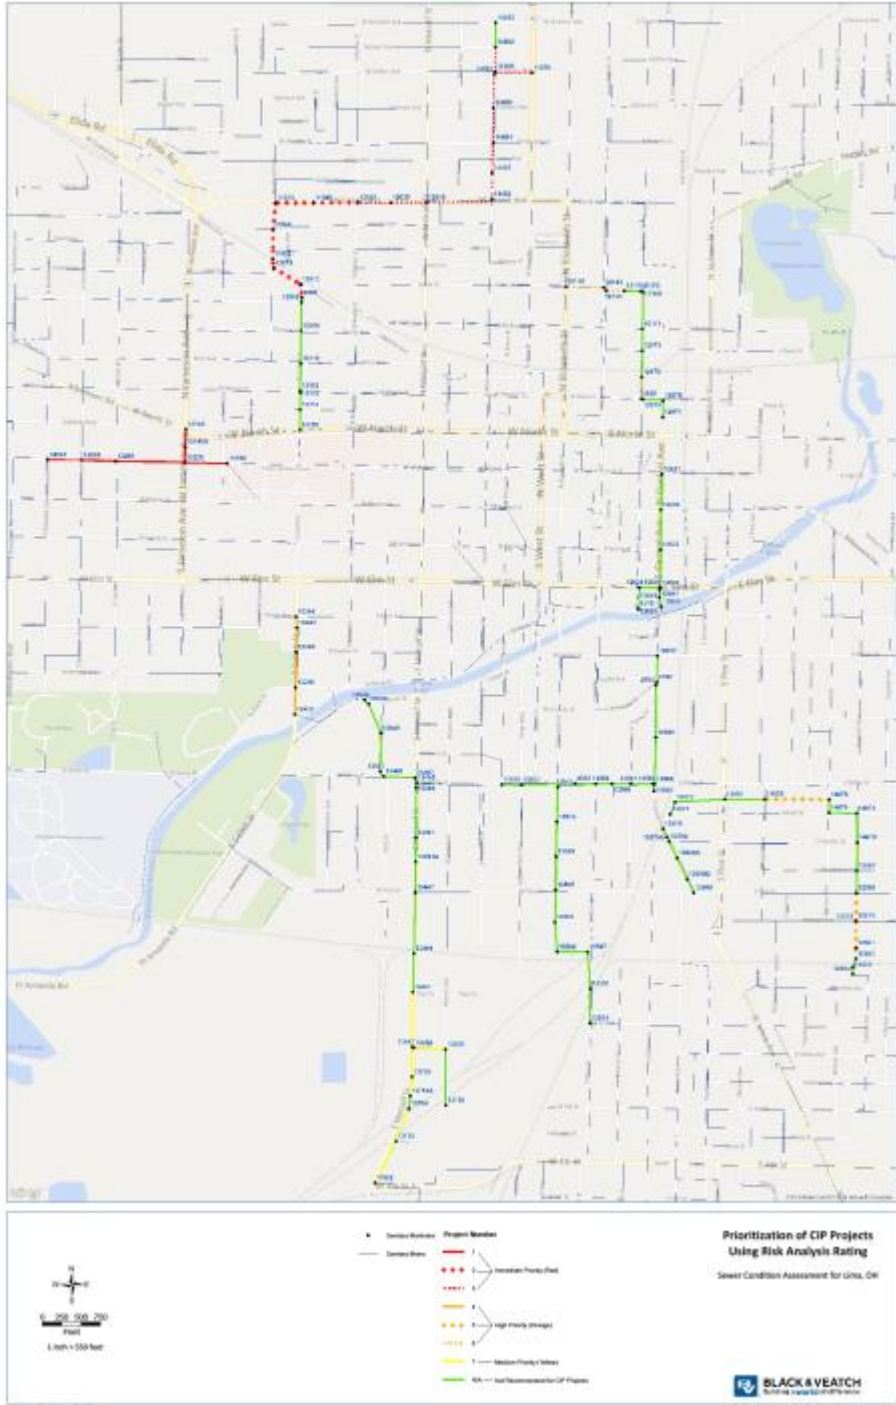
# Prioritization of CIP Projects Using Risk Analysis Ratings

Project No.	Project Priority	Total Project Cost	Length (ft)	Diameter (in.)	Structural BRE			Maintenance		Recommended Method of Restoration
					Immediate Risk (ft)	High Risk (ft)	Medium Risk (ft)	Low Risk Priority	Lowest Priority	
1	< 1-yr	\$ 2,700,000	2,106	48, 54, 78	1,393	0	205	508	0	Rehabilitation
2	< 1 - 2-yr	\$ 5,400,000	2,549	78	1,799	0	0	749	0	Rehabilitation
3	< 1 - 3-yr	\$ 5,600,000	4,028	30, 54, 66	337	1,323	1,197	1,143	28	Rehabilitation
<b>Total</b>	<b>&lt; 1 - 3-yr</b>	<b>\$ 13,700,000</b>	<b>8,682</b>		<b>3,529</b>	<b>1,323</b>	<b>1,402</b>	<b>2,400</b>	<b>28</b>	
4	2 - 5-yrs	\$ 2,900,000	1,254	78, 84	0	0	452	657	145	Rehabilitation
5	2 - 5-yrs	\$ 1,700,000	1,672	42, 60	0	0	137	1,535	0	Rehabilitation
6	2 - 5-yrs	\$ 600,000	1,051	27, 30, 36	0	0	486	565	0	Rehabilitation
<b>Total</b>	<b>2 - 5-yrs</b>	<b>\$ 5,200,000</b>	<b>3,977</b>		<b>0</b>	<b>0</b>	<b>1,075</b>	<b>2,757</b>	<b>145</b>
