June 27, 2019

BWARI Biofilter Rehabilitation Converting a Liability into an Asset

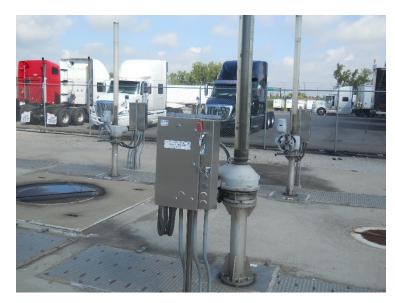
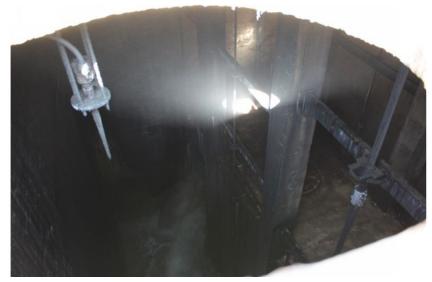
BBX

- Slide Gates & Weir Gates
- Level
- PLC & Radio
- Actuators
- RTC

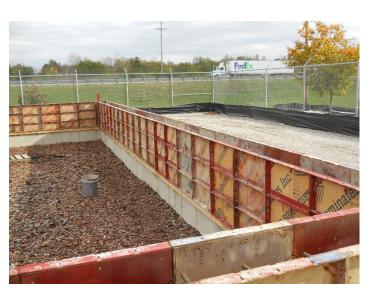
Construction Start August 2016

- Raised Wall
- Removed Existing Media

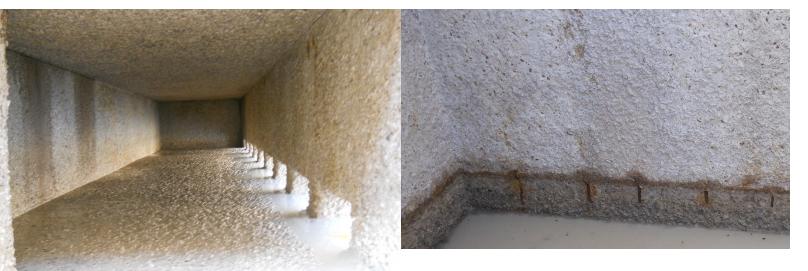
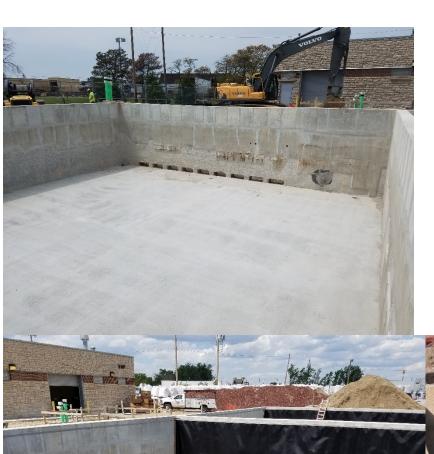
Concrete Corrosion

- Corrosion Significantly Worse Than Expected
 - 2-year Period Between Condition Assessment and Construction
 - Could Not Inspect Biofilter Floor
- Contract Included Significant Allowance

- Installed New Concrete Floor in Cells
- Changed to HDPE Liner
- Added FRP Pipe Header
- Hallsten Floor Replacement

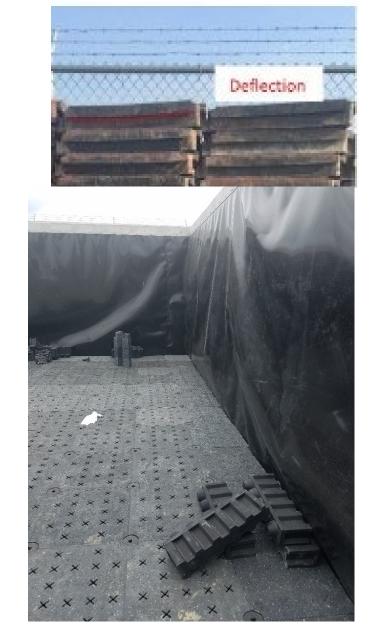
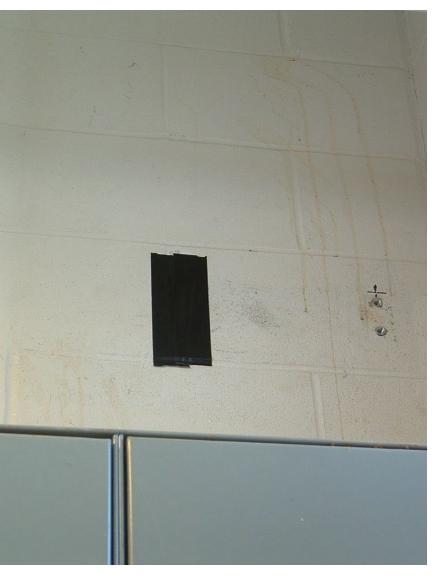
"Plumbing" Issues

- Tunnel Venting Through Building Plumbing Vents
 - Odors Prevalent at Site with Fans & Dampers Off
- Plumbing Vent Penetration in Electrical Room
- Added Trap on Sanitary Lateral
