A Tale of A Corroded Pipe: Failures, Analysis and Mitigation

Marissa Lauer – Brown and Caldwell
Mike Erkkila – Lake County Department of Utilities
June 26, 2019

- Located in Concord Township (Lake County)
- ~4,500 LF of 3"/4" ductile iron sanitary force main
- Begins at the Far Hills Pump Station
- Installed in 1993 (25 years old)
- Lake County hired Brown and Caldwell (BC) in Spring/Summer 2018 to investigate the Far Hills force main and its recent failures

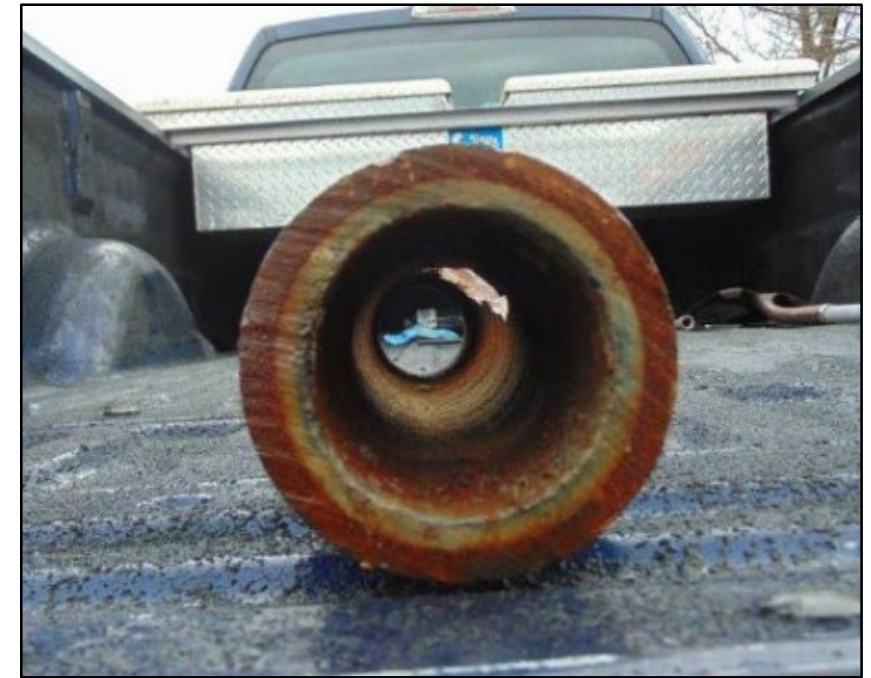
4 Separate Failures in February 2018

- All within ¼ mile radius of one another
- No apparent changes in weather or flow characteristics
- Failed segments removed and retained, existing pipe repaired, trenches backfilled
- Failures resulted in sanitary sewer overflows (SSOs)
- Pipeline not historically failure-prone

Failures #1, #2, and #4

Failure #3

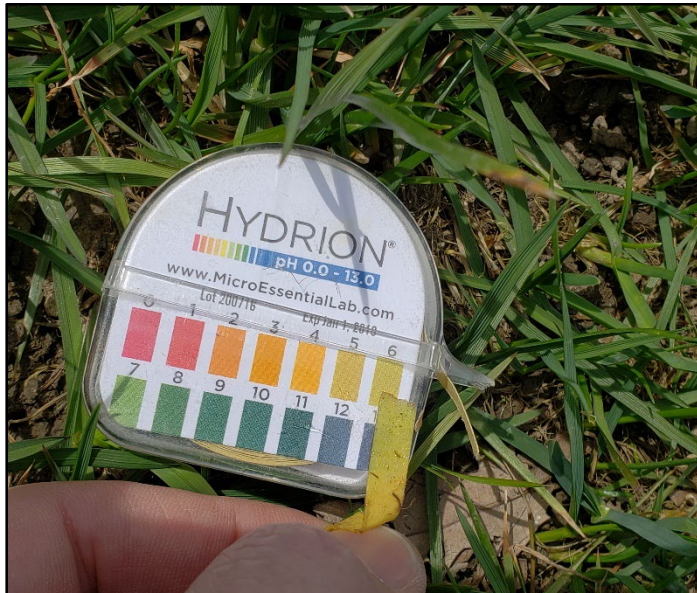
Surface pH

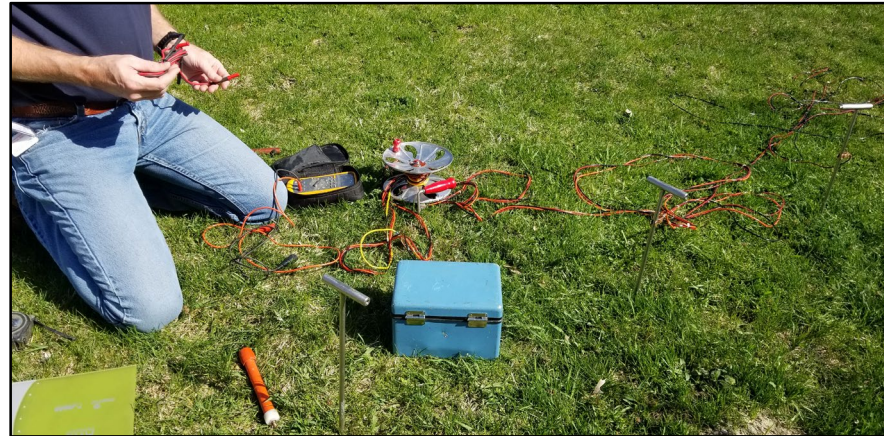
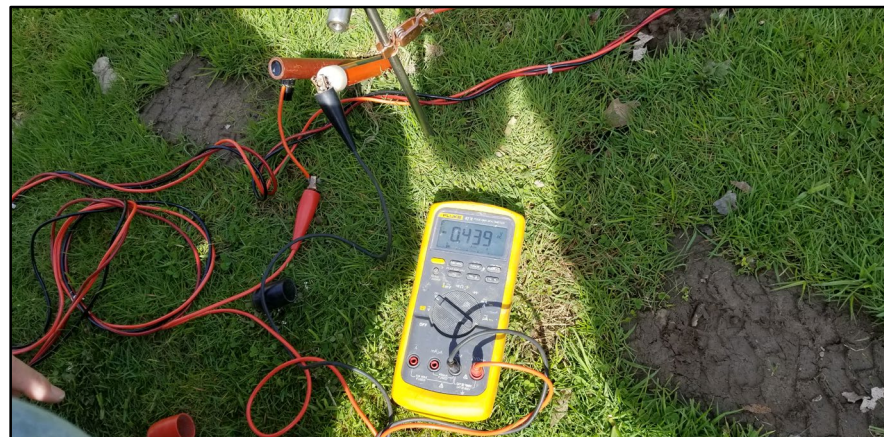
Soil resistivity averaged over 2.5 FT, 5.0 FT and 7.5 FT depths

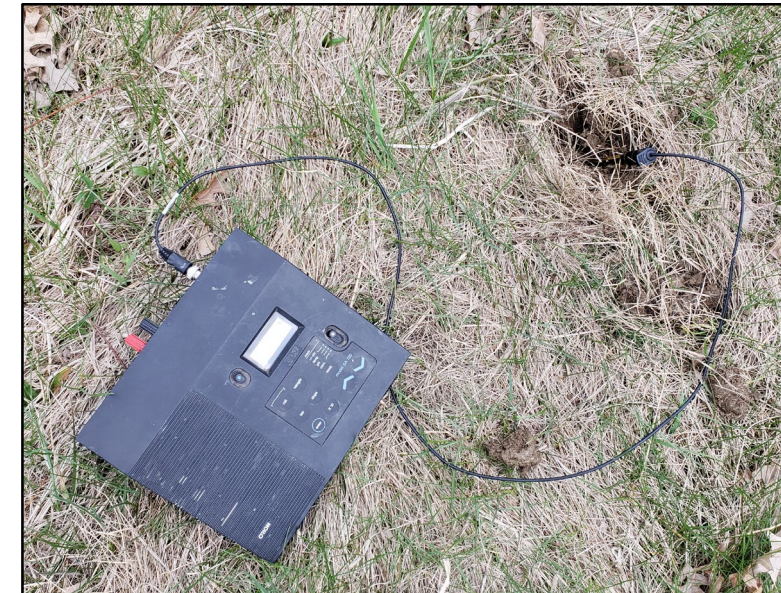
Surface oxidation and reduction (REDOX) potential

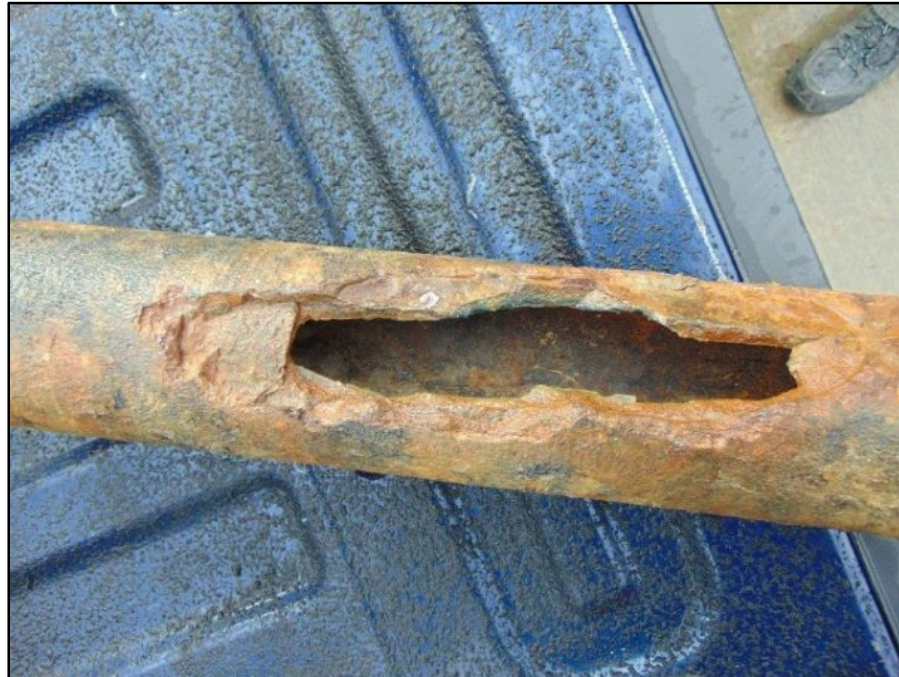
Exterior Corrosion Prediction Holds True

- Field and lab analysis from Phase 1 suggested the mechanism of pipe deterioration was exterior corrosion (differential aeration cell) as predicted
 - Graphitic and/or electrolytic corrosion

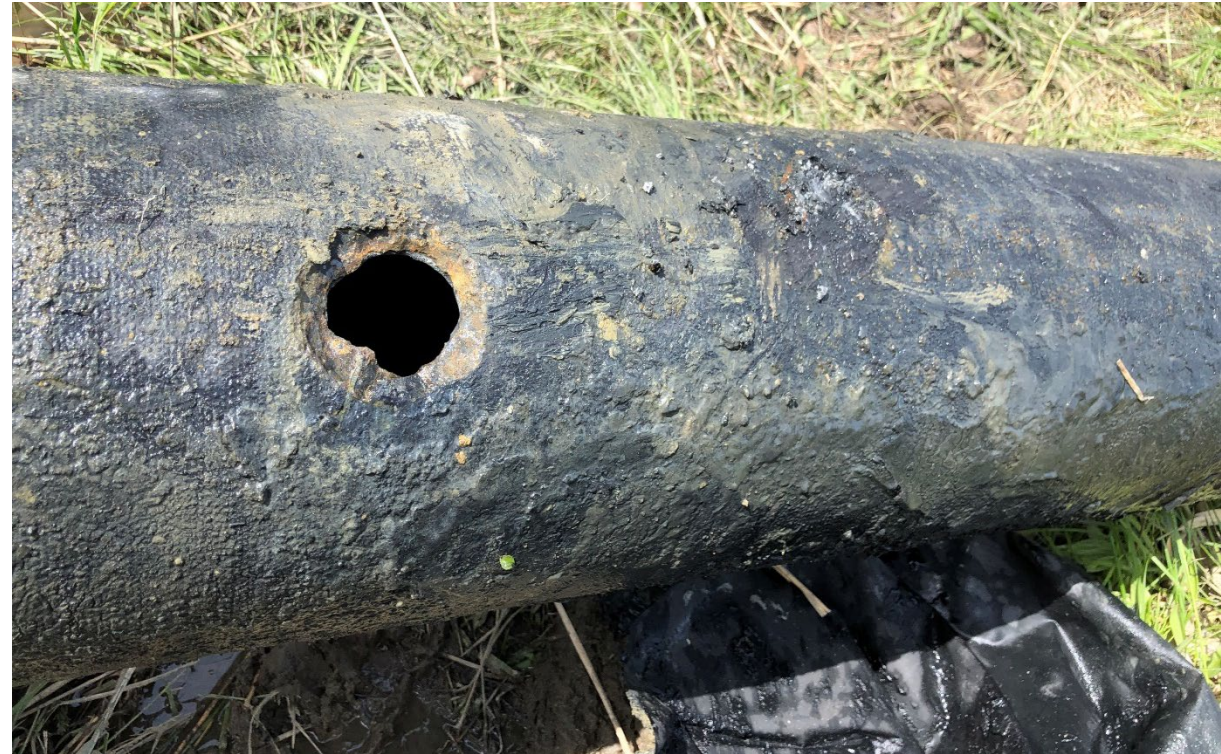
- Timeline of Events
 - 5/13/19
 - 5/14/19
 - What can go wrong, will go wrong!
- Williams Pump Station Force Main
 - Located in Grand River, Ohio
 - Similar pipe, soil characteristics, and number of breaks as the Far Hills FM
- Photos: What we found?
