# EXPEDITED SEWER REHABILITATION USING PROGRESSIVE DESIGN - BUILD

River Valley Highlands Sewer

June 26, 2019

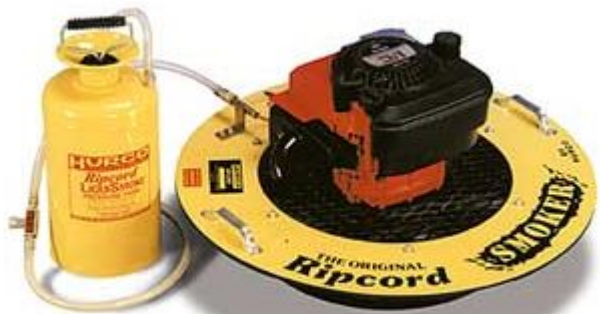
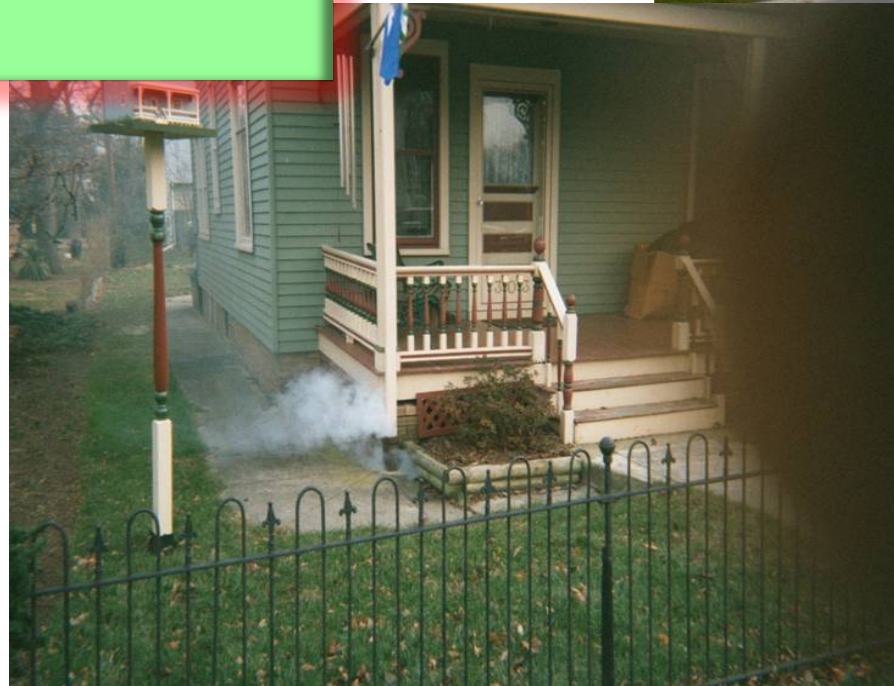
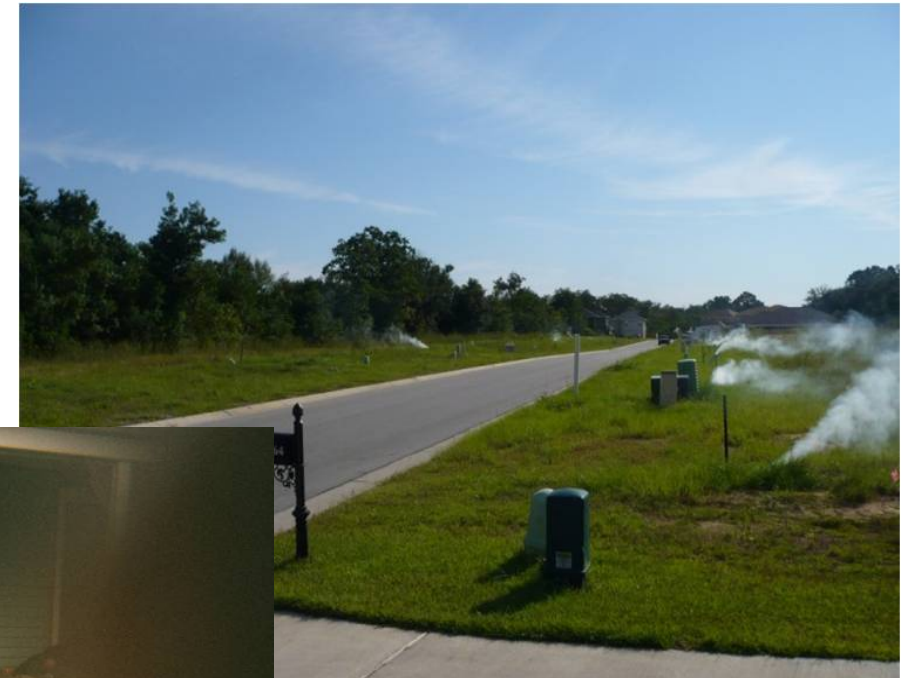
# Smoke Test

- Ensure there are no roof or area drains
- Determine if there are any indirect cross connections between storm and sanitary pipes
- Identify clipped cleanouts

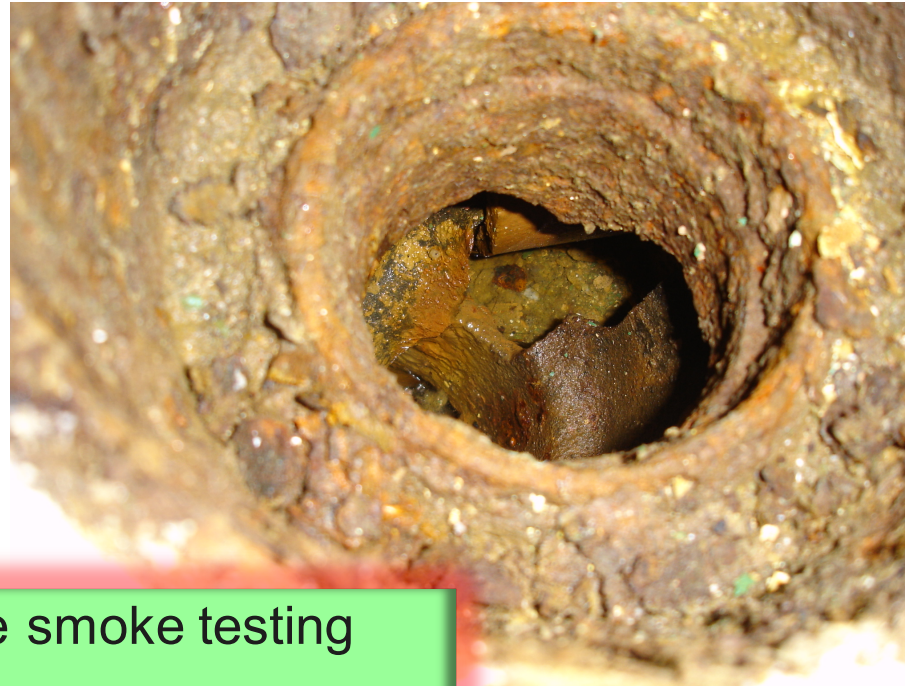
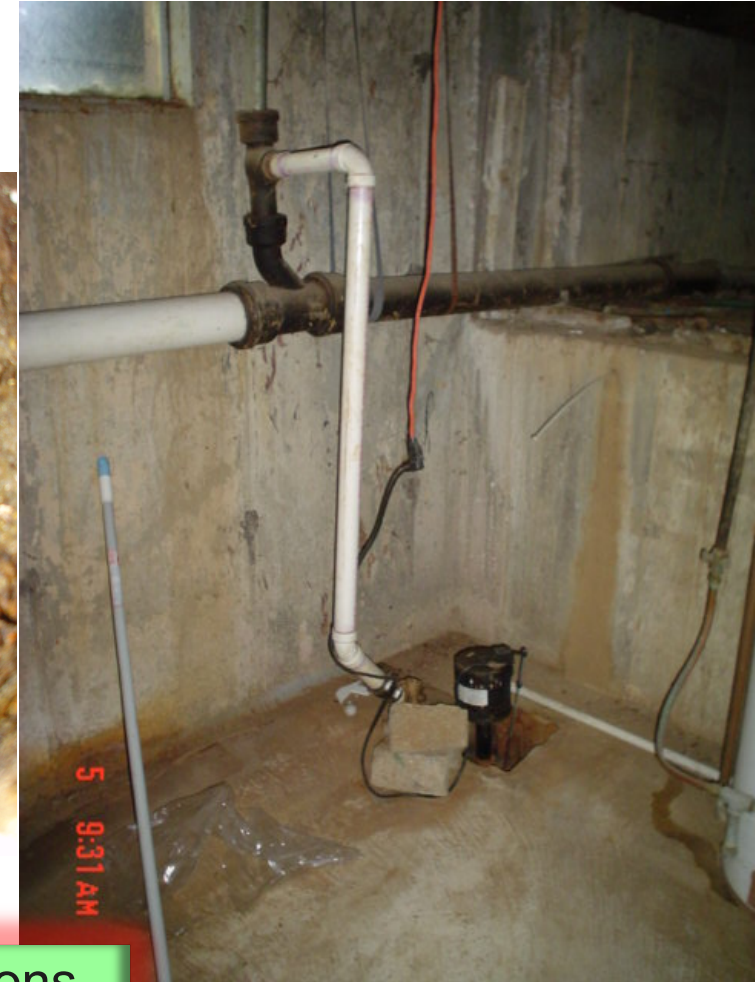
# Basement Inspections

- Conduct while smoke testing
- Identify illegal sump pumps or punctured floor drains

- 29 basement inspections

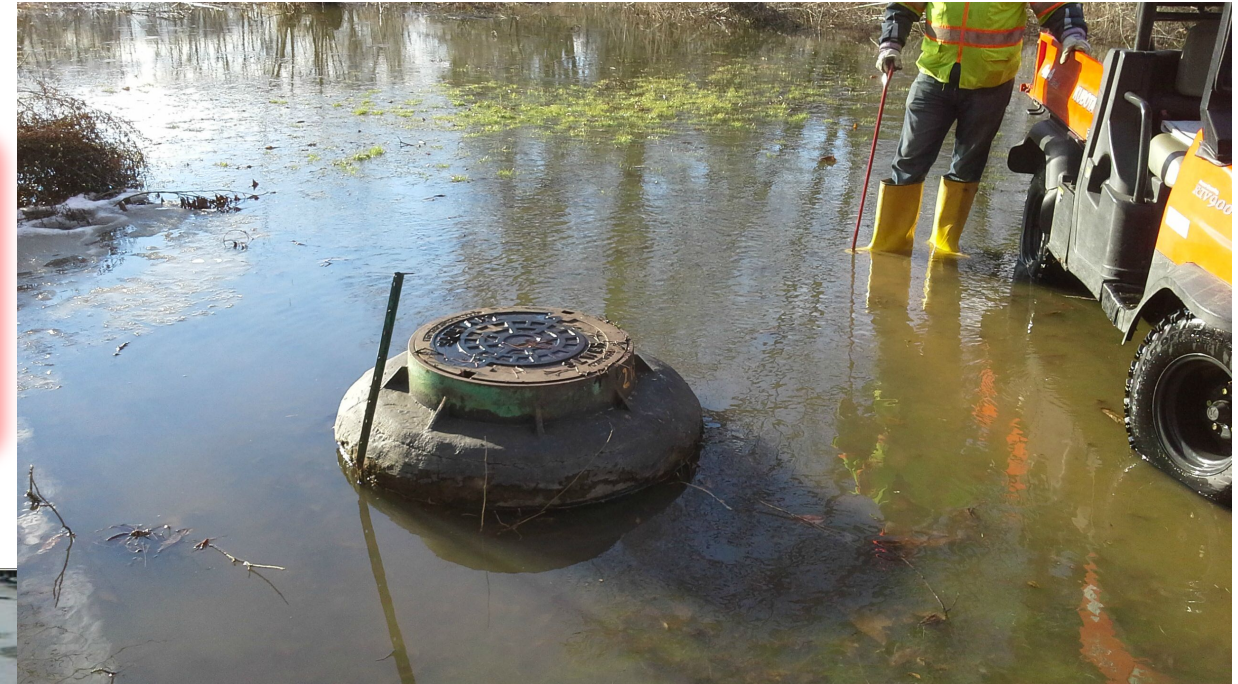
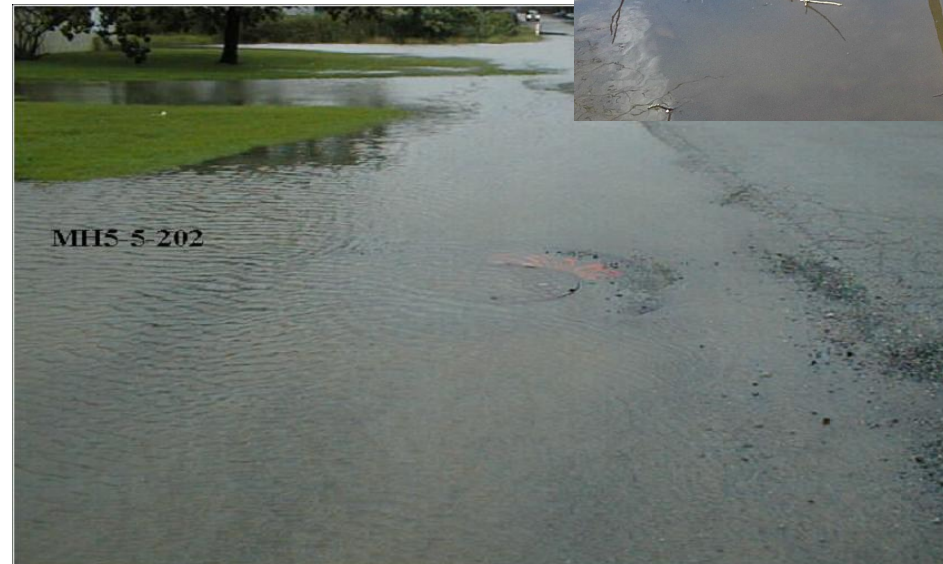
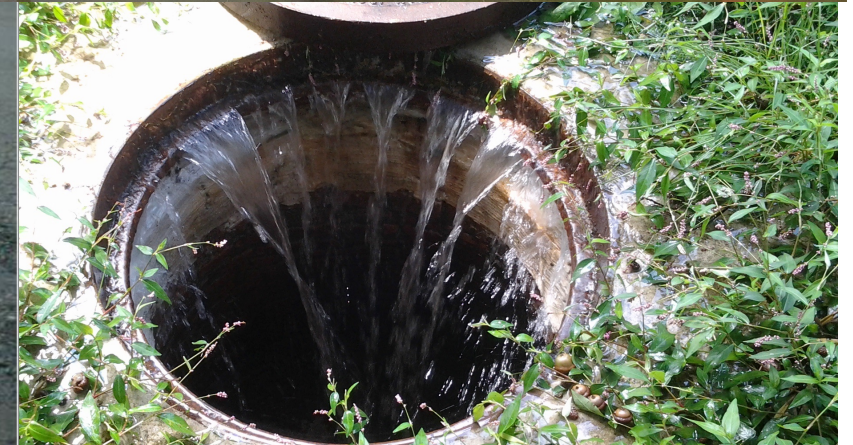
# Low Area/Wet Weather Observations

- Best done right after rain event
- Identify inundated manholes
- Identify soft ground

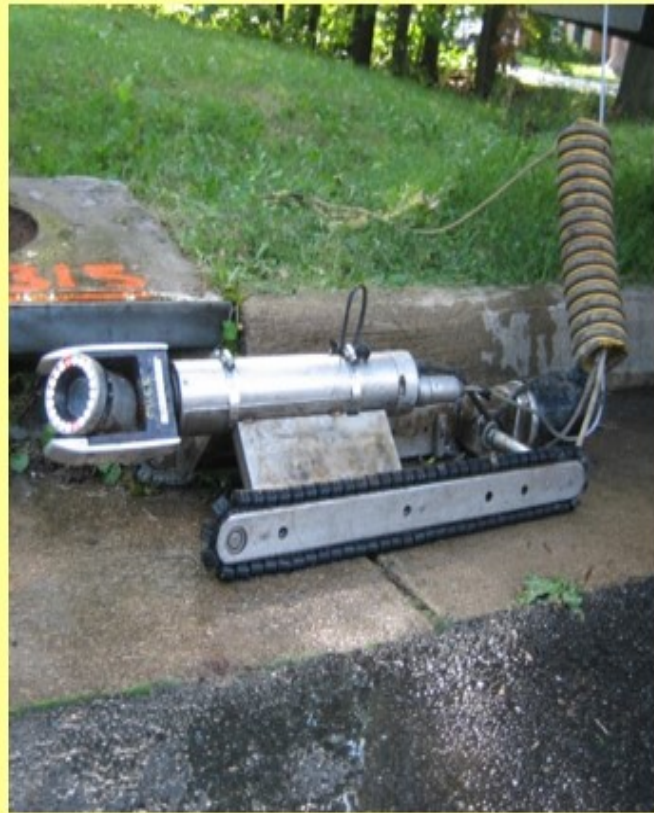
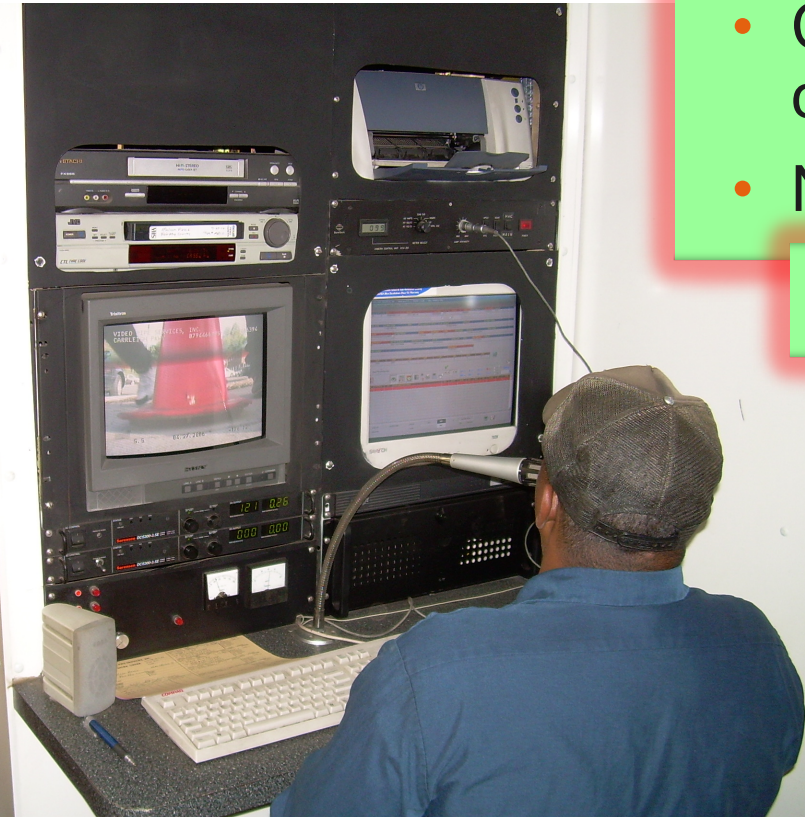
# CCTV

- Confirm pipe physical condition
- No cleaning before CCTV
- 7300 lf of mainline inspection

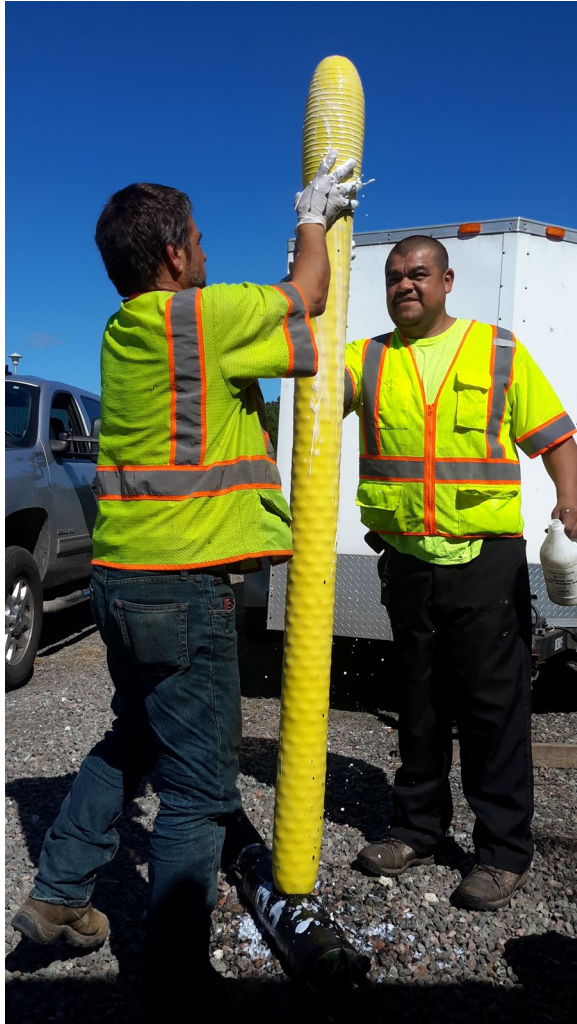
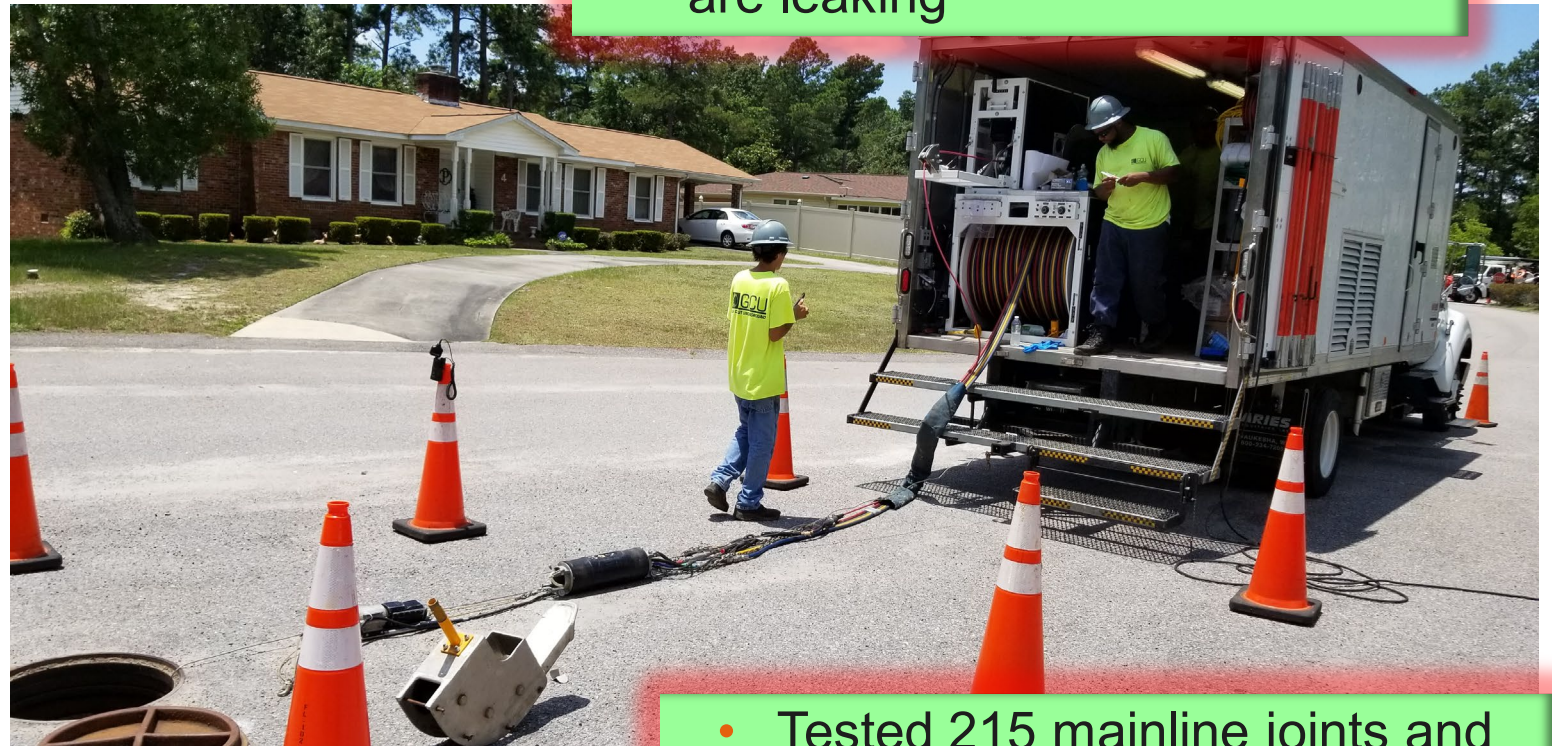
# Air Test Joints and Taps

- Evaluate if joints are structurally sound but leaking
- Evaluate if taps and lower lateral are leaking

- Tested 215 mainline joints and 34 taps/laterals

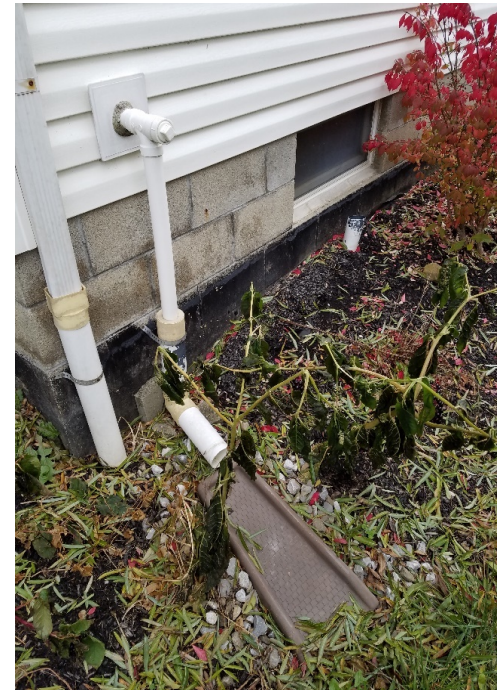
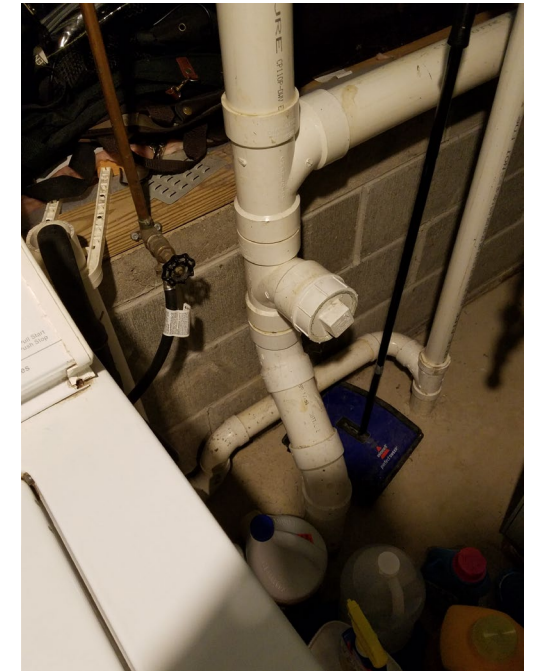
# House Inspection Findings

- Basement inspections
- No roof drains or illegal sump pumps

Knocked	Refused Entry	Inspected	No Answer
Houses	117	8	29	80

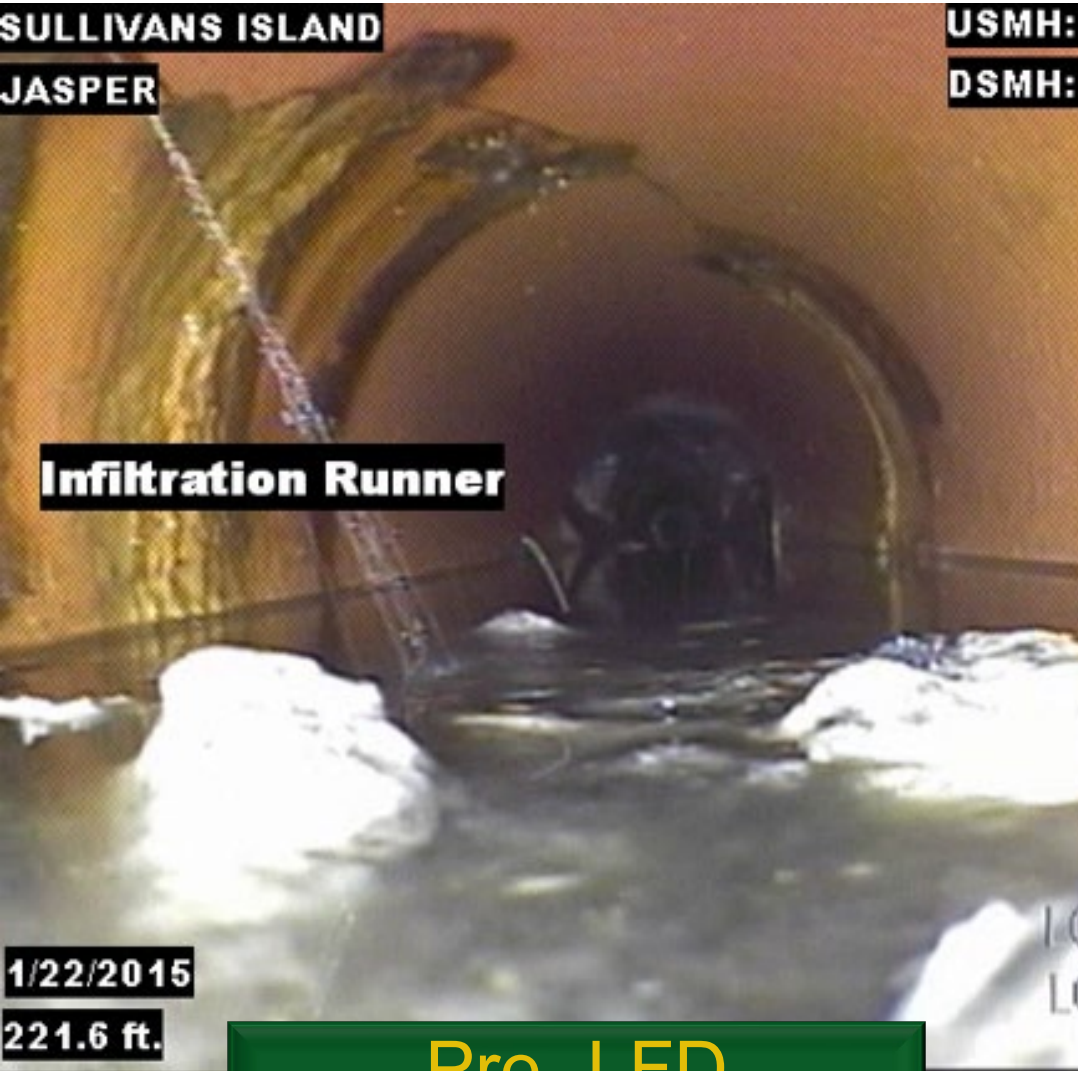
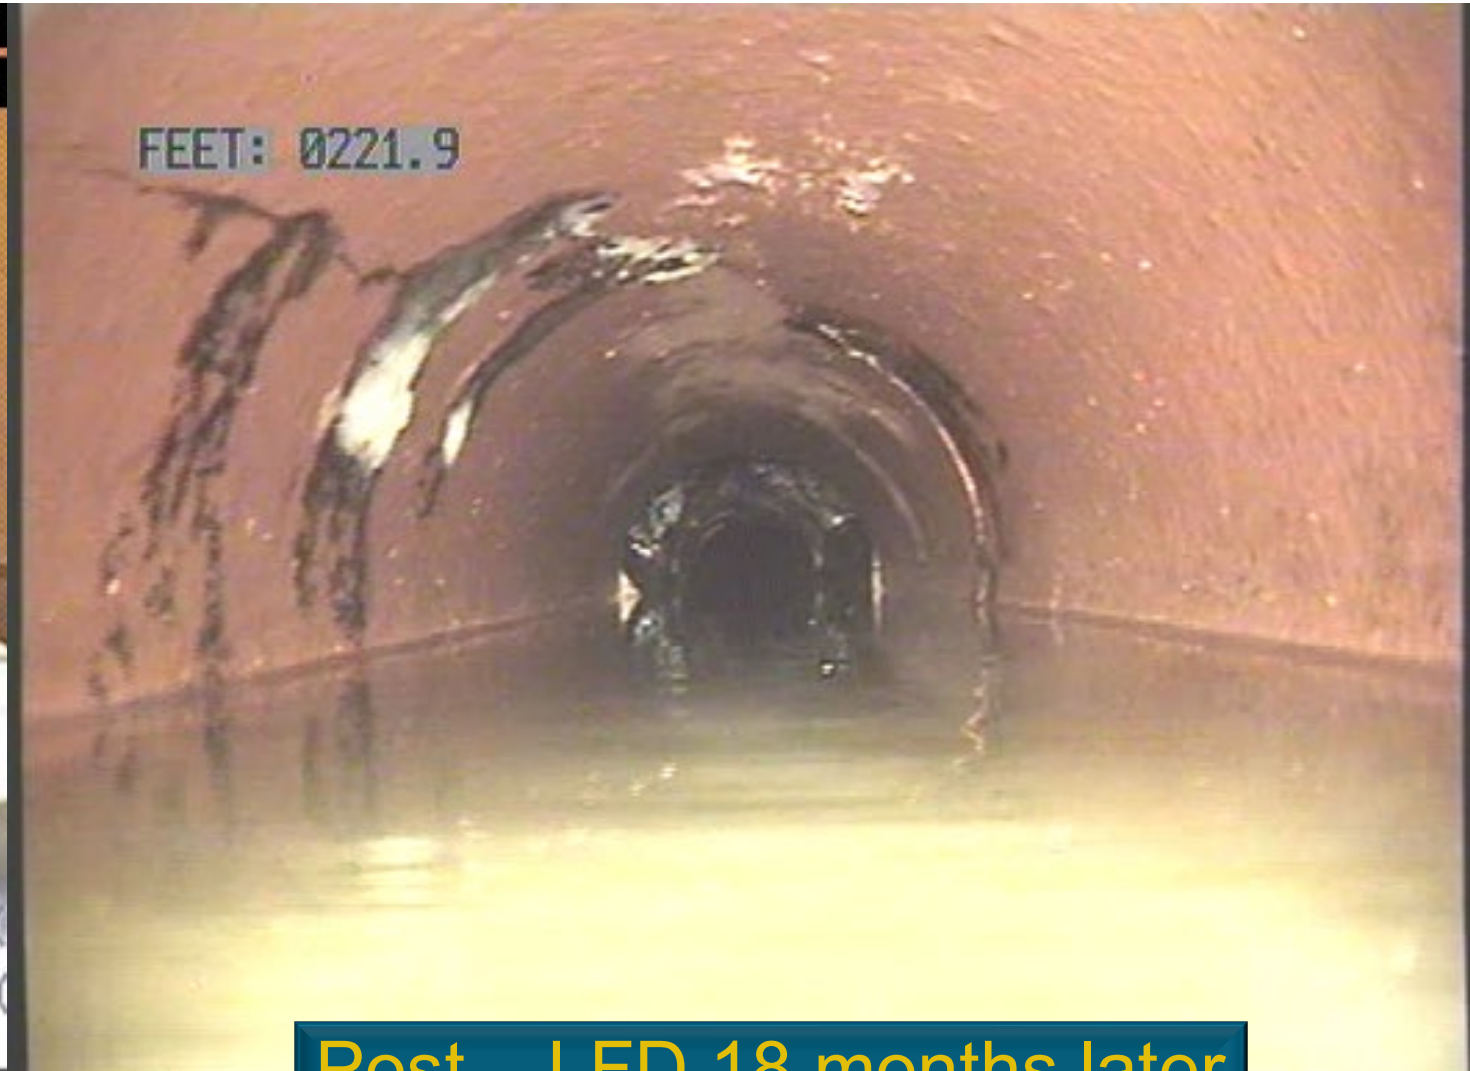
**Pre- LFD**

**Post – LFD 18 months later**

**Grouted  
Spiral  
Fracture**

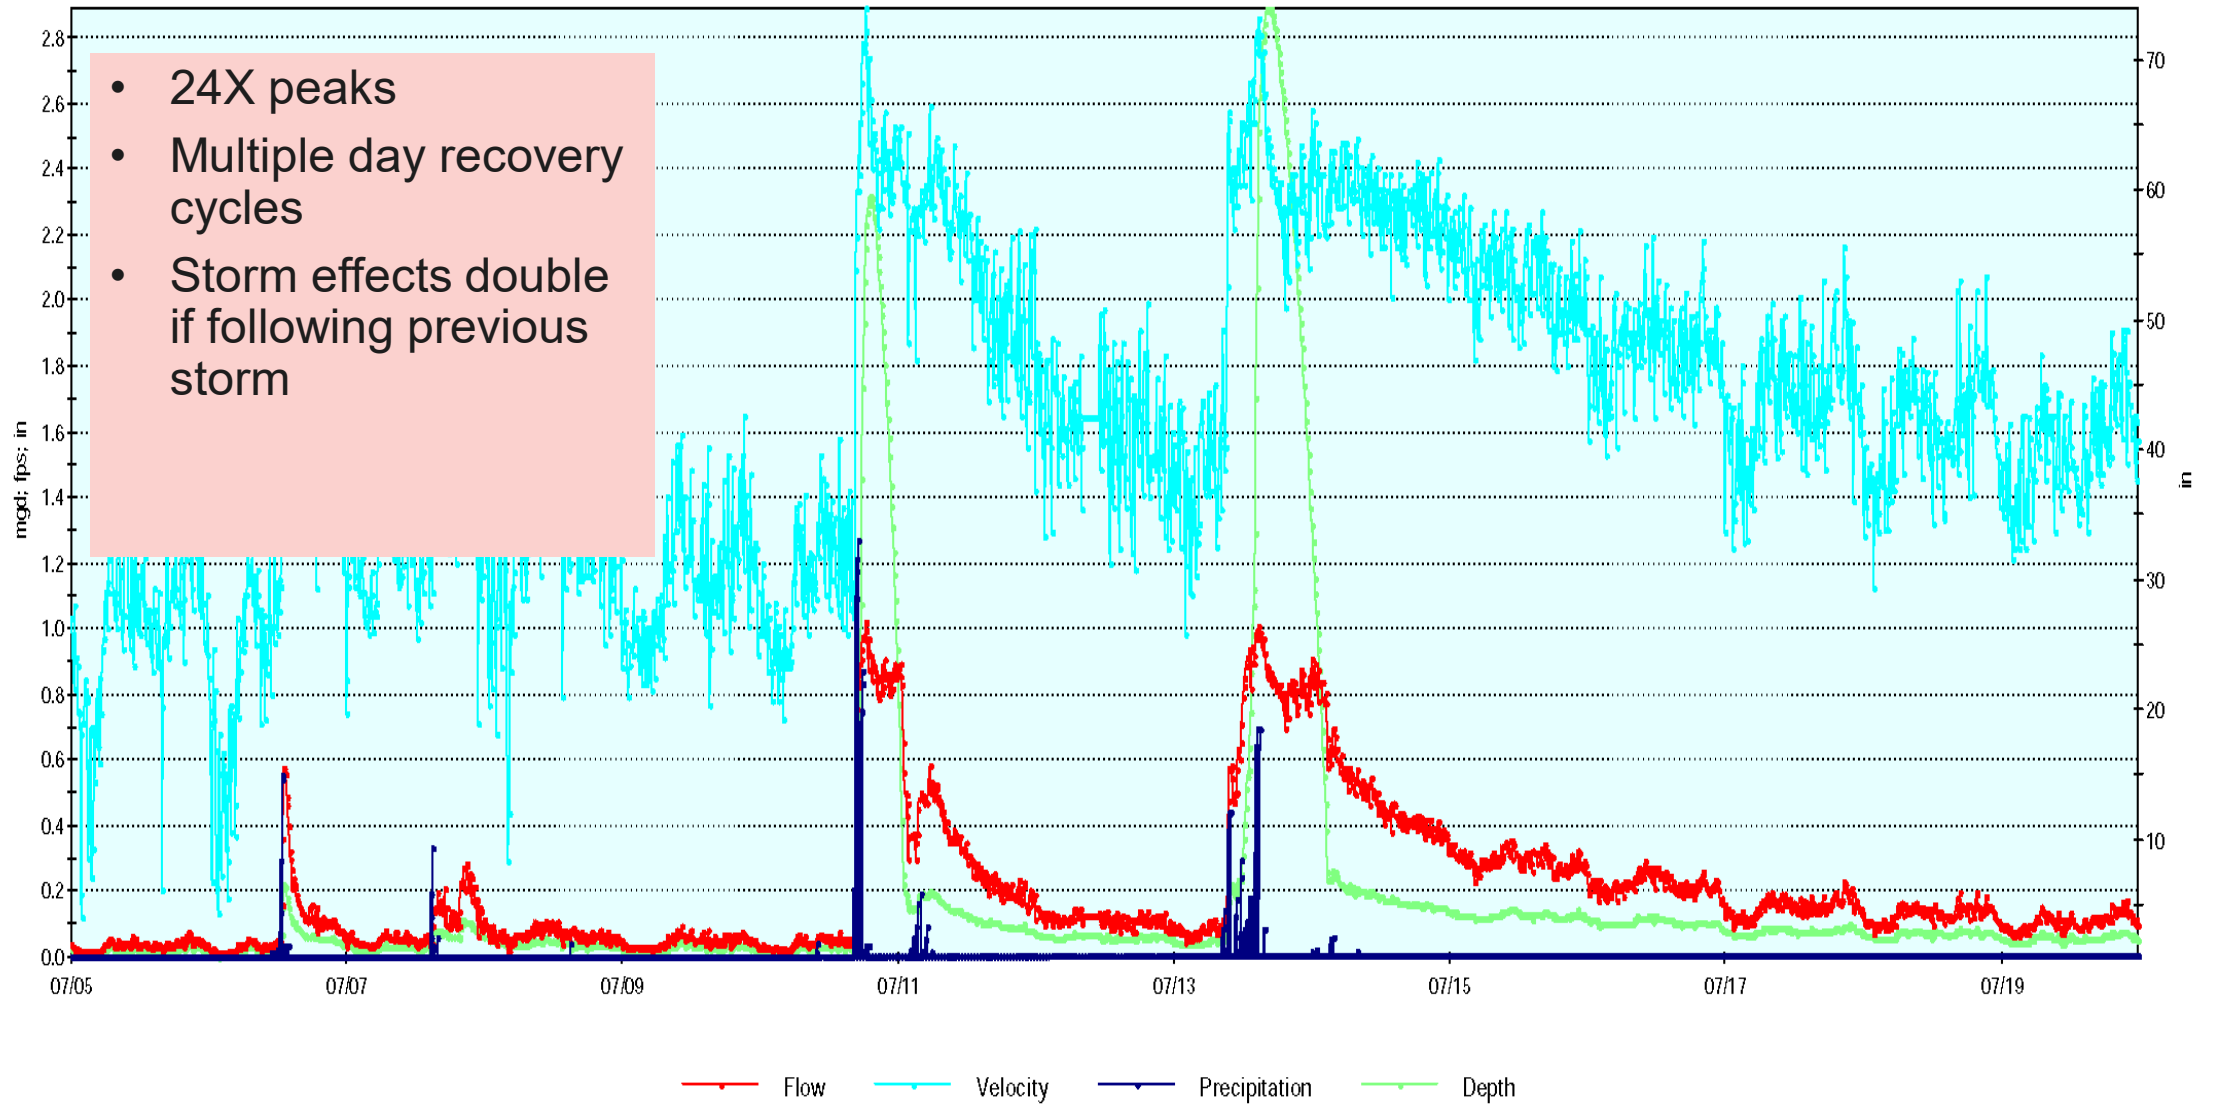
Prairie Grass Meter

Still have inflow coming in the  
sunken manhole,  
But <3x peak  
And rainfall induced infiltration  
has been almost completely  
eliminated
