Corrosion Condition Assessments of Force Mains

James T Lary Corrpro 1055 W Smith Road Medina, OH 44256 Tel: 330-723-5082 (x1215) Email: JLary@corrpro.com

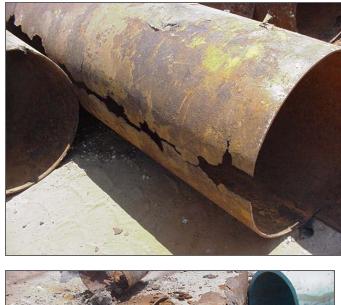
- Internal failure following loss of internal mortar lining
- Failure was along top of pipe due to formation of hydrogen sulfide gas

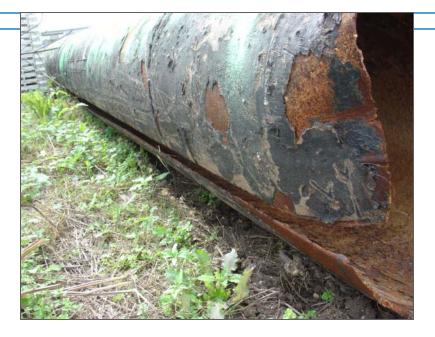
Dual 26" Force Mains

- Internal failures at bottom of pipe
- Failure following loss of internal mortar lining
- Failures concentrated at low areas (dips) in pipeline alignment
- Cause is corrosion under accumulated solids

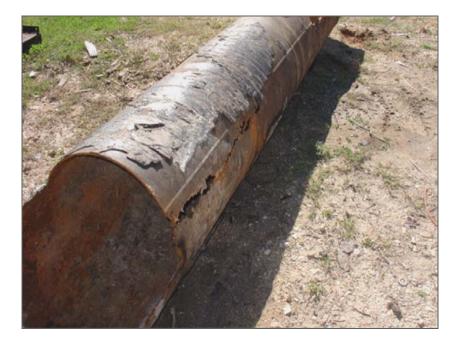
36" Above Ground Crossing

- Failure of force main at above ground crossing
- Crown of pipe attacked by hydrogen sulfide gas

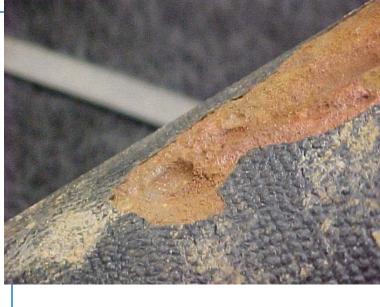
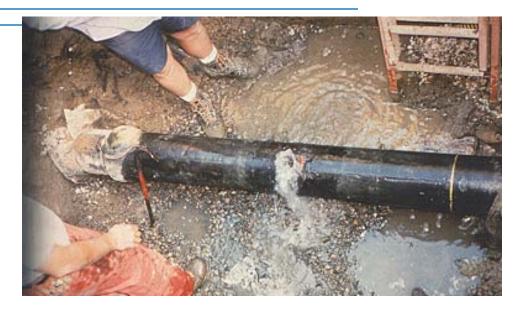
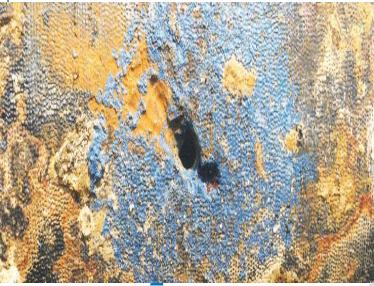
External pitting (concentrated) corrosion attack on thinner walled ductile iron pipe.

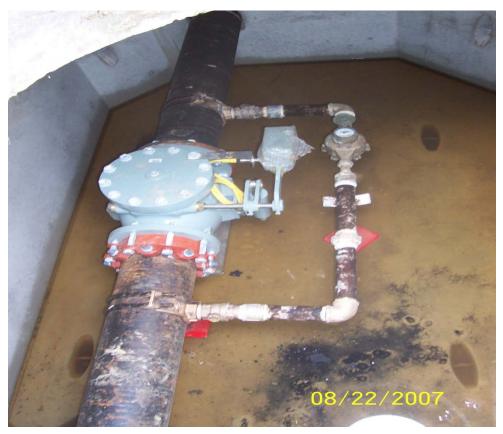
Meter Vaults

Cathodic Protection of Metallic Fitting

(Keep dry if possible)

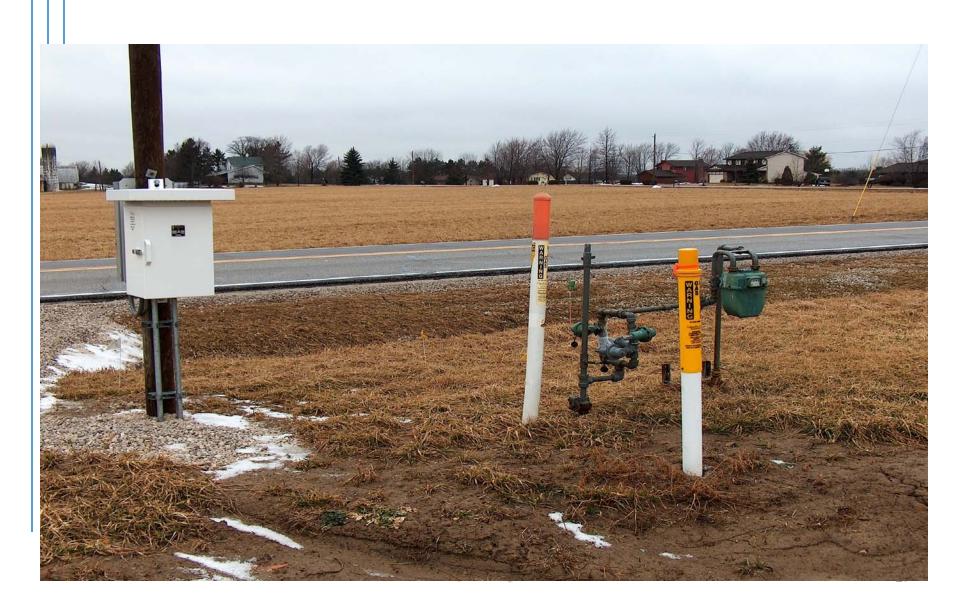
Impressed Current CP System on Oil/Gas Lines can Create Stray Current Problem on Water Lines

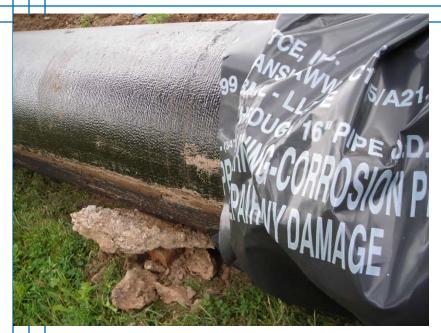
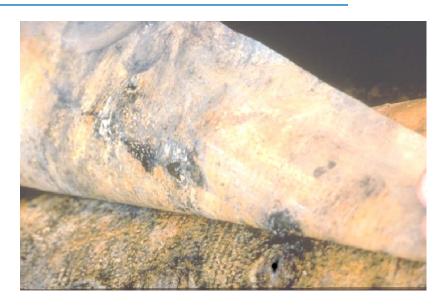
Polyethylene Encasement of Ductile Iron Pipe

-Follow DIPRA installation procedures -Clean pipe before installing polywrap -Repair tears or damage to encasement -Engage an inspector to oversee installation

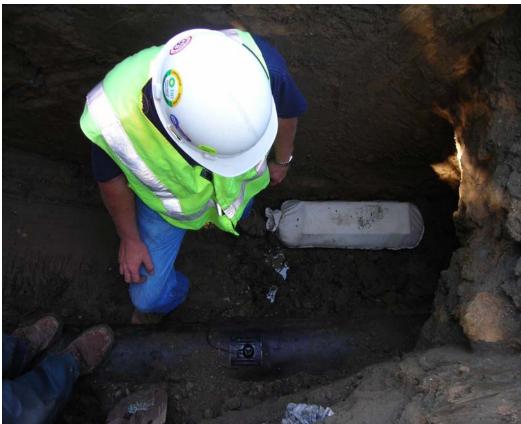
Repair of Break Should Include Anode Installation

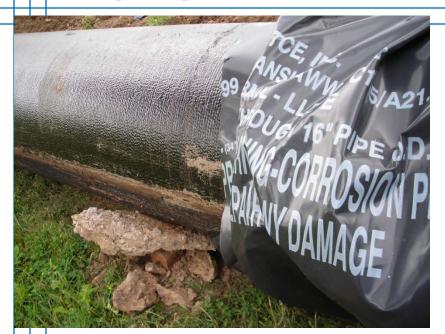
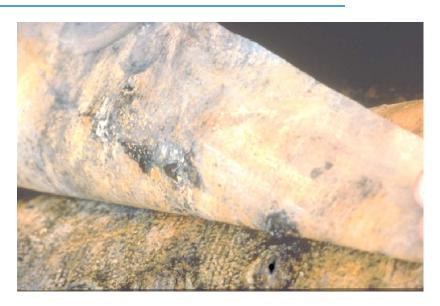
Polyethylene Encasement of Ductile Iron Pipe

-Follow DIPRA installation procedures -Clean pipe before installing polywrap -Repair tears or damage to encasement -Engage an inspector to oversee installation

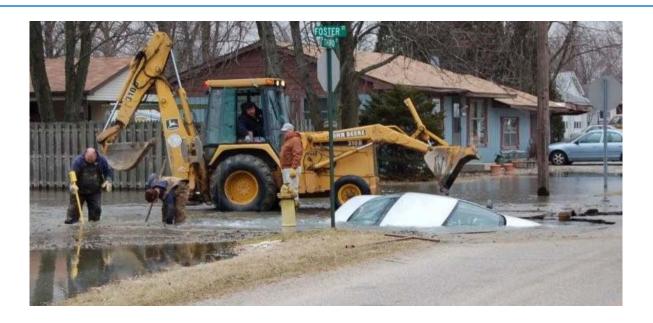
Existing Force Mains:

Internal Corrosion is likely the leading cause of main breaks

External Corrosion may also be a factor

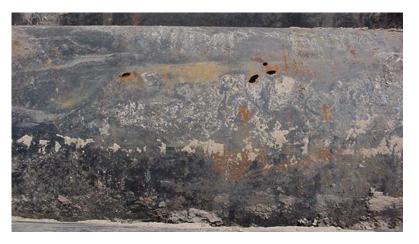
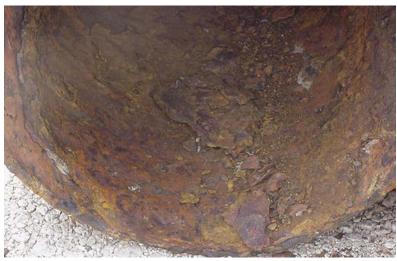
- Multiple failures at Buffalo Bayou on bottom of pipe
- Performed ultrasonic thickness measurements in lift station
- Cases of failure are scouring and turbulent flow

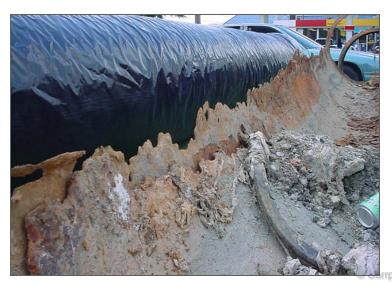
30" Ductile Iron

- Internal corrosion failure at crown of pipe.
- Hydrogen sulfide gas formed sulfuric acid which attacked the mortar coating and then the underlying metal surface.

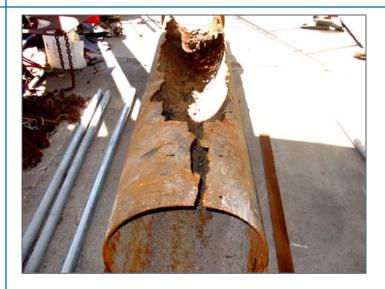
- Internal pipe failures along crown of pipe
- Failures following loss of internal mortar lining
- Cause is formation of hydrogen sulfide gas

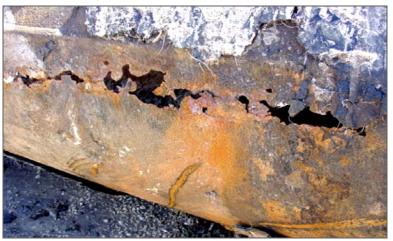
#3 - Direct Examination:

- Physical Examination
- Photographic Documentation
- Pipe-to-Soil Potential Measurements
- Bi-metallic Connections, e.g. services
- Soil, Bedding, Backfill and Groundwater Tests
- Coating Assessment (if applicable)
- Mapping and Measurement of Corrosion Defects
- Ultrasonic Thickness Measurements
- AC and DC Stray Current Measurements
