# **A Dangerous Situation Exposed With Private Property Laterals**

**Stu Bowns  
Hydromax USA  
and  
Laurie Chase  
Blue Heron Engineering**

**Ohio WEA – June 2010**

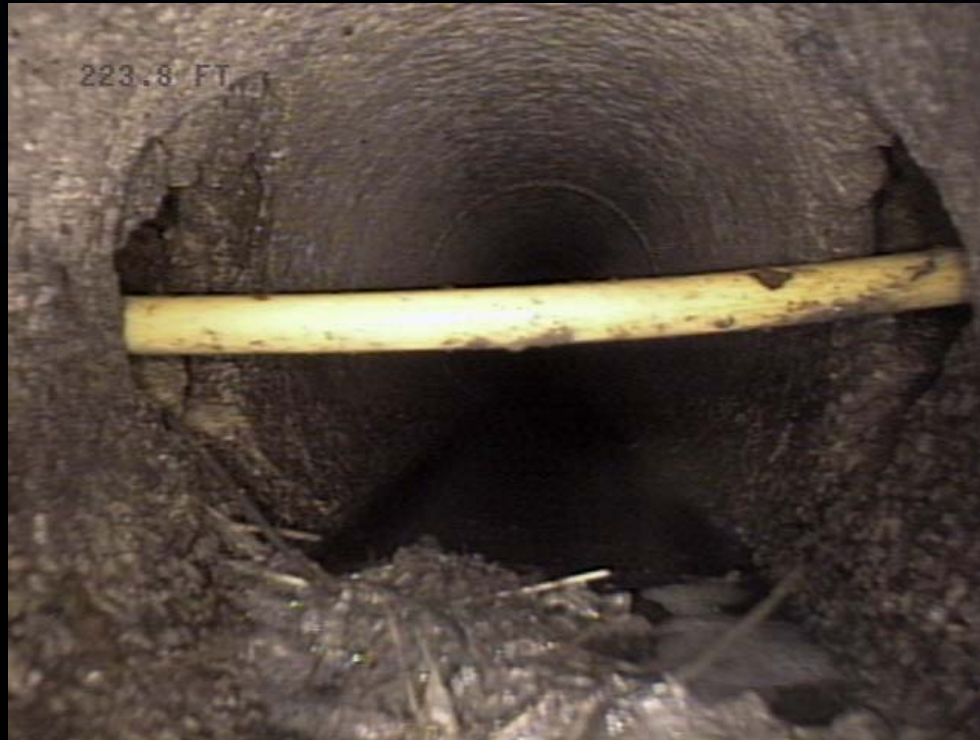
# What is a Cross-Bore?

A cross-bore is “...an intersection of an existing underground utility or underground structure by a second utility resulting in direct contact between the transactions of the utilities that compromises the integrity of either utility or underground structure.”

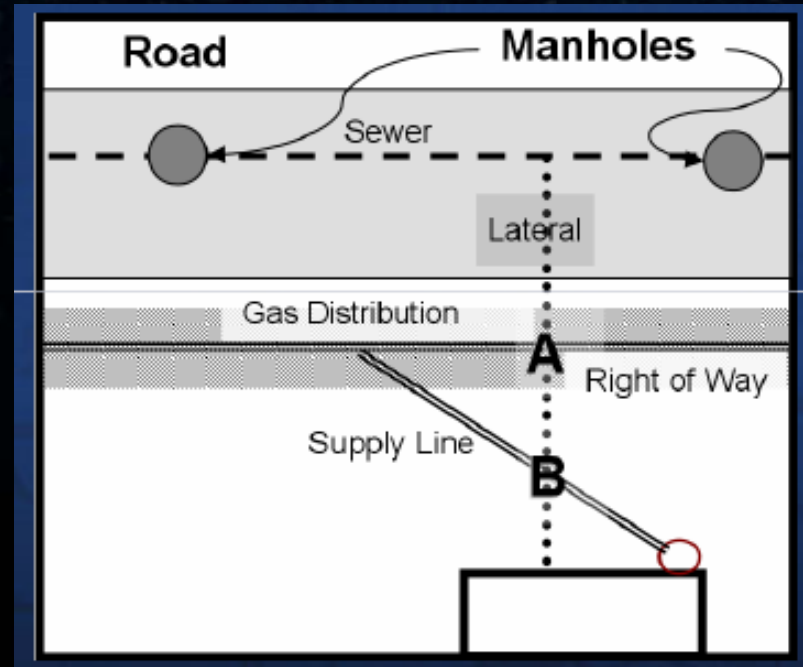
# Common Cross-Bore Locations

Cross-bores tend to occur at right angles to homes and building:

- Location A: Within the utility right-of-way
- Location B: Supply line to House
- Other Documented locations:
  - Mainline sewers
  - Storm pipes
  - Electrical and telecommunication ducts

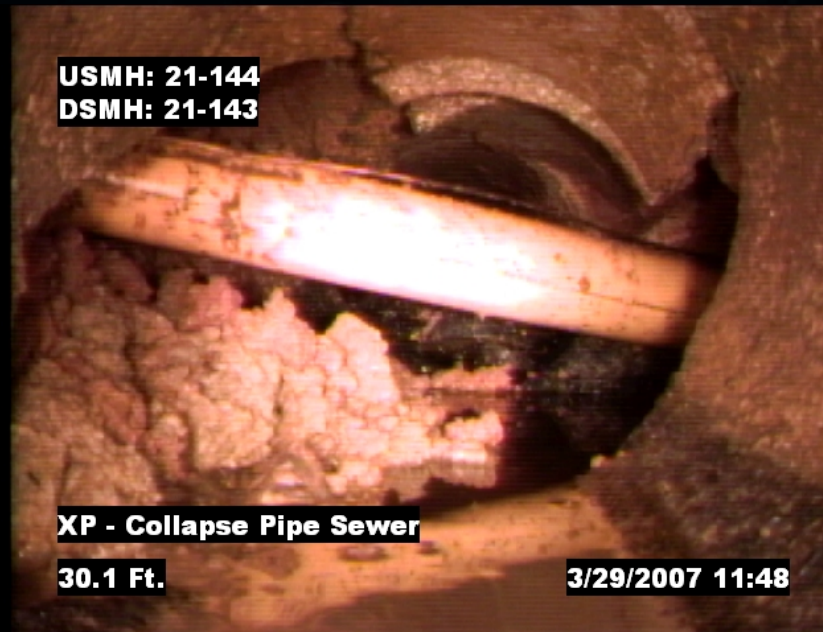
Hydromax has inspected over 40,000 laterals and our field experience suggests that there are 2 to 3 cross-bores per mile of sewer main

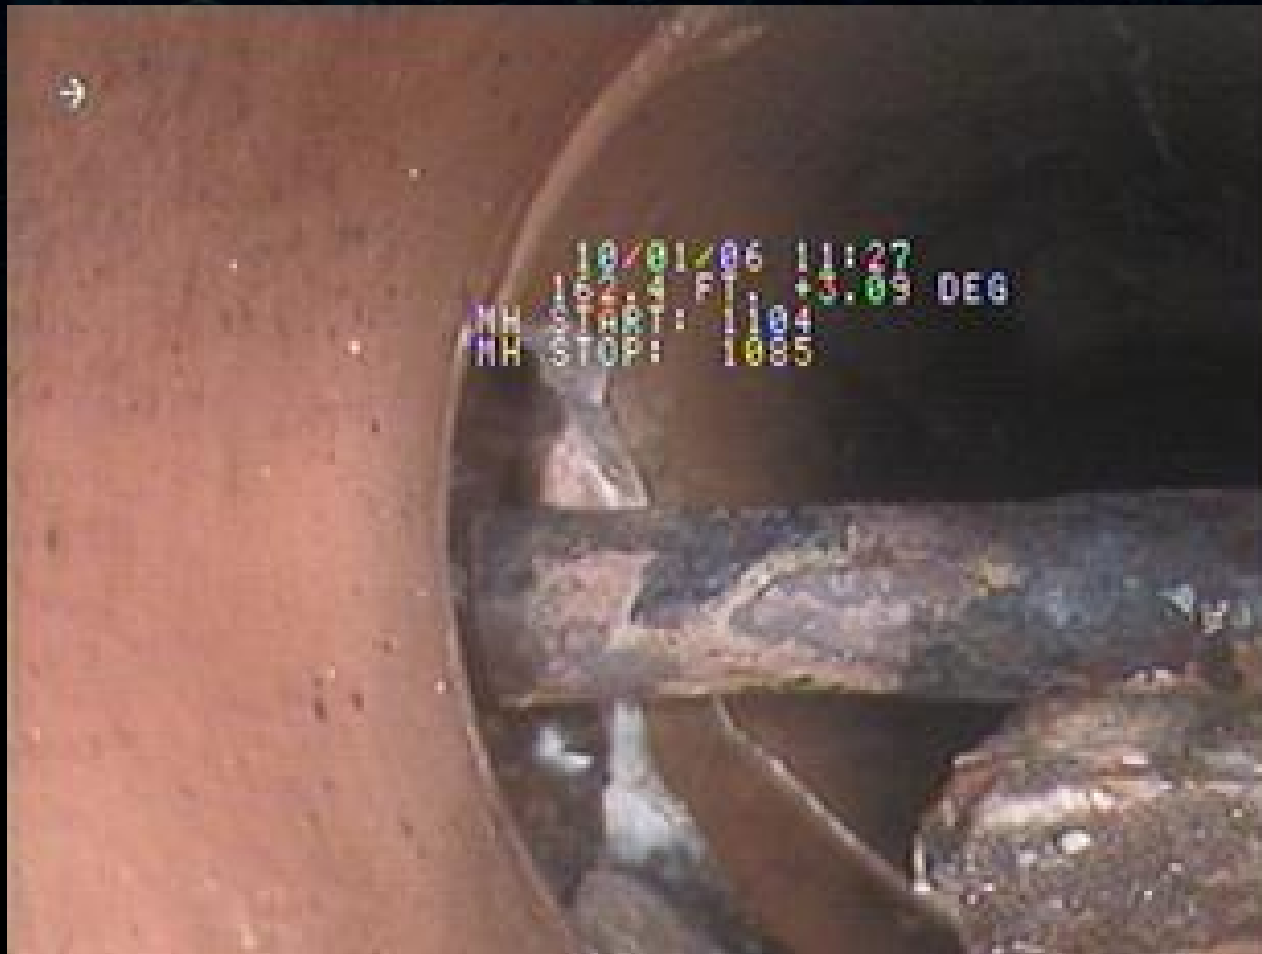
# New Gas Construction Cross Bore

A cross bore created during present construction activities

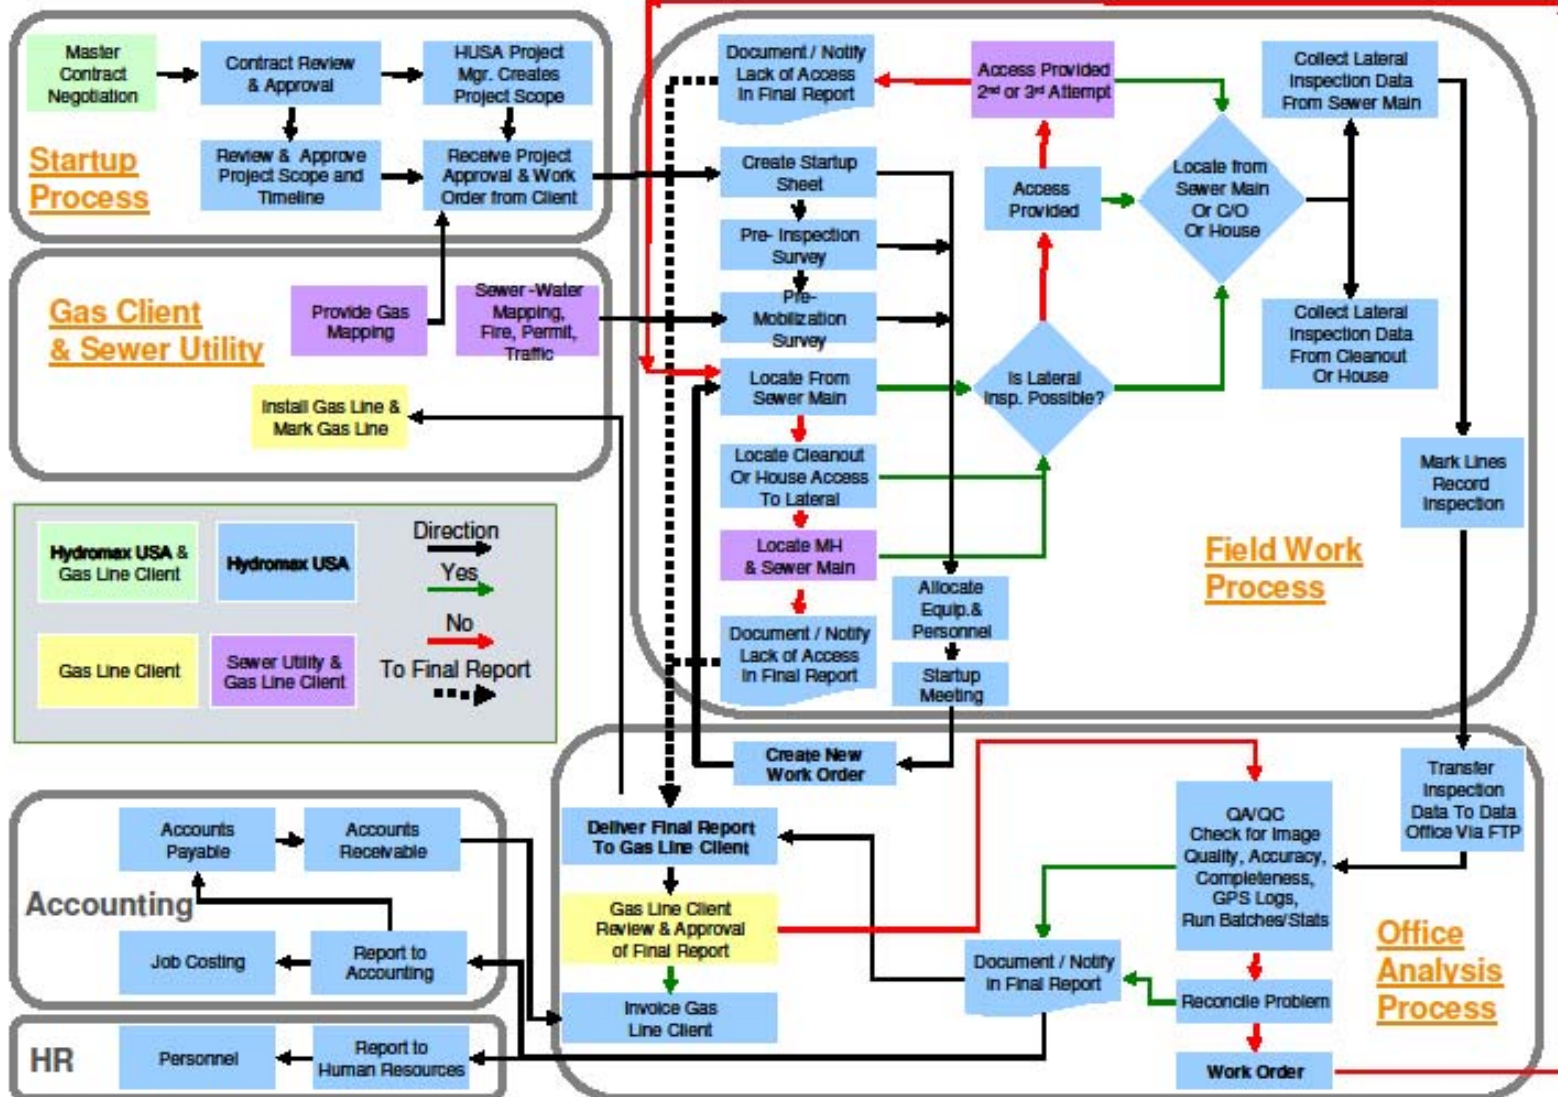
# New Gas Construction - Location Inspection Process Chart

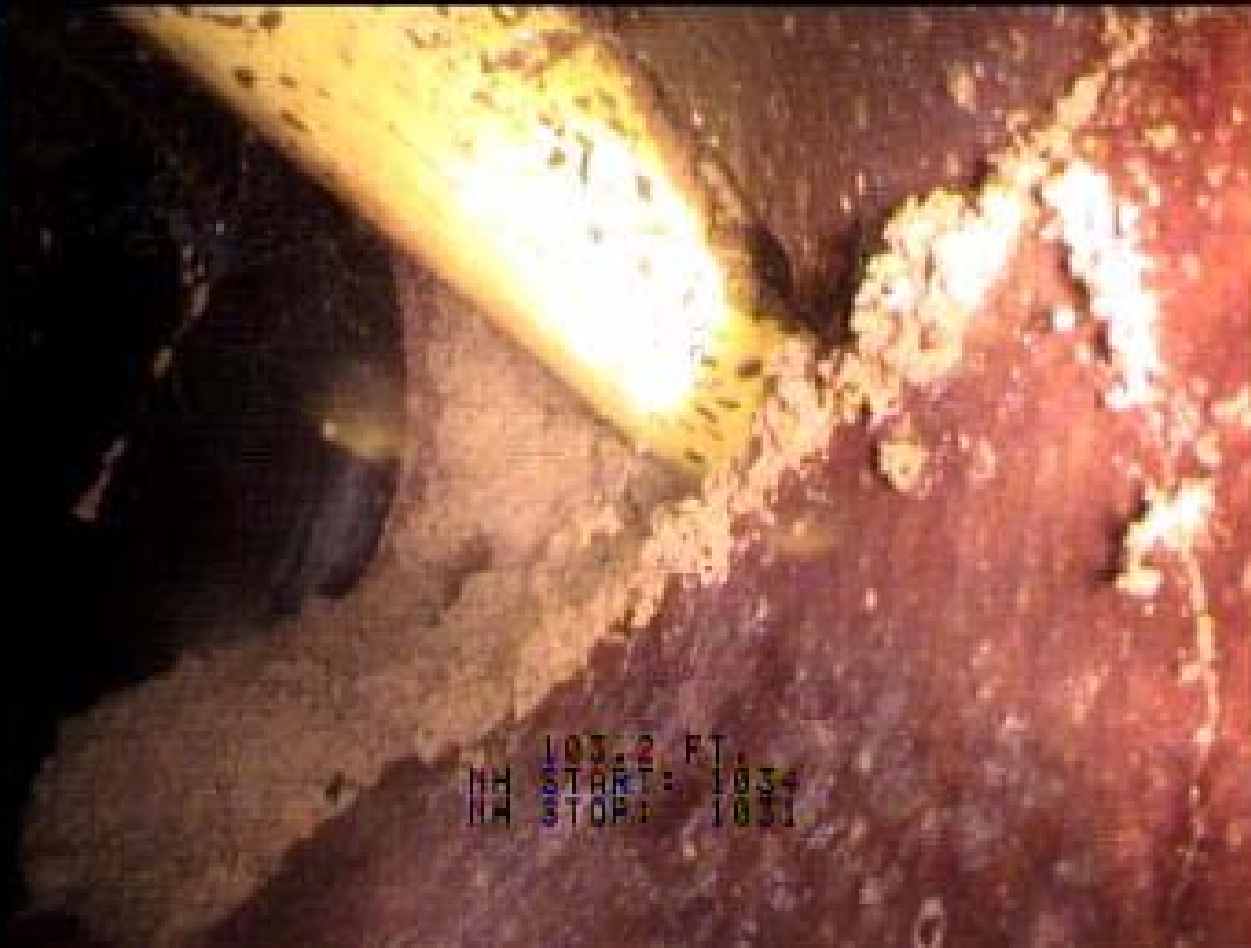
## Legacy Cross Bore

A cross bore created during prior construction activities
